APPENDIX A – PROBLEMS AND NEEDS MAPS

Problems and Needs Map - Walton Creek

Citywide Stormwater Master Plan
City of Steamboat Springs, Colorado

Figure
A-1

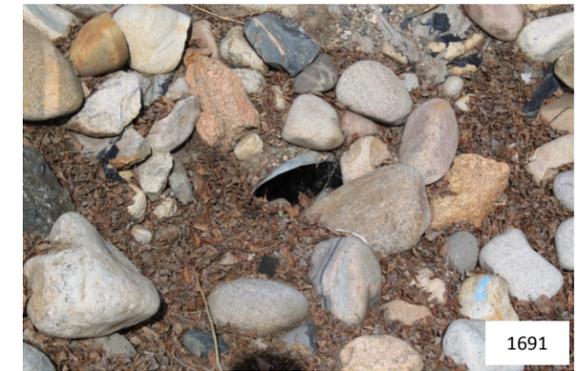
Location: North side of Stone Circle East of Chinook Lane.
Problem/Solution: Remove sediment and debris from buried 18-inch CMP and replace.

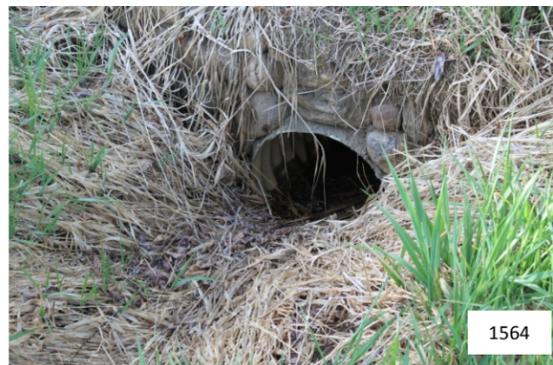
Location: East of Lincoln Avenue beneath Walton Creek Trail that outfalls into Walton Creek.
Problem/Solution: Remove vegetation and debris and add a flap gate to existing 18-inch CMP.

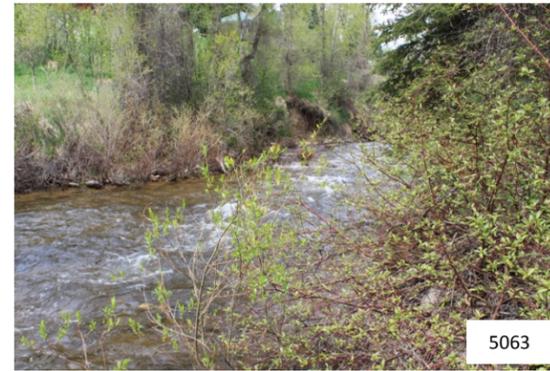
Location: Along Soda Creek upstream from Pahwintah Street.

Problem/Solution: Repair erosion damage and install bank protection/stabilization.

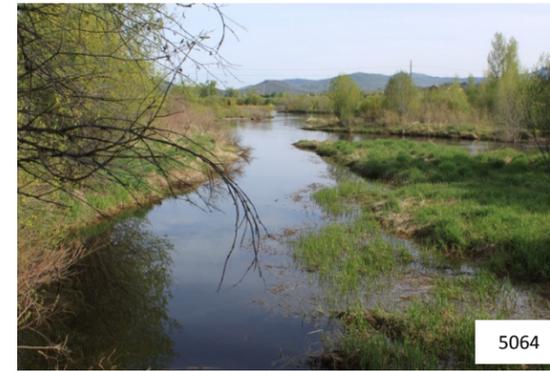
Location: Downstream end of Walton Creek where it outfalls into the Yampa River.

Problem/Solution: Evidence of sandbags.

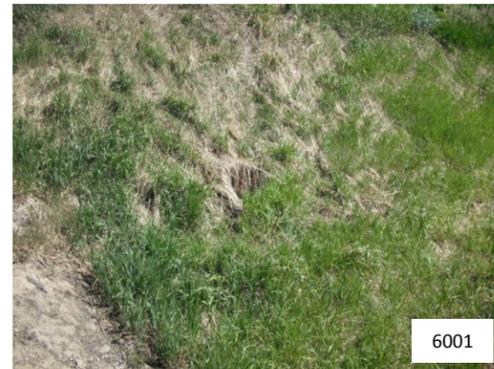
Location: At Whistler Road along the Bear Creek Trail.

Problem/Solution: Repair erosion damage.

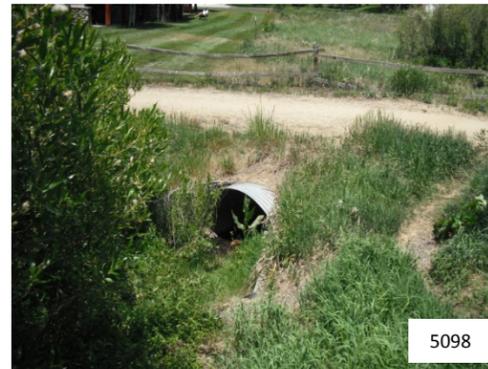
Location: Under Bear Creek Trail Crossing in between Whistler Road and Meadow Lane.

Problem/Solution: Remove sediment from existing 60-inch CMP.

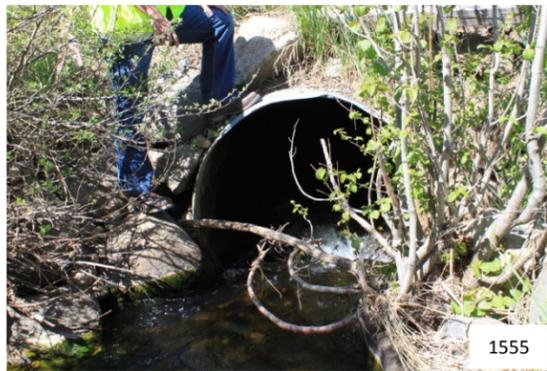
1555

Location: On Lake Drive North of Walton Creek Road
Problem/Solution: Undersized 48-inch CMP requires replacement to ensure no overtopping of Walton Creek Road by Burgess Creek. Pipe entrance and exit zones require maintenance to clear vegetation and debris.

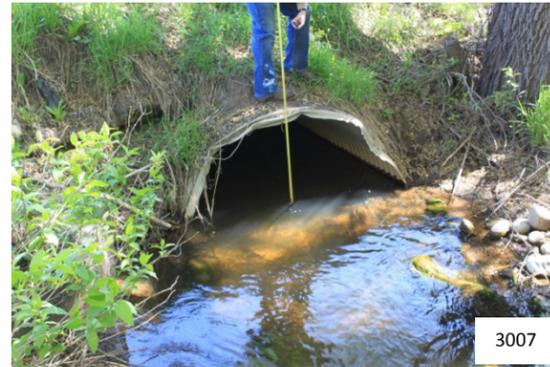
3007

Location: South side of Walton Creek Road
Problem/Solution: Replace undersized 48-inch CMP beneath Walton Creek Road. Clear vegetation, sediment, and debris to restore capacity.

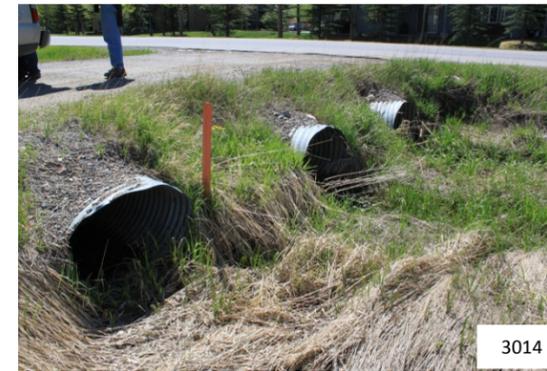
3014

Location: North side of Walton Creek Road, west of Eagle Ridge Drive
Problem/Solution: Triple 30-inch CMPs require maintenance: Clean out sediment and clear out vegetation and debris at outfalls.

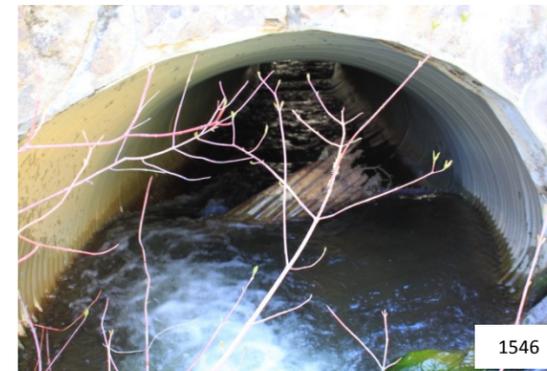
1546

Location: Beneath pedestrian trail crossing between Eagle Ridge Drive and Eagle Glen Road
Problem/Solution: Replace/upsized existing CMP. Short term, remove torn corrugated metal obstruction and other debris.

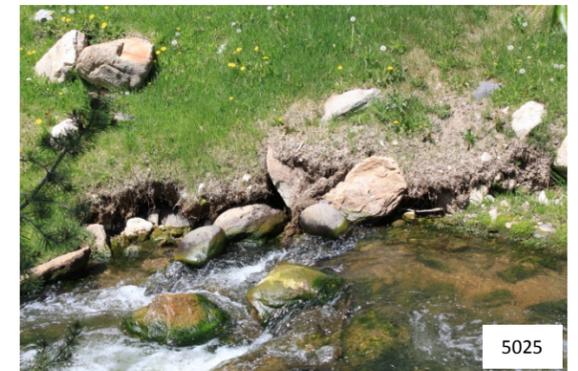
5025

Location: On Burgess Creek, downstream of Eagle Ridge Drive crossing
Problem/Solution: Repair right bank erosion upstream of pedestrian bridge.

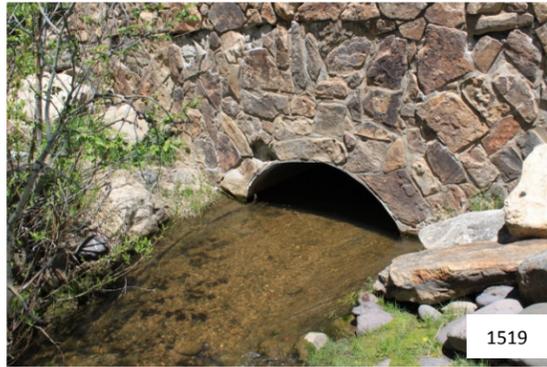
Location: Culvert at Eagle Ridge Drive
Problem/Solution: Culvert replaced summer of 2012.

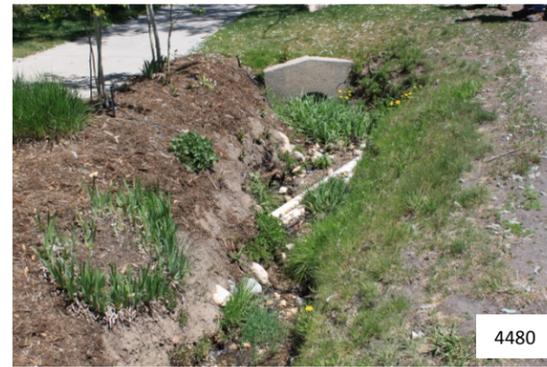
Location: Roadside swale on North side of Eagle Ridge Drive, just west of culvert crossing
Problem/Solution: Clean out 24-inch CMP, remove vegetation, and restore grade. Investigate status of exposed pipe/conduit.

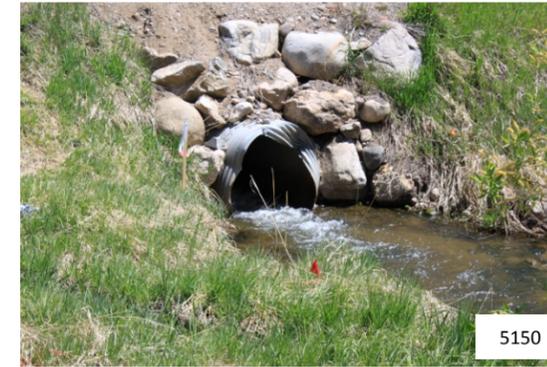
Location: West of Village Drive, South of Highmark Hotel.
Problem/Solution: Repair damaged 60-inch CMP outfall beneath Village Drive. Install flared end section and outfall protection.

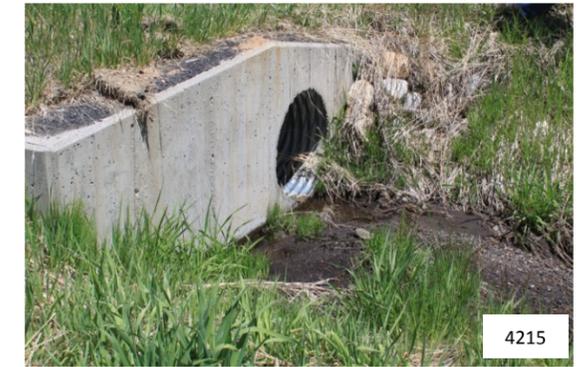
Location: West of Village Drive, in parking lot of Highmark Hotel.
Problem/Solution: Install outlet protection around 30-inch CMP outfall from north.

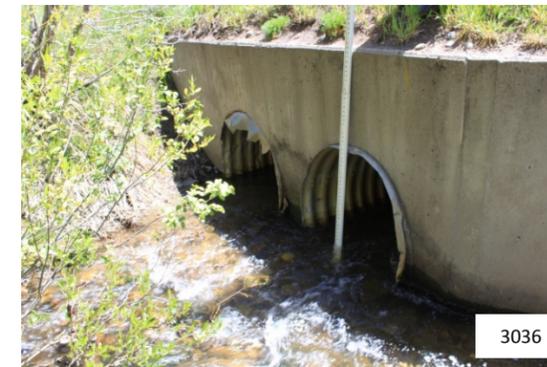
Location: North side of Apres Ski Way near Village Drive
Problem/Solution: Remove sediment and debris to restore capacity to twin 48-inch CMPs. Repair damaged sheet metal to ensure no blockage of flows.

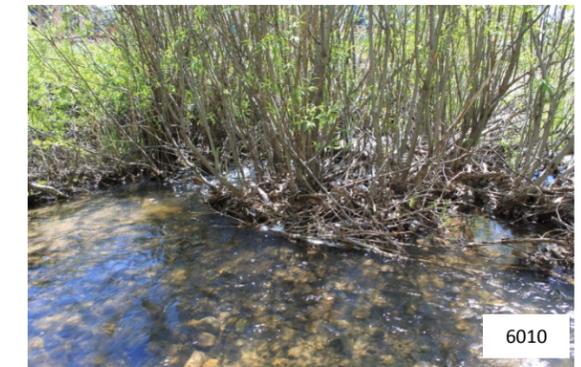
Location: North side of Apres Ski Way near Village Drive
Problem/Solution: Clear "debris dam" from Burgess Creek to restore full flow capacity.

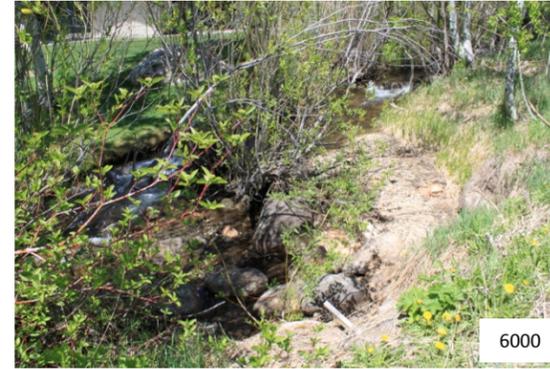
Location: In between Ski Time Square Drive and Burgess Creek Road
Problem/Solution: Repair erosion damage and install bank protection/stabilization.

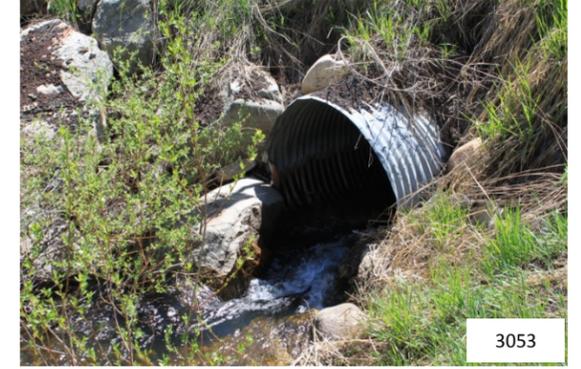
Location: At the intersection of Burgess Creek Road and Storm Meadows Drive
Problem/Solution: Install entrance protection around 48-inch CMP beneath Storm Meadows Drive and remove blockages and sediment to ensure full capacity.

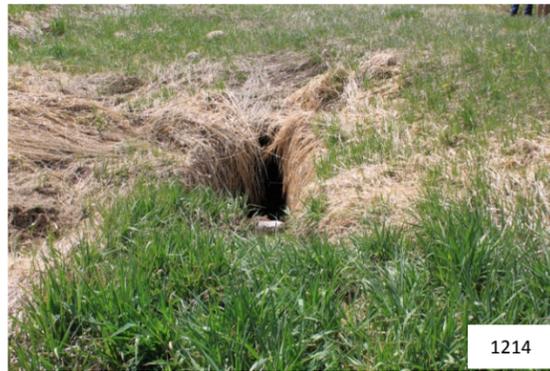
Location: North side of Rockies Way just East of Montview Drive.

Problem/Solution: Remove vegetation and debris from buried 36" CMP and replace.

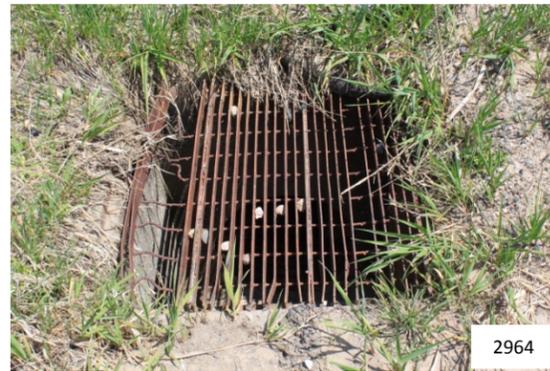
Location: Under Mount Werner Road just east of Montview Lane.

Problem/Solution: Remove vegetation from runoff ditch and replace 3'X3' inlet grate and 24-inch CMP.

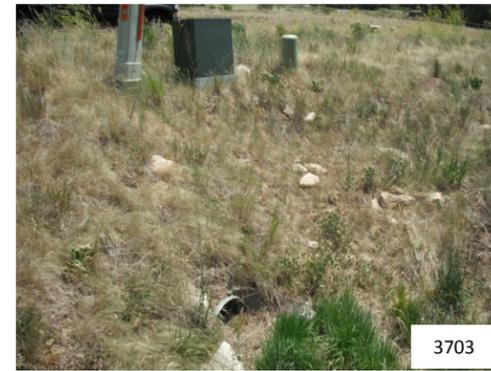
Location: Near end of cul-de-sac under Angels View Way.

Problem/Solution: Remove sediment and debris from 18-inch CMP.

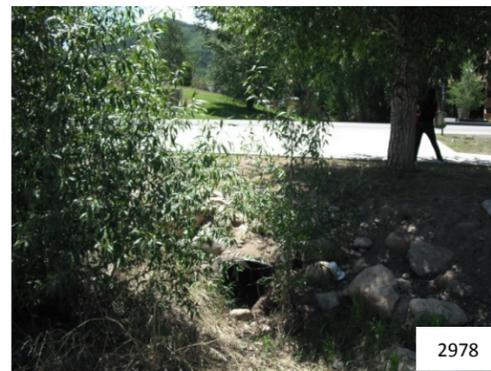
Location: At intersection of Angels View Way and Pine Grove Road.

Problem/Solution: Replace damaged 30-inch CMP on East side of Pine Grove Road by City Market.

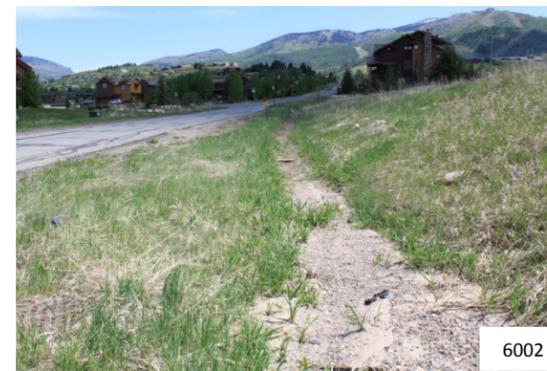
Location: Roadside swale on south side of Rockies Way, just west of Steamboat Boulevard.

Problem/Solution: Remove accumulated sediment and restore grade; consider check dams to slow velocities and enhance sediment removal.

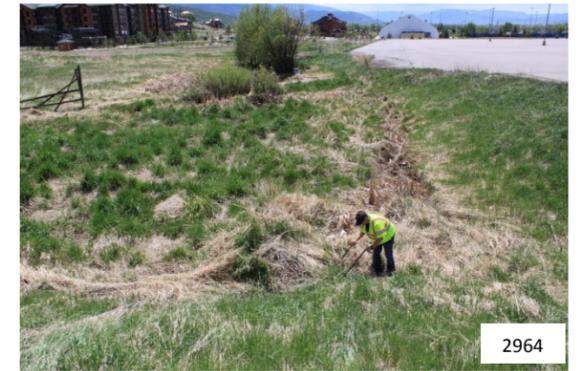
Location: Looking south from Mount Werner Road along embankment for missing culvert outlet.

Problem/Solution: Locate outlet for culvert crossing or study basin further to establish flowpath.

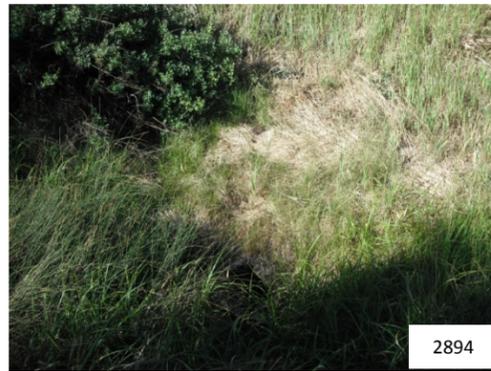
Location: Under Hilltop Parkway South of Tamarack Drive

Problem/Solution: Remove vegetation and replace 18" CMP with squashed entrance.

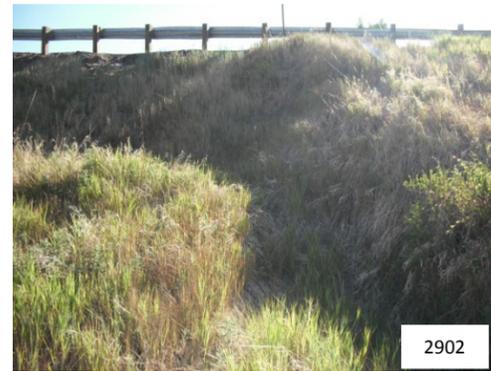
Location: At intersection of Hilltop Parkway and Tamarack Drive

Problem/Solution: Unable to locate outlet pipe but photos show evidence and erosion present. Clean up vegetation and install erosion control.

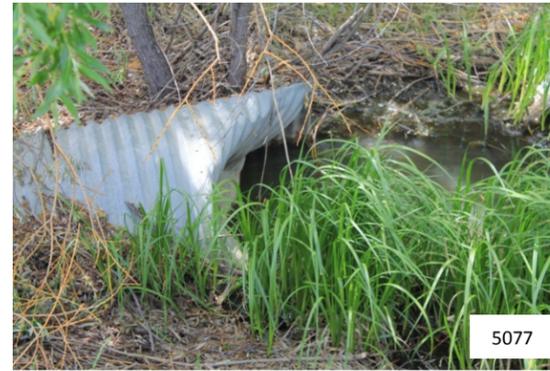
Location: Under entrance West of Lincoln Avenue and North of Trafalgar Drive.
Problem/Solution: Remove standing water and repair / replace crushed CMP.

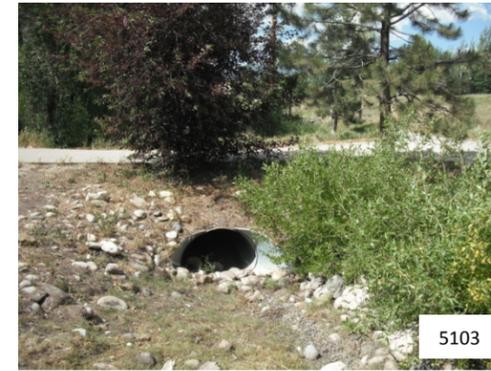
Location: Adjacent to the Pet Kare Clinic west of Lincoln Avenue
Problem/Solution: Remove sediment and debris at both ends of this 36-inch CMP adjacent to the Pet Kare Clinic.

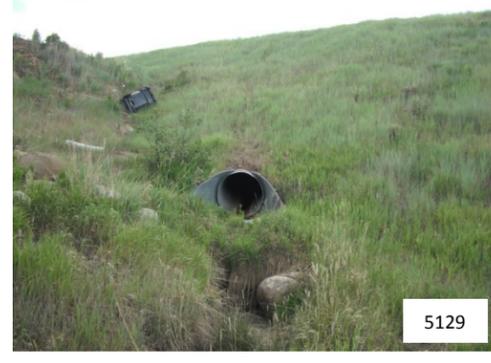
Location: Underneath Hilltop Lane just east of intersection with Longview Circle.
Problem/Solution: Repair erosion damage 5' downstream of 36-inch CMP.

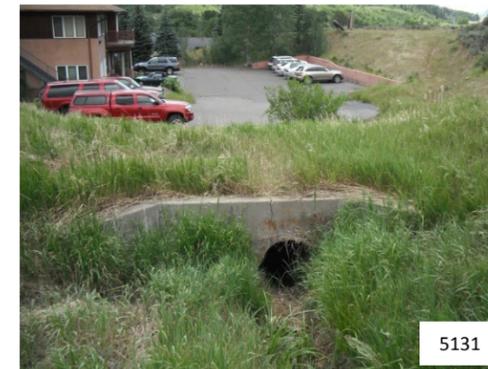
Location: East of Lincoln Avenue behind Anchor Realty.
Problem/Solution: Remove vegetation and locate discharge outfall end to 24-inch CMP.

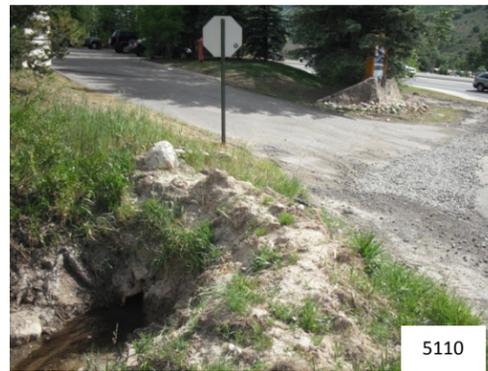
Location: Beneath driveway off High Point Drive
Problem/Solution: Replace existing squashed 15-inch CMP

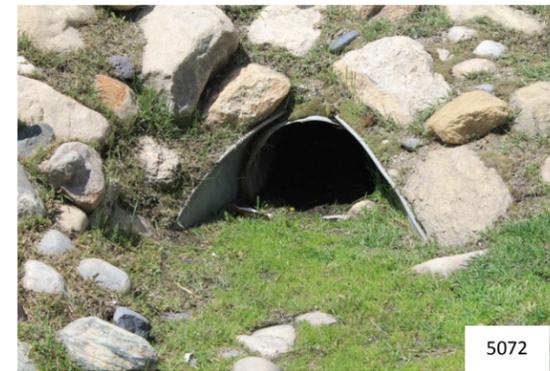
Location: Along north side of Hilltop Parkway at Lincoln Avenue
Problem/Solution: Replace existing squashed and silted 15-inch CMP

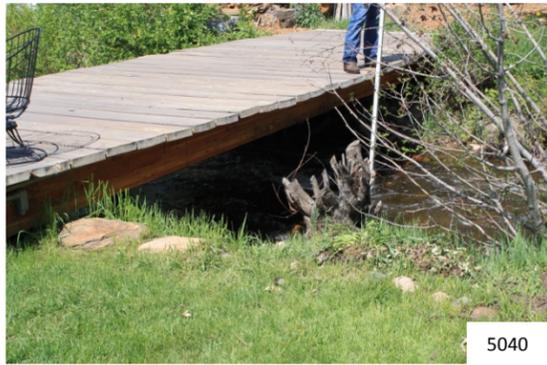
Location: Private deck over Spring Creek, just downstream of 2nd and Pine Streets.

Problem/Solution: Check hydraulic capacity of Spring Creek beneath deck to minimize flood hazards and risks associated with backwater and overtopping.

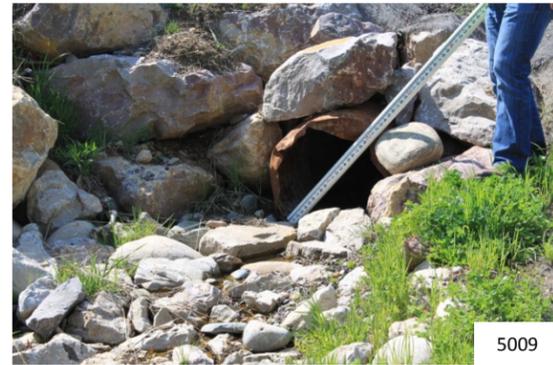
Location: 24-inch CMP beneath Fish Creek Falls Road.

Problem/Solution: Clean and inspect for overall condition and replace, if necessary.

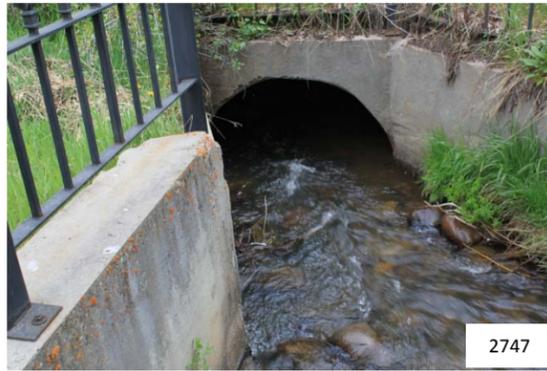
Location: Upstream end of CMP culvert crossing at intersection of Pine Street and 6th Street.
Problem/Solution: Overall condition is poor; evidence of overtopping suggests capacity issues are likely.

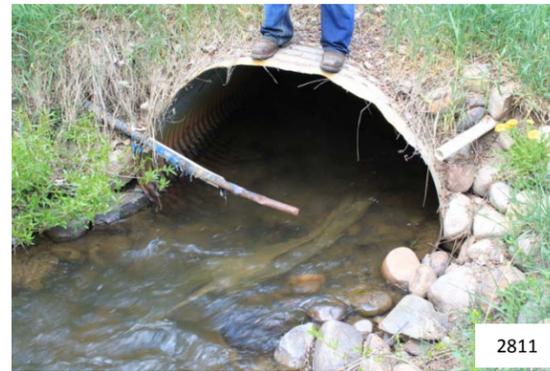
Location: Downstream end of 60-inch CMP beneath Butcherknife Alley at Larimer Street.
Problem/Solution: Invert of 60-inch CMP is completely rusted away. Replace existing 60-inch CMP with culvert sized to convey the 100-year storm event without overtopping.

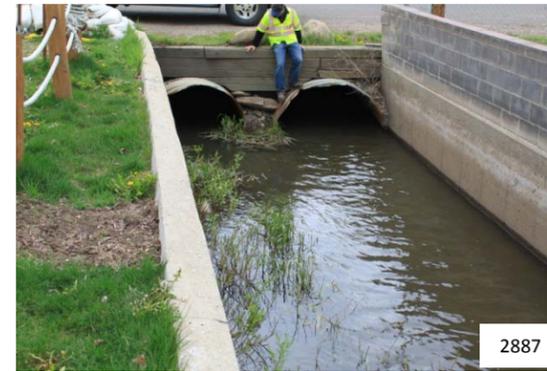
Location: Butcherknife Creek Twin 60-inch CMP outfall pipes just northwest of 6th Street.
Problem/Solution: Backwater from Yampa River decreases hydraulic capacity of Butcherknife system; explore flapgate system for outfall.

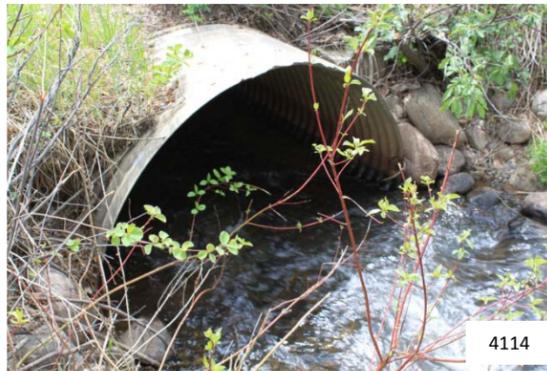
Location: Outfalls into Butcherknife Creek off of Eastern side of Spruce Street
Problem/Solution: Replace squashed elliptical 4966 CMP that outfalls into Butcherknife Creek.

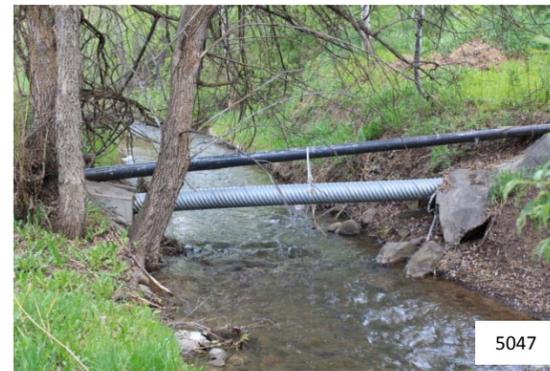
Location: South side of Hill Street between Grand and Larimer Streets.
Problem/Solution: Reconfigure utility pipe to remove obstruction of floodway.

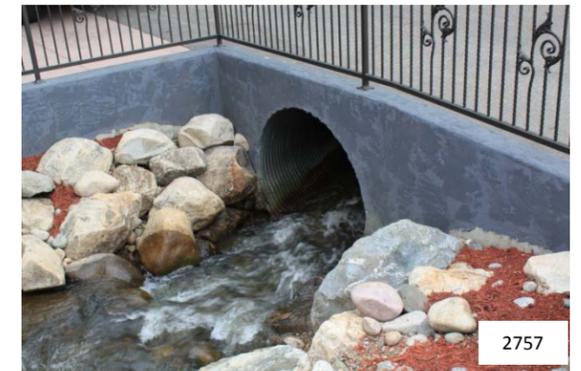
Location: 7th Street between Lincoln Avenue and Yampa Street.
Problem/Solution: 54-inch CMP is potentially undersized for updated hydrology and too close to public infrastructure and private property, creating the potential for flood hazards.

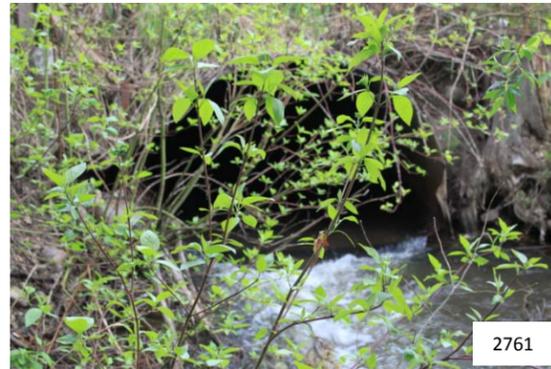
Location: Downstream end of 70-inch by 44-inch CMP structure beneath Oak Street.
Problem/Solution: Overall condition and capacity suggests replacement is necessary to prevent overtopping, potential collapse of Oak Street because of piping, and backwater effects.

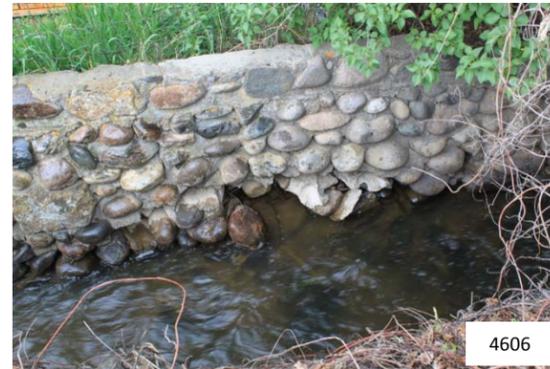
Location: Upstream of Oak Street in Butcherknife Creek.
Problem/Solution: Channel repair and stabilization required; a larger channel section is necessary to convey 100-year flows.

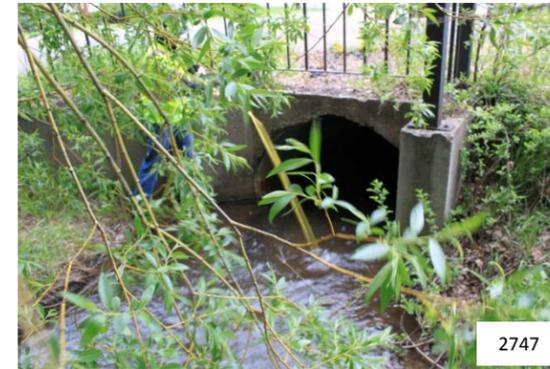
Location: Downstream end of CMP culvert crossing at Pine Street.
Problem/Solution: Overall condition of culvert is poor; exposed footing; potentially undersized for 100-year storm event.

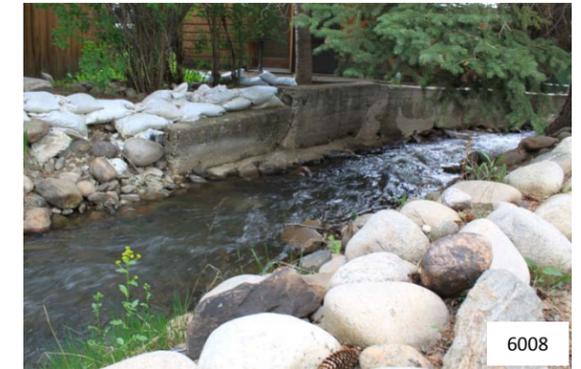
Location: 238 James Street.
Problem/Solution: Flooded home caused by close proximity of undersized channel, backwater caused by undersized culverts, and poor overall channel condition.

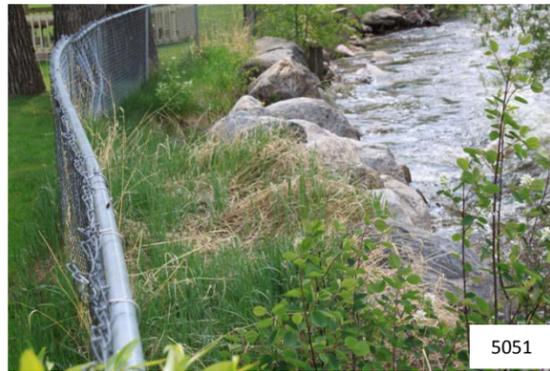
Location: Adjacent to Little Toots park.
Problem/Solution: Repair erosion damage and install bank protection/stabilization.

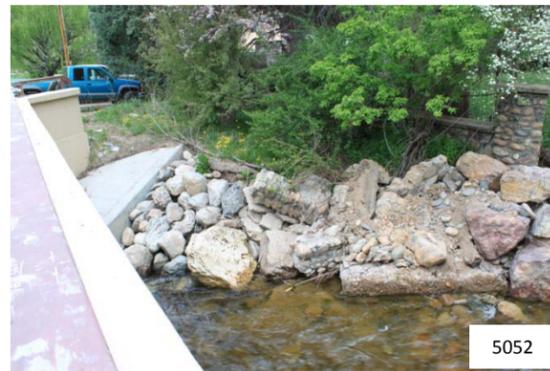
Location: Upstream side of Pine Street and bridge.
Problem/Solution: Repair erosion damage around bridge and install bank protection/stabilization.

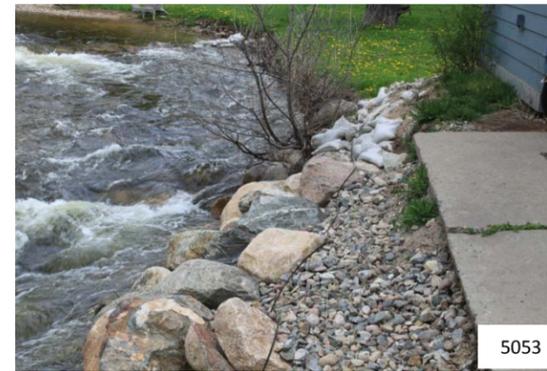
Location: Soda Creek at the northwest end of Grove Place.
Problem/Solution: Evidence of bank erosion and sandbags in close proximity to structure. Repair erosion damage and install bank protection/stabilization.

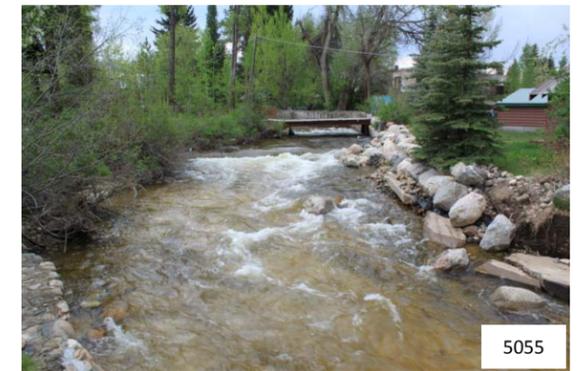
Location: Just upstream of Yahmonite / Aspen Street.
Problem/Solution: Repair collapsed wall and eroded wall and install bank protection along left bank downstream of the drop structure.

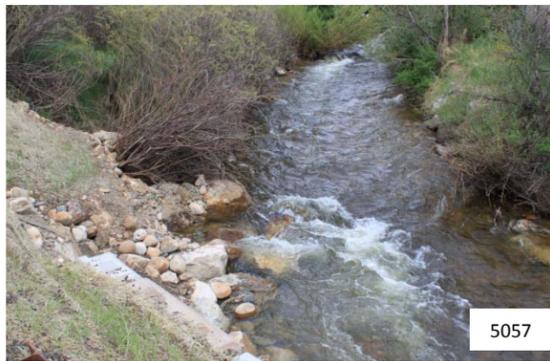
Location: Along 12th Street with intersection at Lincoln Avenue.
Problem/Solution: Repair erosion damage on northern and southern bank and install bank protection/stabilization along both banks.

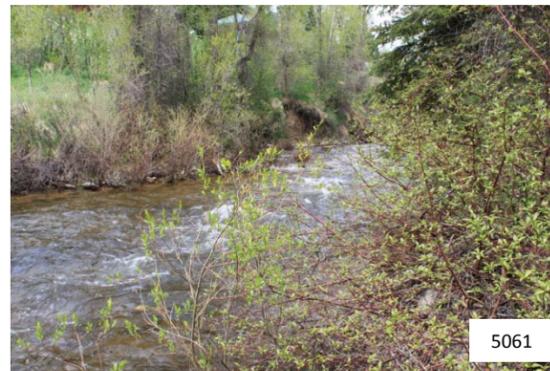
Location: Soda Creek upstream of Pahwintah Street.
Problem/Solution: Repair erosion damage and install bank protection/stabilization.

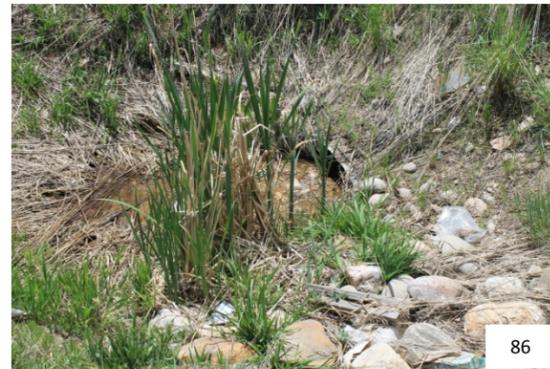
Location: Under Shield Drive intersecting with Yampa River Core Trail.
Problem/Solution: Remove rocks, silt, and vegetative growth from crushed CMP and replace.

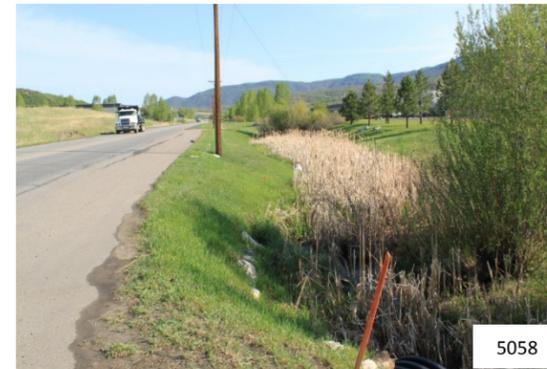
Location: At intersection of Elk River Road and Copper Ridge Drive.
Problem/Solution: Remove sediment and vegetative growth from roadside swale to restore capacity.

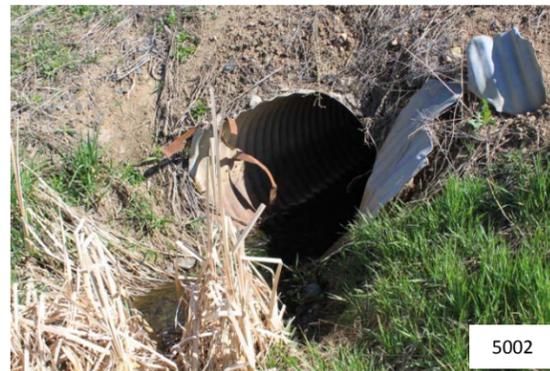
5002

Location: Outfalls into Yampa River and under Rail Road tracks East of Shield Drive.
Problem/Solution: Replace damaged 30-inch CMP with outfall pipe sized to convey 100-year storm flows.

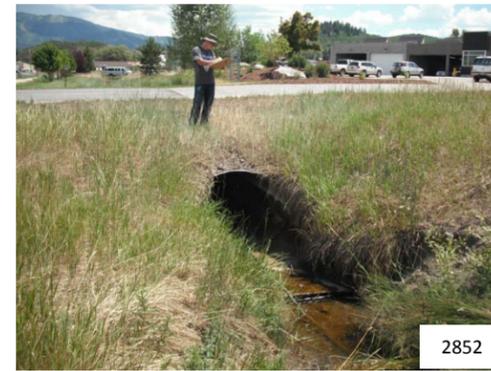
2852

Location: Under Critter Court off of 13th Street near the Transit Operations Center.
Problem/Solution: Remove sediment and debris and replace rusted 54-inch CMP.

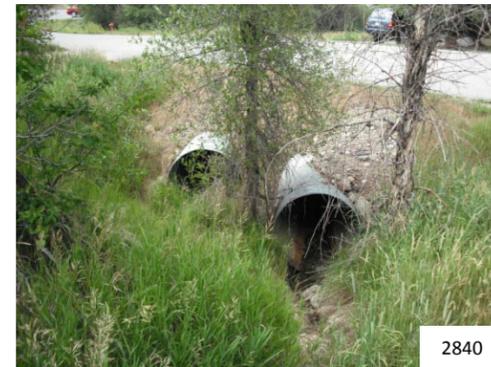
2840

Location: Under Manitou Avenue between Pitkin Street and Gilpin Street.
Problem/Solution: Remove sediment and debris and replace Twin 36-inch CMPs.

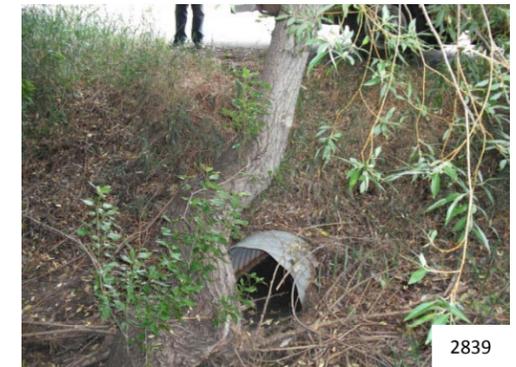
2839

Location: At Southwest corner of Glenwood Court and Manitou Avenue.
Problem/Solution: Remove sediment, debris, and trees, and replace 15-inch CMP that leads into a 24-inch CMP.

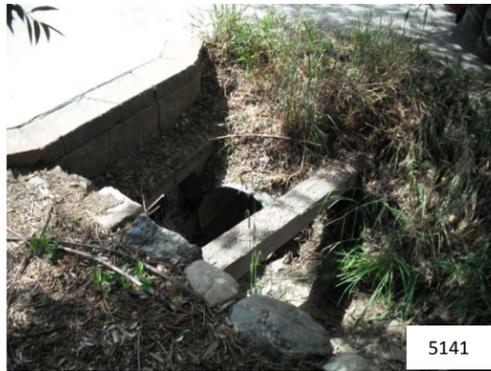
Location: Under Saratoga Avenue West of Gilpin Street.
Problem/Solution: Remove sediment from existing 24-inch CMP.

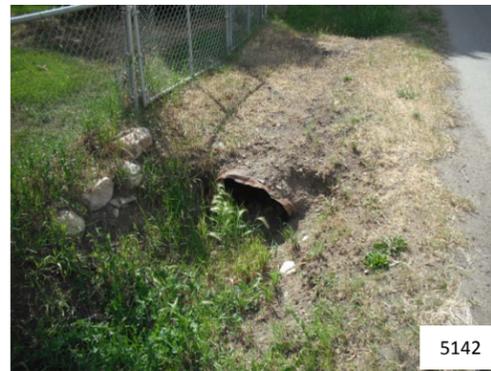
Location: On south side of 13th Street, Northwest of Gilpin Street.
Problem/Solution: Replace 24-inch CMP driveway culvert with missing invert.

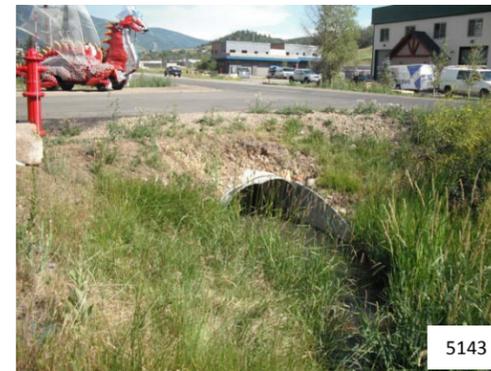
Location: South side of 13th St near Ferrell Gas
Problem/Solution: Remove sediment and vegetative growth standing water from outlet to existing CMP.
