COLORADO CULTURAL RESOURCE SURVEY

Architectural Inventory Form

- 1. Resource number: **5RT.2662** Parcel number(s): **115210032**
- 2. Temporary resource number: **N/A**
- 3. County: **Routt**
- 4. City: **Steamboat Springs**
- 5. Historic Building Name: **House**
- 6. Current Building Name: **Williams House**
- 7. Building Address: **58 Spruce Street**
- 8. Owner Name: **Thomas D. & Kathleen A. Williams**
- Owner Organization:
- Owner Address: **2900 West Acres Dr #89
Steamboat Springs, Co 80487-5069**

47. Photograph number(s):	CD #2, Images 322-325	CDs filed at:	City of Steamboat Springs
48. Report title:	Old Town Steamboat Springs Residential Survey Phase VII		137 10th Street
49. Date(s):	11/08/2008		Steamboat Springs, CO 80477
50. Recorder(s):	Carl McWilliams Timothy Wilder		
51. Organization:	Cultural Resource Historians		
52. Address:	1607 Dogwood Court Fort Collins, CO 80525		
53. Phone number(s):	(970) 493-5270

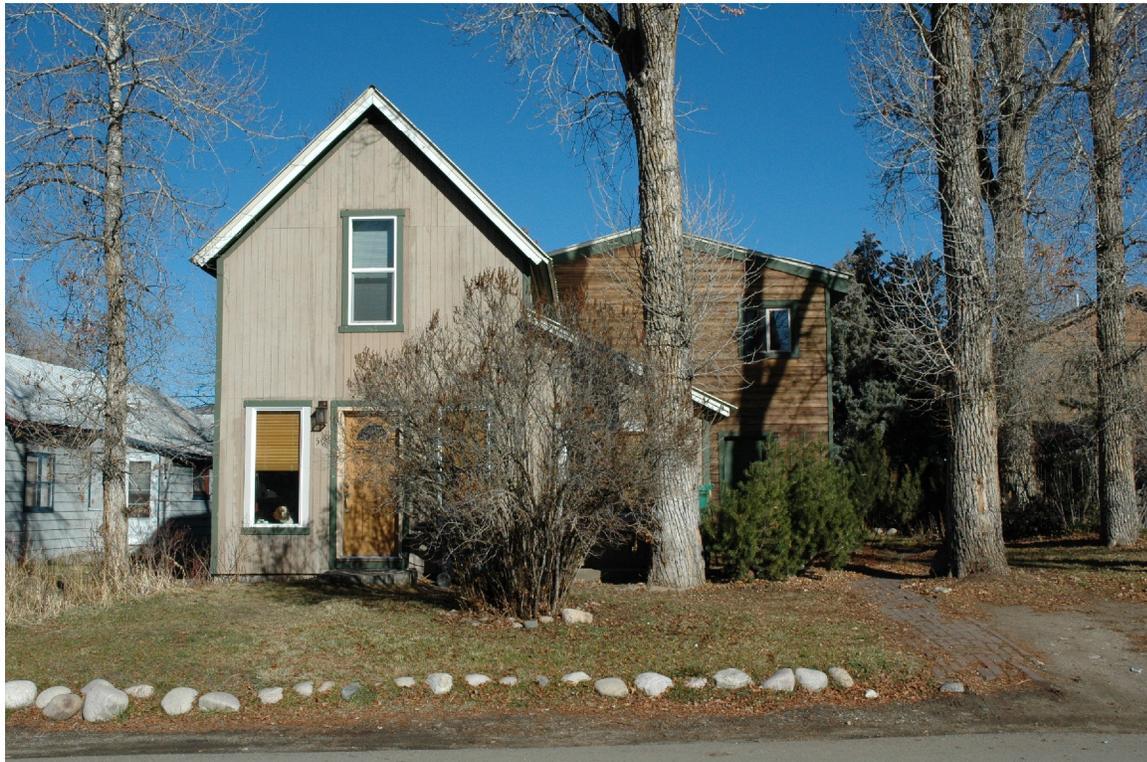
18. Roof configuration: **Gabled Roof/Front Gabled Roof**
19. Primary external roof material: **Metal Roof**
20. Special features: **Porch**
Balcony
21. General architectural description:
The residence at 58 Spruce Street is composed of three elements: a main 1½-story front gabled section which measures 28' N-S (deep) by 15' E-W (across); a single-story shed-roofed extension to the gabled section's east elevation, which measures 28' N-S by 8' E-W; and a gabled two-story addition to the east end of the north (rear) elevation which measures 24' by 24'. The entire house is supported by a low concrete foundation. The exterior walls of the original 1.5-story front gabled section and the shed-roofed extension are clad with beige color vertical wood siding. The gable and shed roofs are covered with metal roofing material, and the eaves on the main gabled section are boxed with painted green and white wood trim. Painted green rafter ends, covered by a painted white fascia board, appear beneath the eaves on the shed-roofed extension's east elevation. The home's windows include 1/1 double-hung sash, 1x1 horizontal sliders, and single-light fixed-panes, primarily with painted green wood surrounds. A stained natural brown wood-paneled front door, with a fan-shaped upper sash light, enters the façade (south elevation) from a small uncovered concrete block porch. The 24' by 24' addition features painted or stained brown horizontal weatherboard exterior walls, with painted green 1" by 4" corner boards, and it is covered by a low-pitched gable roof. The roof is covered with metal roofing material, and the eaves are boxed with painted green wood trim. A painted green wood-paneled door enters the addition's north elevation from a concrete block stoop and a brick-paved patio. A painted green solid wood door enters the addition on its south (front) elevation. A painted green wood-paneled door, covered by a painted green wood screen door, opens from the addition's second story onto a wooden balcony on the north elevation. The addition's windows include 1x1 horizontal sliders and vertically-oriented single-light fixed panes.
