COLORADO CULTURAL RESOURCE SURVEY

Architectural Inventory Form

- 1. Resource number: **5RT.3159** Parcel number(s):
- 2. Temporary resource no.: **N/A** **159502001**
- 3. County: **Routt**
- 4. City: **Steamboat Springs**
- 5. Historic building name: **Brookshire House**
- 6. Current building name: **Ralston Associates Architects et. al. Building**
- 7. Building address: **117 12th Street**
- 8. Owner name and address: **Robert S. Ralston & Betty M. Ralston**
P. O. Box 773627
Steamboat Springs, CO 80477-3627

48. Report title: **Old Town Steamboat Springs Residential Survey Phase IX**

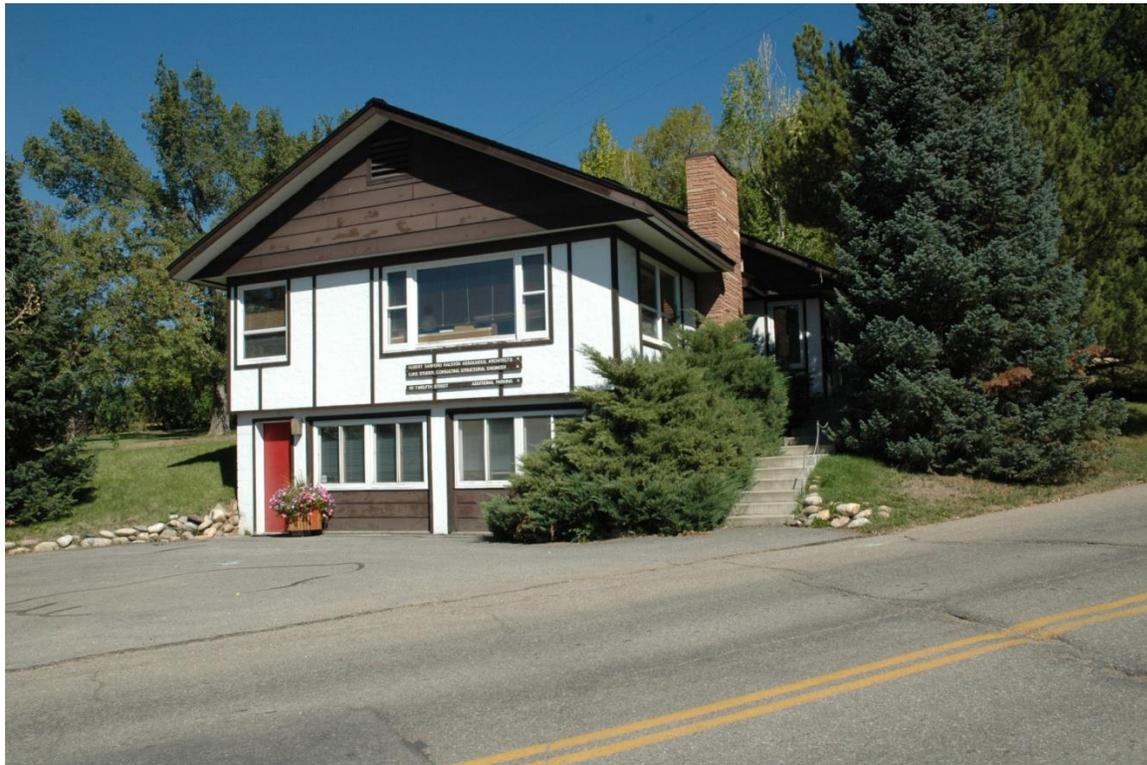
21. General architectural description:
This is a single-story, wood frame, building with a walkout basement on the south elevation. It is supported by a painted white concrete block foundation, and its exterior walls are clad with painted white stucco with stained or painted brown 1" by 4" corner boards. The moderately-pitched gable roof is covered with brown asphalt composition shingles. The eaves are boxed, with painted white and brown wood trim, while painted or stained brown horizontal wood siding appears in the upper gable ends. A large stone fireplace chimney is located on the façade (east elevation). A single-light fixed-pane window, flanked on either side by a narrow 1/1 double-hung sash window, penetrates the south elevation. Other windows include 1/1 double-hung sash, casements or awnings, and a glass block window on the north elevation. Thirteen concrete steps lead from 12th Street to the front entry on the east elevation. This entry provides access into "Robert Sanford Ralston Associates, Architects." A painted red solid wood door enters the walkout basement on the south elevation. Signs on the south elevation advertise: "Robert Sanford Ralston Associates Architects" and "Luke Studer Consulting Structural Engineer." A painted white entry door on the west elevation is covered by a painted white wood storm door. This rear entry door opens onto a concrete porch covered by an extension of the roof eave. A small, lower, gabled extension is located at the west end of the north elevation.
