COLORADO CULTURAL RESOURCE SURVEY

# Architectural Inventory Form

- 1. Resource number: **5RT.3146** Parcel number(s):
- 2. Temporary resource no.: **N/A** **145033002**
- 3. County: **Routt**
- 4. City: **Steamboat Springs**
- 5. Historic building name: **Warm's Body Shop, J&B Body Shop, Brummett Realty**
- 6. Current building name: **McGill Law Building**
- 7. Building address: **1107 Lincoln Avenue**
- 8. Owner name and address: **1107 Building Inc.**  
**P. O. Box 773058**  
**Steamboat Springs, CO 80477-3058**

48. Report title: **Old Town Steamboat Springs Residential Survey Phase IX**

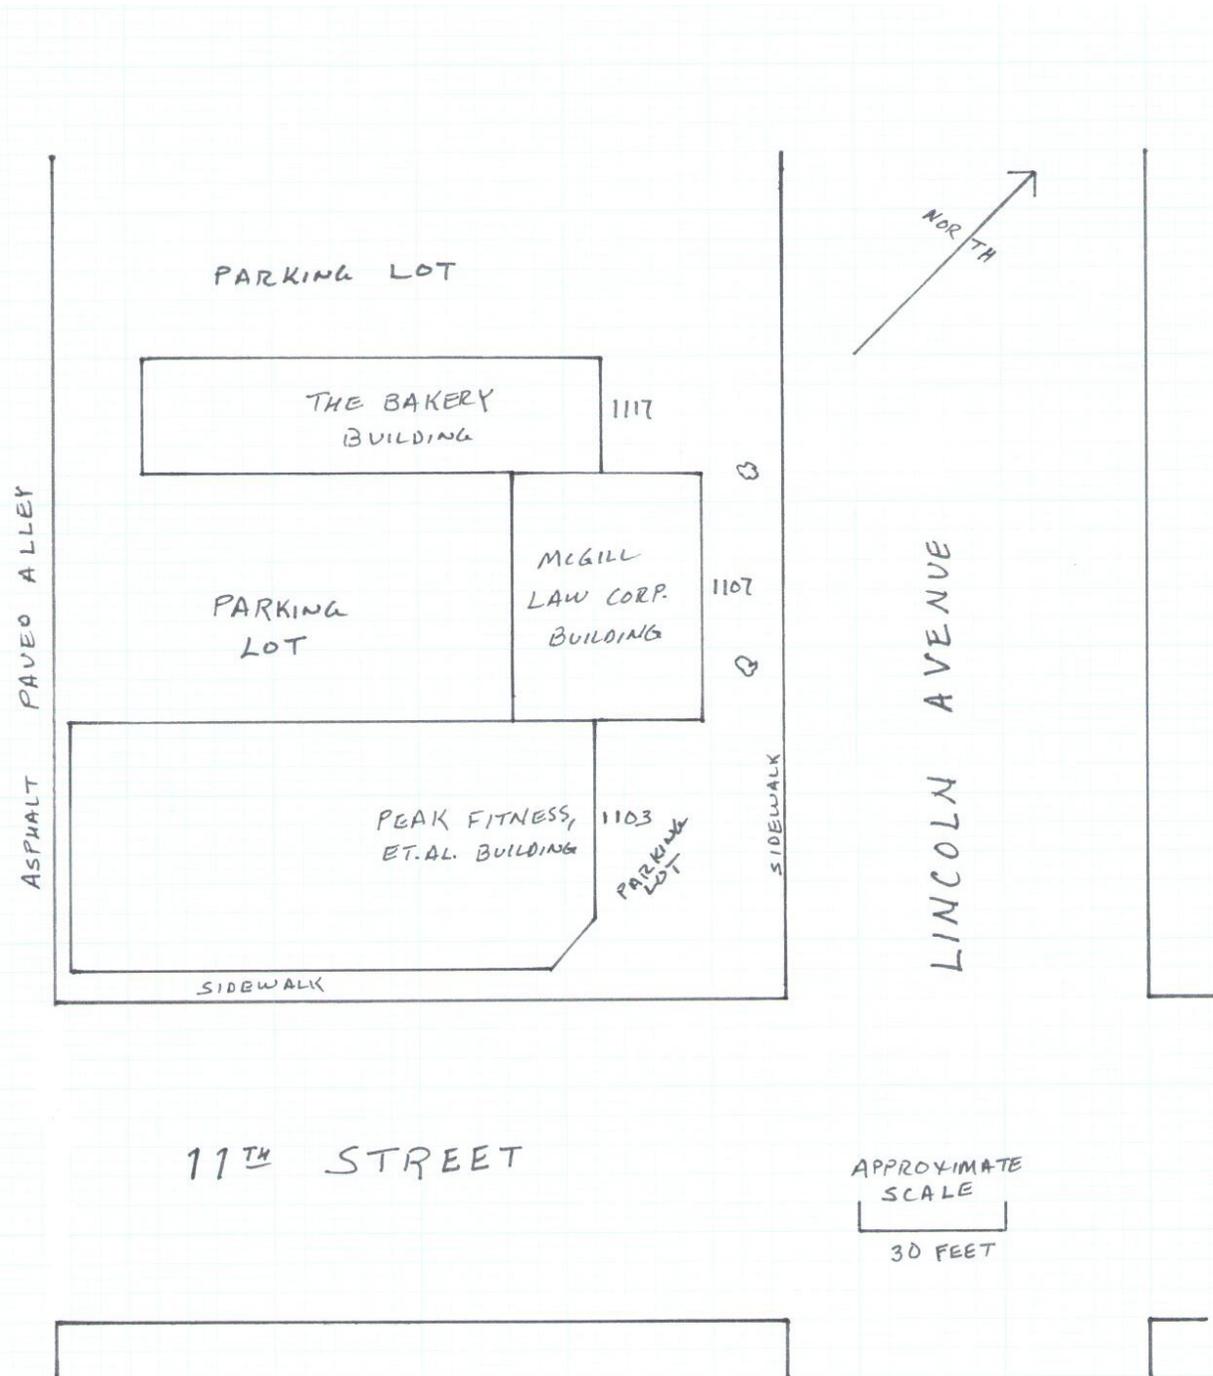
### Sketch Map

**This building is located on the southwest side of Lincoln Avenue in the block between 11th and 12th Streets. A wide concrete sidewalk with brick pavers parallels the building's facade (northeast elevation) along Lincoln Avenue. Two deciduous trees are planted among the brick pavers. An asphalt paved parking lot and alley are located behind the building to the southwest. This building is located between the "Peak Fitness" building at 1103 Lincoln Avenue to the southeast, and the "Bakery" building at 1117 Lincoln Avenue to the northwest.**
