COLORADO CULTURAL RESOURCE SURVEY

Architectural Inventory Form

- 1. Resource number: **5RT.3154** Parcel number(s):
- 2. Temporary resource no.: **N/A** **288400001**
- 3. County: **Routt**
- 4. City: **Steamboat Springs**
- 5. Historic building name: **Dodd Diesel Building**
- 6. Current building name: **Back Door Sports / Wheels Building**
- 7. Building address: **841 Yampa Street**
- 8. Owner name and address: **River Front Partners LLC**
111 N. 181st Street, Suite 202
Elkhorn, NE 68022-4713

48. Report title: **Old Town Steamboat Springs Residential Survey Phase IX**

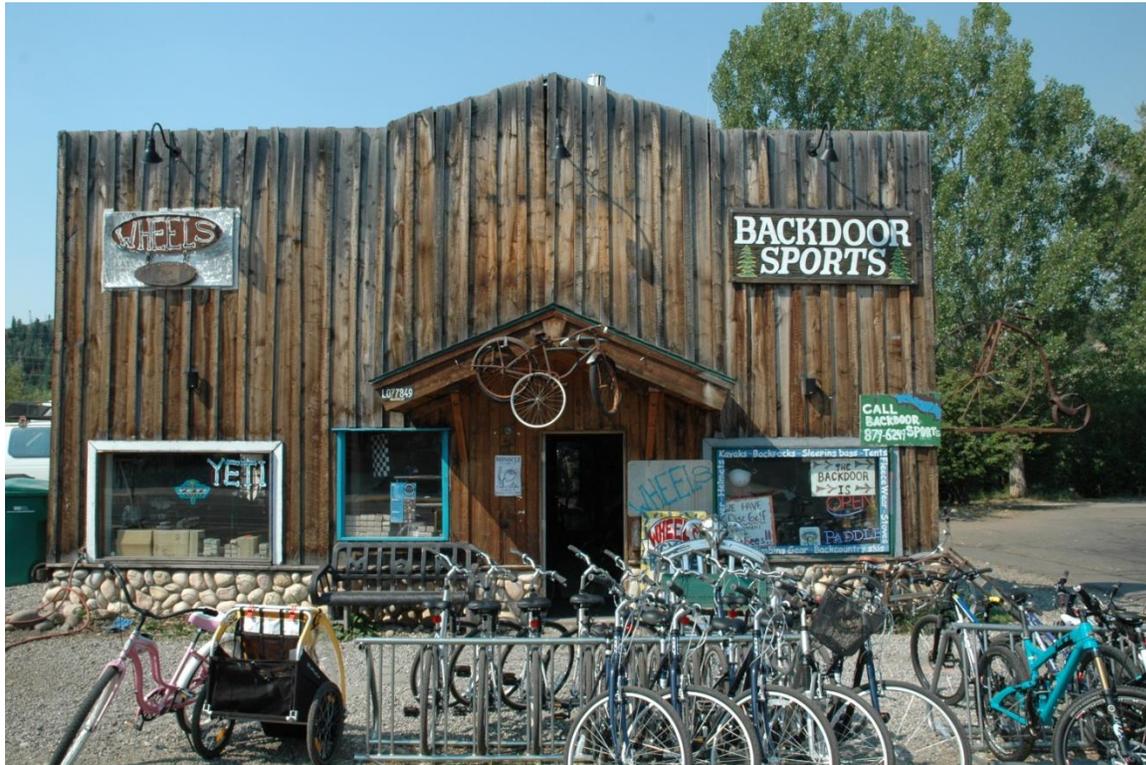
18. Roof configuration: **Gabled Roof / Front Gabled Roof**
19. Primary external roof material: **Metal Roof**
20. Special features: **False Front**
21. General architectural description:
This rectangular-shaped building is supported by an unpainted poured concrete foundation which is faced with river rock on the northeast elevation (façade). The exterior walls are made of stained brown board-and-batten, except for the southwest (rear) elevation which is clad with white corrugated metal. The façade wall false front with a centered gabled pediment. Two signs are affixed to the façade wall, one advertising "BACKDOOR SPORTS" and the other advertising "WHEELS SALES PARTS SERVICE SINCE 1996." A painted turquoise with black trim wood-paneled door, with one upper sash light, enters the façade beneath a gabled porch roof with knee brace supports. The façade wall is also penetrated by three single-light fixed-pane windows. The southwest elevation wall is penetrated by a painted green glass-in-wood-frame door, and by two single-light fixed-pane windows. One of these windows is vertically oriented, and the other is square. The northwest (side) elevation is penetrated by three 1x1 horizontal sliding windows and by one single-light fixed-pane window. The southeast (side) elevation is penetrated by two 1x1 horizontal sliding windows and by one single-light fixed-pane window. A small shed-roofed extension is located at the southeast end of the southwest elevation.

Oral sources indicate that this building was erected circa 1976 as a diesel repair shop. The false front façade was erected by Pete Vandecarr in 1993. He is the owner of Backdoor Sports, a retail business located in the building since 1990. The original building, now hidden behind a false front façade, is rectangular in shape, front gabled, and with metal-clad walls.
