COLORADO CULTURAL RESOURCE SURVEY

# Architectural Inventory Form

- 1. Resource number: **5RT.2792** Parcel number(s):
- 2. Temporary resource no.: **N/A** **115210014**
- 3. County: **Routt**
- 4. City: **Steamboat Springs**
- 5. Historic building name: **Trask House; Mulkey House; Brannick House**
- 6. Current building name: **Kleman House**
- 7. Building address: **25 Missouri Avenue**
- 8. Owner name and address: **Susanne E. Kleman**  
**P. O. Box 772694**  
**Steamboat Springs, CO 80477-2694**

48. Report title: **Old Town Steamboat Springs Residential Survey Phase VIII**

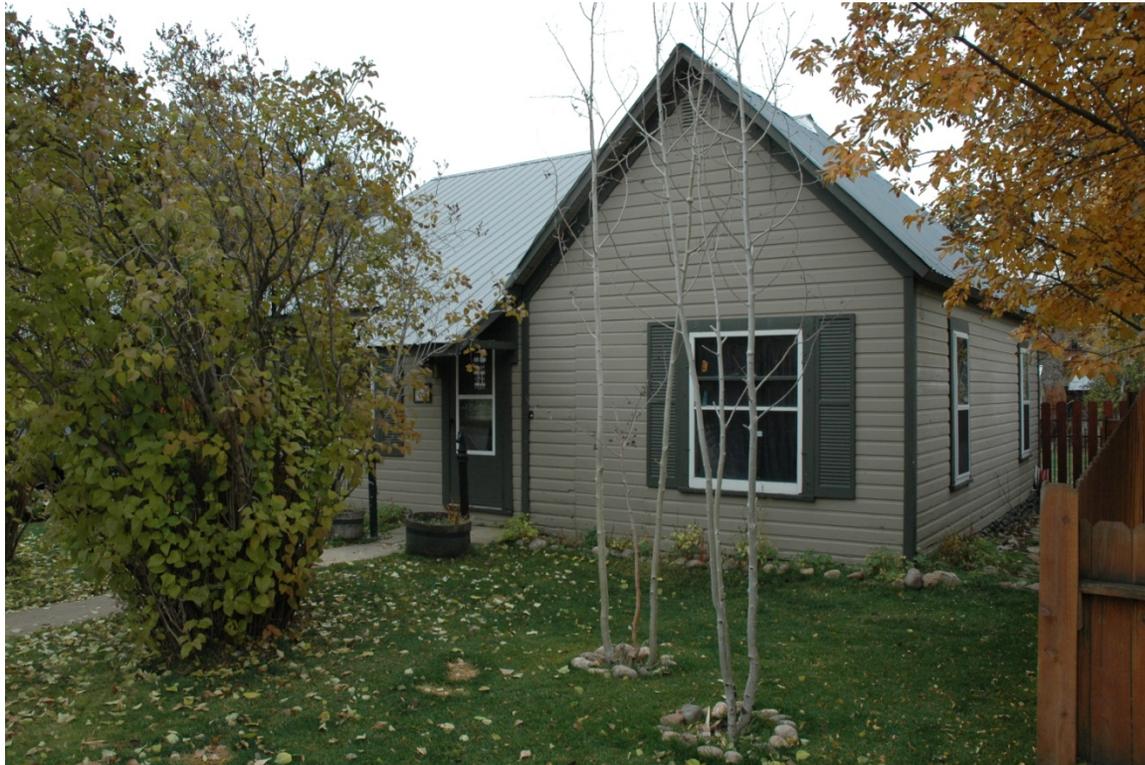
**This 1½-story wood frame house is supported by a low river rock and concrete foundation, and its exterior walls are clad with beige color horizontal weatherboard siding with painted dark green 1' by 4" corner boards. The moderately-pitched cross gable roof is covered with metal roofing material, while delicate rafter ends, covered by a painted dark green fascia board, are exposed beneath the eaves. A brown brick chimney is located on the roof ridge. The home's windows are primarily single, paired, and tripled 1/1 double-hung sash with painted dark green wood frames and surrounds. Windows on the façade (north elevation), facing Missouri Avenue, also have painted dark green decorative wood shutters. A painted dark green and grey wood-paneled front door, with one upper sash light, and covered by a green metal storm door, enters the façade from a small concrete porch covered by a shed roof with knee brace supports. A rear entry door leads into an enclosed shed-roofed rear section of the house on the south elevation.**

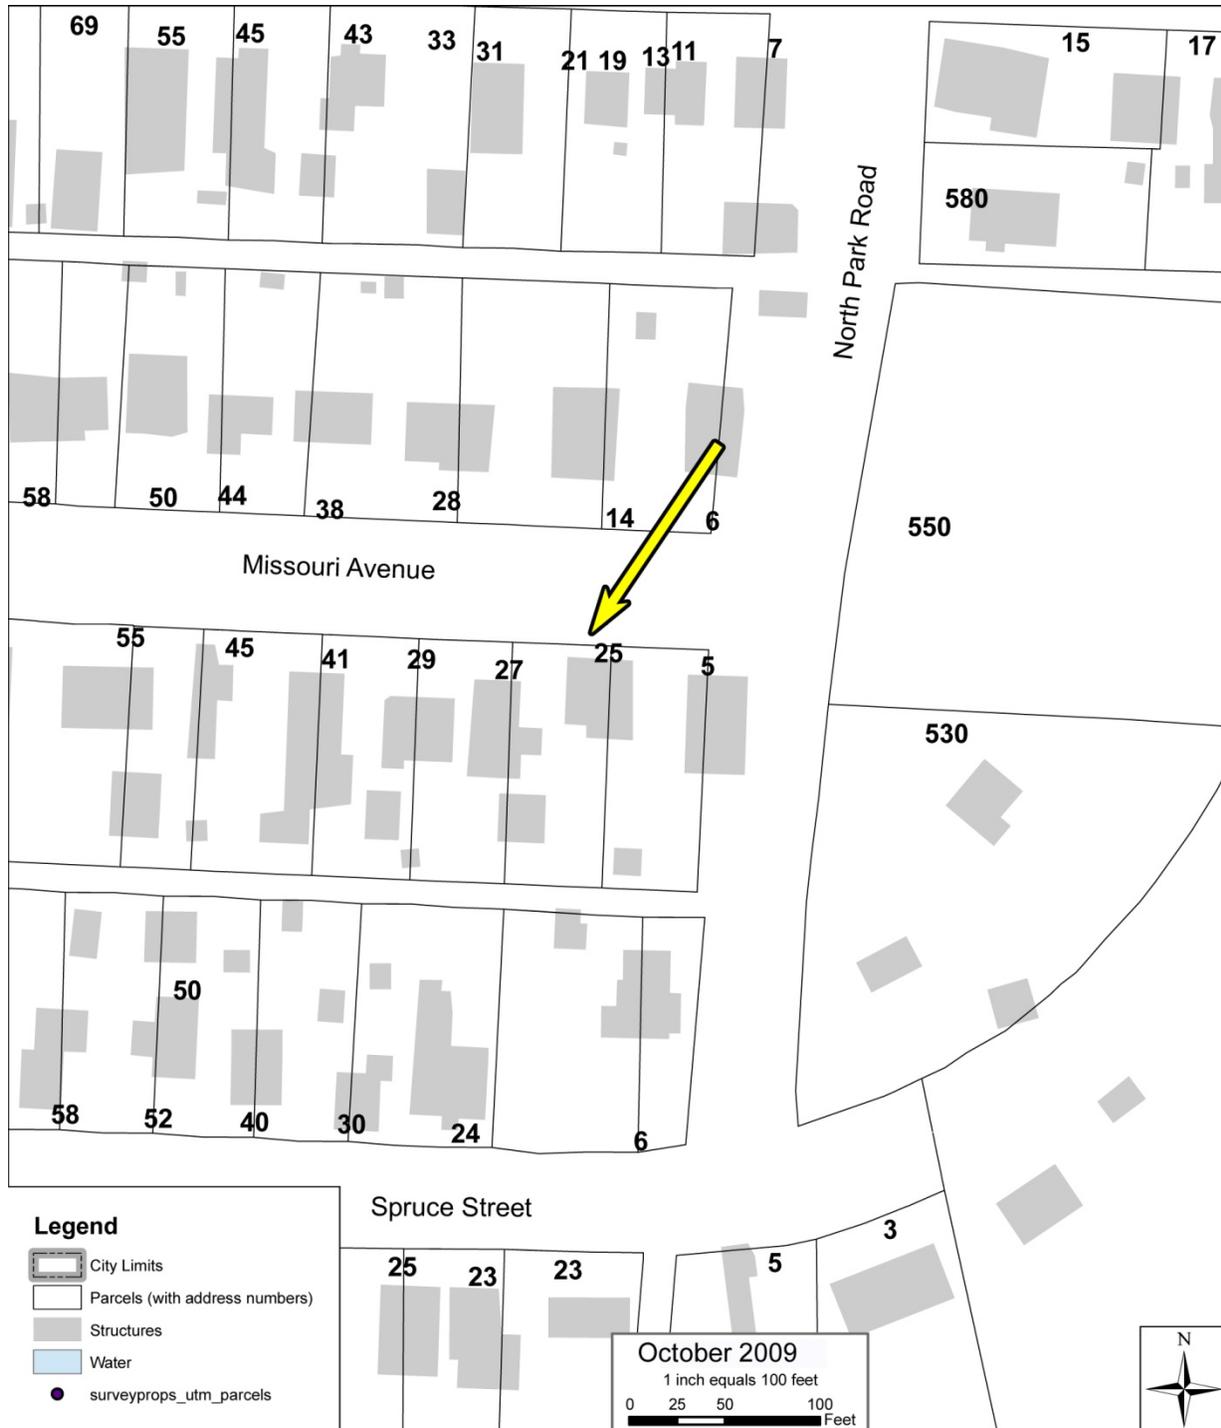
### Sketch Map

23. Landscaping or special setting features: **This well-maintained property is located on the south side of Missouri Avenue, the second property west of the east end of Missouri Avenue where it intersects with North Park Road. A planted grass front yard is nicely landscaped with low native plants and flowers along the perimeter of the house. Twin wood shrubs flank the front sidewalk. A modern black wrought iron and wood post fence encloses a large backyard.**

**A wood frame barn is located adjacent to the alley at the rear of the property. This building consists of: a main 1½-story gambrel-roofed section, which measures approximately 16' N-S by 12' E-W; and a lower, single-story, shed-roofed extension to the west elevation which measures approximately 16' N-S by 6' EW. The barn is supported by a concrete slab foundation, and its exterior walls are clad with stained natural brown vertical wood siding except for the east elevation which is clad with older plywood. The gambrel roof over the main 1½-story section is steeply-pitched, and is covered with corrugated metal roofing material laid over 1x wood decking. A set of paired plywood and 1x wood doors, side-hinged with metal strap hinges, open toward the alley on the south elevation. A vertical wood plank hayloft door, side-hinged with metal strap hinges, is located in the south elevation's upper gable end. A low vertical wood plank door, with X-bracing, and side-hinged with metal strap hinges, enters the shed-roofed extension at the west end of the south elevation. Another vertical wood plank door opens into the backyard on the north elevation. A non-historic 2-light window penetrates the north elevation's upper gambrel end.**
