COLORADO CULTURAL RESOURCE SURVEY

Architectural Inventory Form

- 1. Resource number: **5RT.2789** Parcel number(s):
- 2. Temporary resource no.: **N/A** **115204029**
- 3. County: **Routt**
- 4. City: **Steamboat Springs**
- 5. Historic building name: **Hawk House**
- 6. Current building name: **Stannard House**
- 7. Building address: **38 Logan Avenue**
- 8. Owner name and address: **Thomas Cleveland Stannard, Trustee**
1580 Union Street #203
San Diego, CA 92101-3058

48. Report title: **Old Town Steamboat Springs Residential Survey Phase VIII**

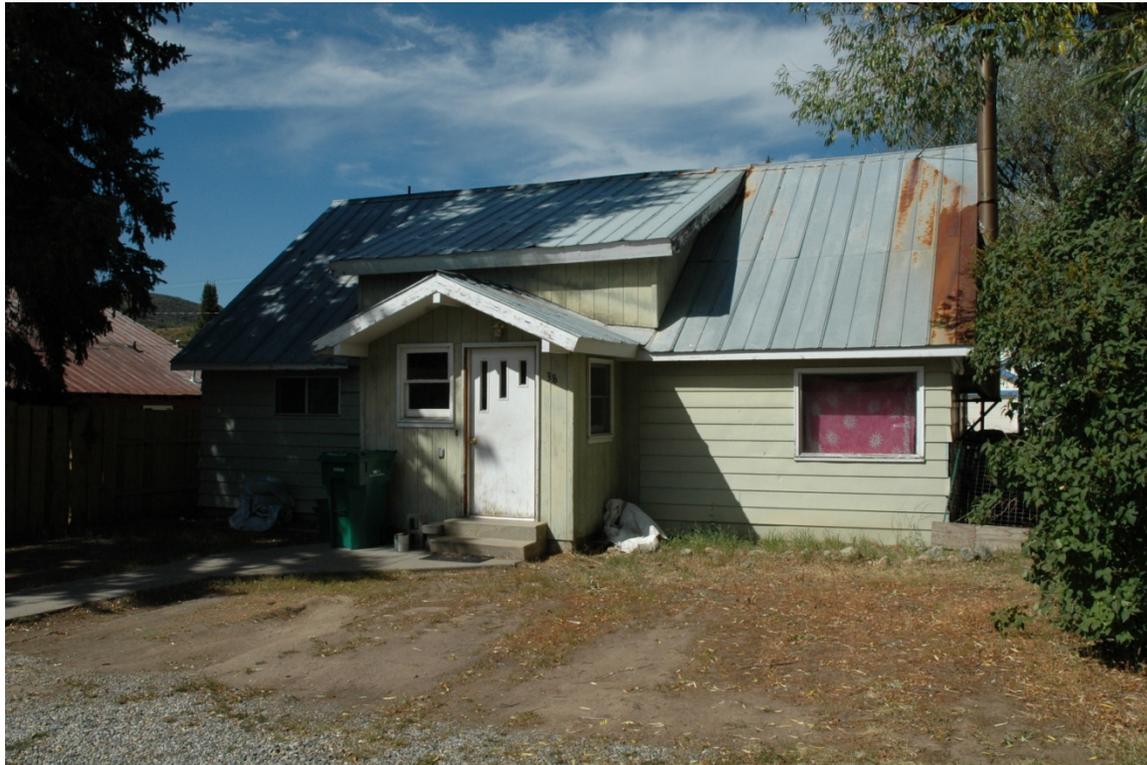
21. General architectural description:
This residence consists of an original side-gabled dwelling, which measures 27' N-S (deep) by 37' E-W (across), and a shed-roofed addition at the east end of the north (rear) elevation, which measures 15' square. The house is supported by a low unpainted concrete foundation, and its exterior walls are clad with wide horizontal metal siding which is painted green. The side-gabled roof is moderately-pitched, and is covered with metal roofing material. The eaves are boxed with painted white wood trim. A non-historic shed-roofed dormer, with no windows, overlooks the façade on the south-facing roof slope. Another shed-roofed dormer is located on the rear, north-facing, roof slope. A painted white solid wood door, with three stepped upper sash lights, enters an enclosed, 5' by 8', gabled porch, from a 2-step concrete stoop, on the façade. Another door enters the house from a non-historic wood deck near the north end of the east elevation. The home's windows consist of a combination of original 1/1 double-hung sashes in wood frames, and non-original 1x1 horizontal sliders and single-light fixed-panes in metal frames.
