COLORADO CULTURAL RESOURCE SURVEY

Architectural Inventory Form

- 1. Resource number: **5RT.2400** Parcel number(s): **136888001**
- 2. Temporary resource number: **N/A**
- 3. County: **Routt**
- 4. City: **Steamboat Springs**
- 5. Historic Building Name: **Leukens Motor Garage**
- 6. Current Building Name: **Marahou Gallery**
- 7. Building Address: **56 9th Street**
- 8. Owner Name: **Lincoln Ridge Comm. THS Assoc.**
- Owner Organization:
- Owner Address: **845 Lincoln Avenue  
Steamboat Springs, CO 80477**

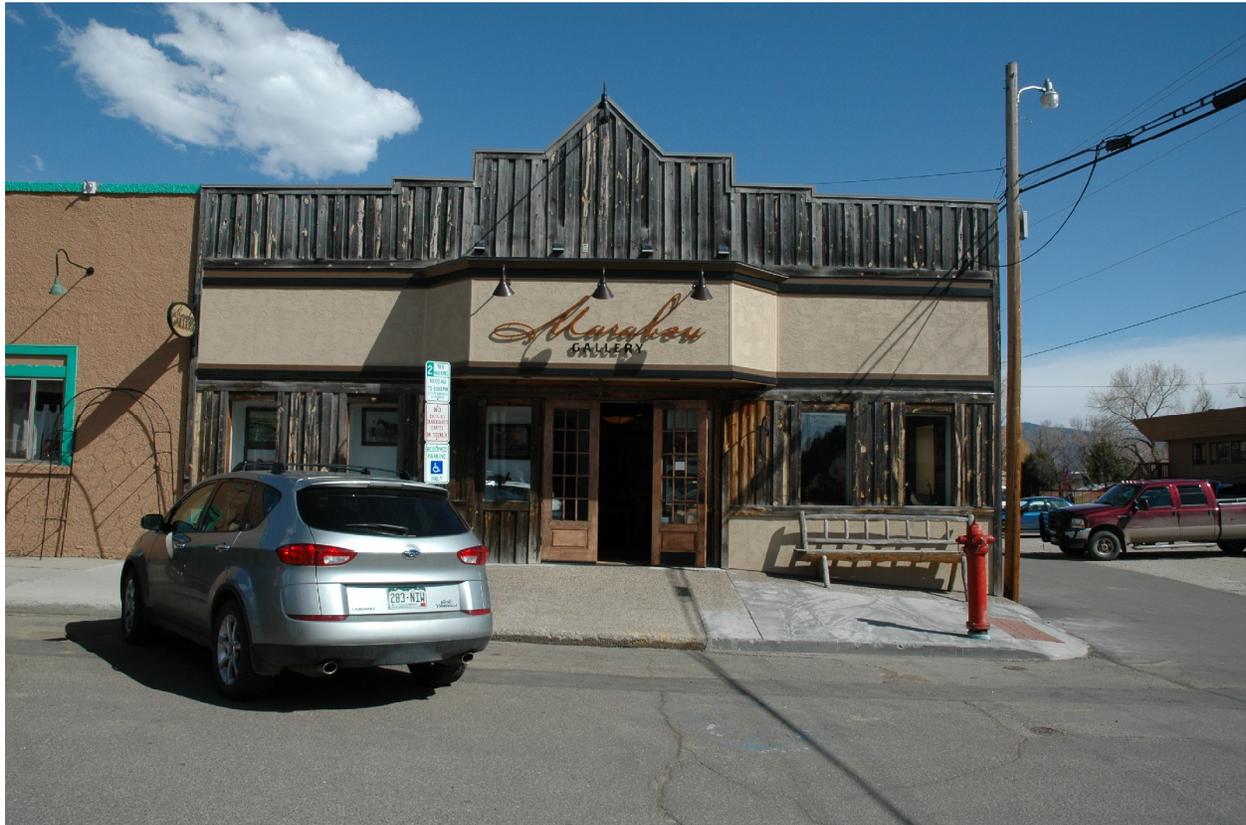
**This single-story commercial building is located on the southeast side of 9th Street, in the block between Lincoln Avenue (U.S. Highway 40) and Yampa Street, in downtown Steamboat Springs. Featuring a basic rectangular plan, the building is supported by a low unpainted concrete foundation, its walls are made of concrete blocks, and it has a flat roof. The symmetrical façade fronts directly onto a wide concrete sidewalk which parallels 9th Street on the northwest elevation. A set of paired, stained natural brown, 15-light glass-in-wood-frame, entry doors, with flanking sidelights, penetrate the center of the façade. These doors are flanked on either side by two vertically-oriented fixed-pane windows. The kick plate areas beneath the windows are clad with beige color stucco. Otherwise, the façade wall is primarily clad with a weathered stained brown vertical wood plank veneer. The façade wall extends above the roof line, and features a centered gabled parapet. A wide belt course of beige color stucco visually separates the upper and lower portions of the façade. A signband advertising "Marahou Gallery" is centered on the belt course where it projects out over the sidewalk directly above the entry doors. The original unpainted concrete block walls are exposed on the building's southwest (side) and southeast (rear) elevations. The southwest elevation, which faces the alley, is penetrated by four non-historic single-light fixed-pane over awning windows, with steel security bars. The building's northeast elevation abuts 68 9th Street, which is currently vacant but until recently was occupied by the "Fiber Exchange."**

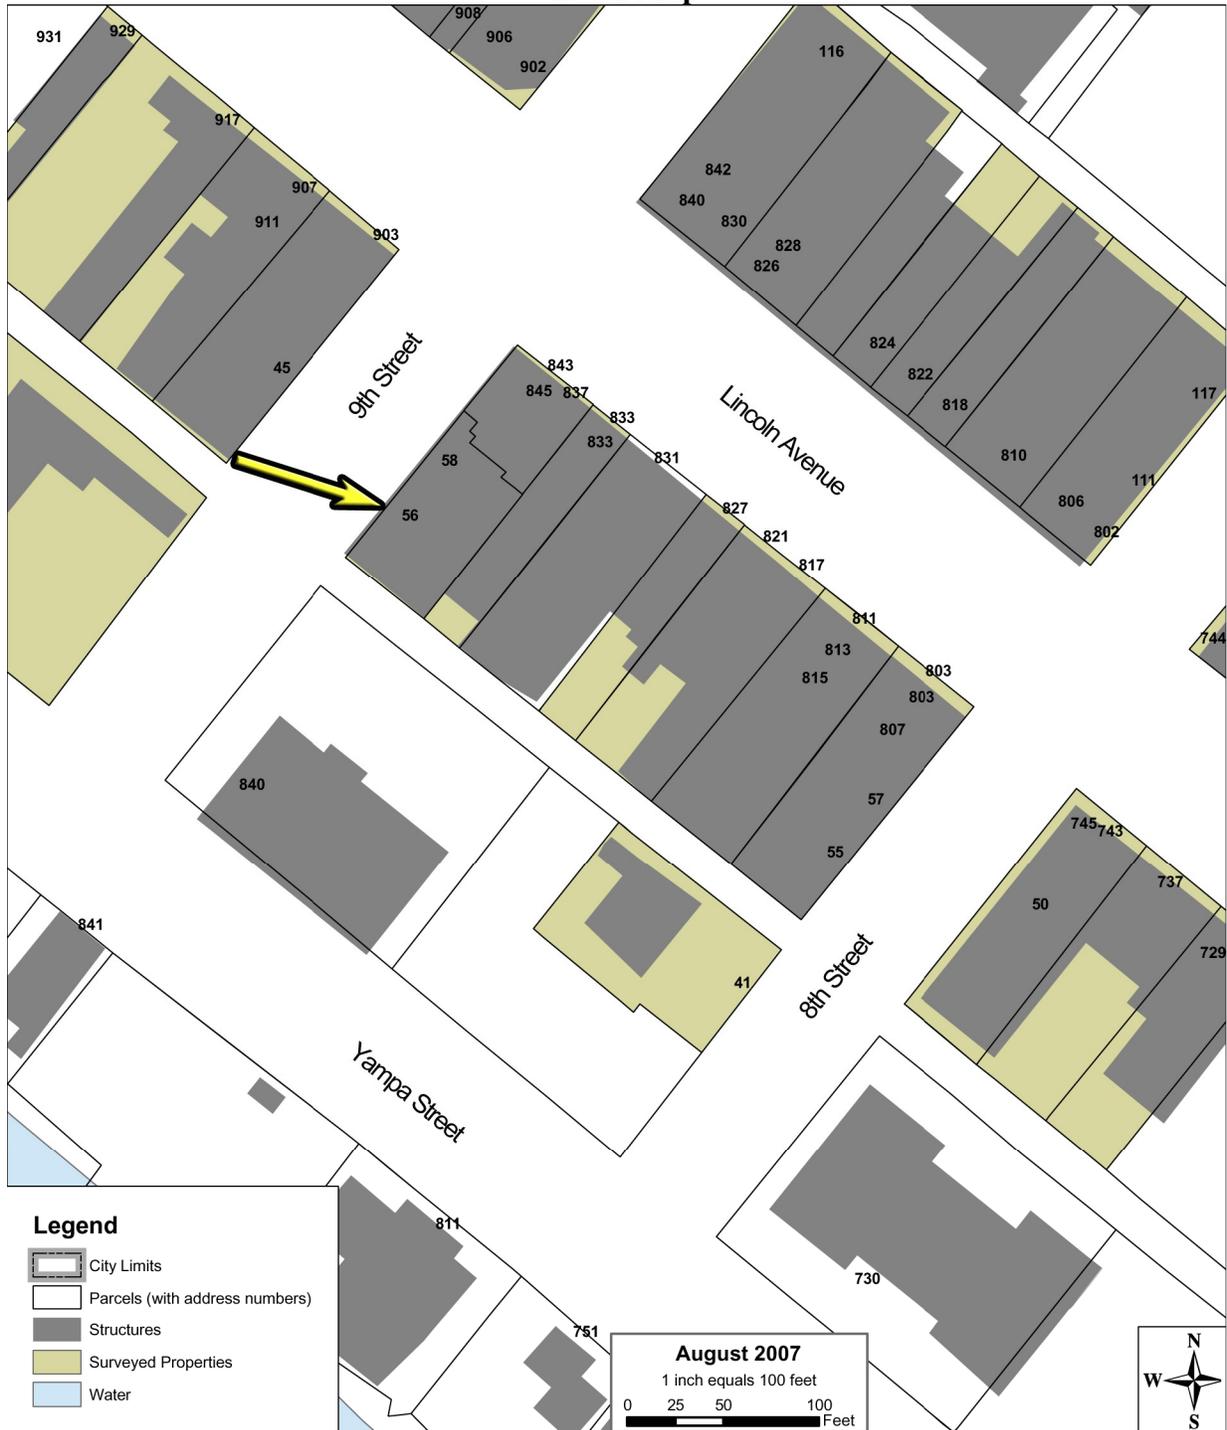
## Sketch Map

23. Landscape or special setting features: **This single-story commercial building is located on the southeast side of 9th Street, in the block between Lincoln Avenue (U.S. Highway 40) and Yampa Street, in downtown Steamboat Springs. The building's façade fronts directly onto a wide concrete sidewalk which parallels 9th Street on the northwest elevation. The southwest (side) elevation abuts the alley between Lincoln Avenue and Yampa Street.**
