COLORADO CULTURAL RESOURCE SURVEY

Architectural Inventory Form

- 1. Resource number: **5RT.2459** Parcel number(s): **144001020**
- 2. Temporary resource number: **N/A**
- 3. County: **Routt**
- 4. City: **Steamboat Springs**
- 5. Historic Building Name: **King House**
- 6. Current Building Name: **Kramer House**
- 7. Building Address: **1020 Crawford Avenue**
- 8. Owner Name: **Lynne E. and Nancy B. Kramer**
- Owner Organization:
- Owner Address: **P.O. Box 772778**
Steamboat Springs, CO 80477

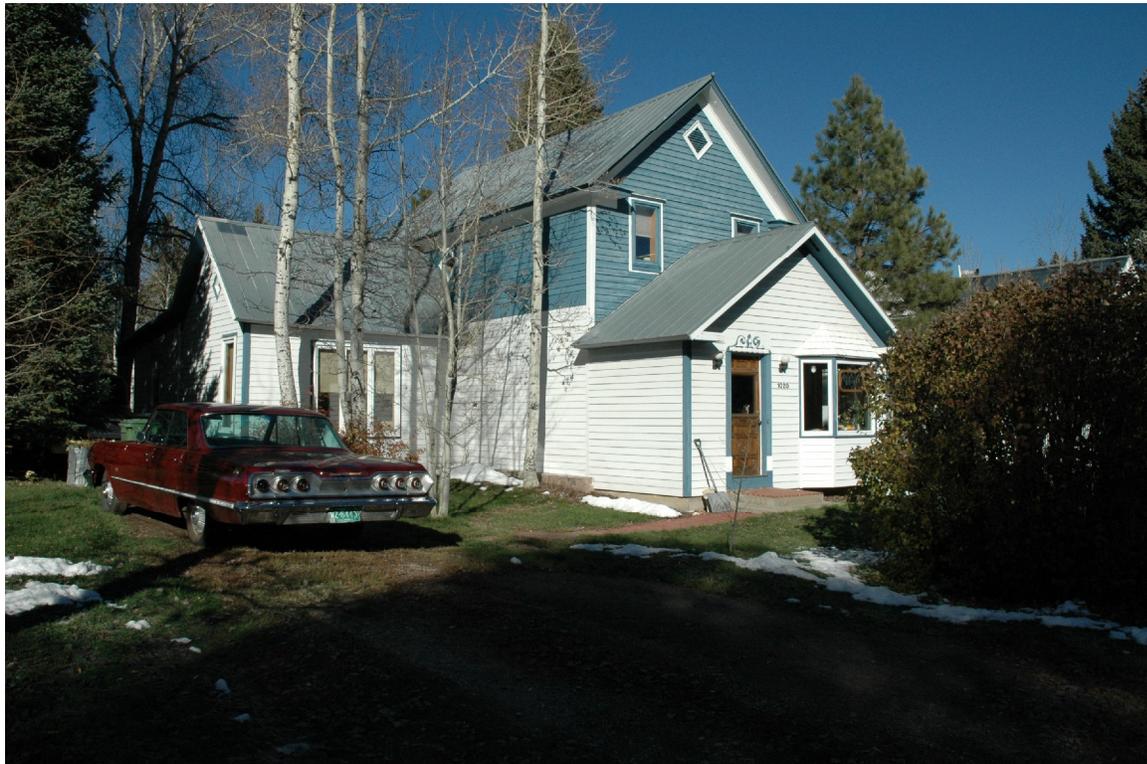
18. Roof configuration: **Gabled Roof/Front Gabled Roof**
19. Primary external roof material: **Metal Roof**
20. Special features: **Porch**
21. General architectural description:
This 2.5-story wood-frame dwelling is supported by an unpainted concrete foundation. Its first story walls are clad with painted white horizontal wood siding, with painted blue 1" by 4" corner boards, while its second story walls are clad with painted blue horizontal wood siding with painted white 1" by 4" corner boards. The house is covered by a steeply-pitched front gable roof, with silver metal roofing material, and with painted blue and white boxed eaves. A stained natural brown wood-paneled front door, with one upper sash light, leads from a 2-step concrete stoop into the west end of an 18' by 8' enclosed gabled porch which forms an addition on the south elevation (façade). Windows on the original house were historically primarily 1/1 double-hung sash; however, they are now primarily single-light windows with painted blue wood frames and painted white wood surrounds. A small diamond-shaped window penetrates the façade's upper gable end. There are two apparent additions the original house. One addition is the 18' by 8' enclosed gabled front porch on the south elevation. The other is a large L-shaped addition which wraps around the original house's rear northwest corner. A rear entry door leads into the addition from a redwood deck at the north end of the east elevation.

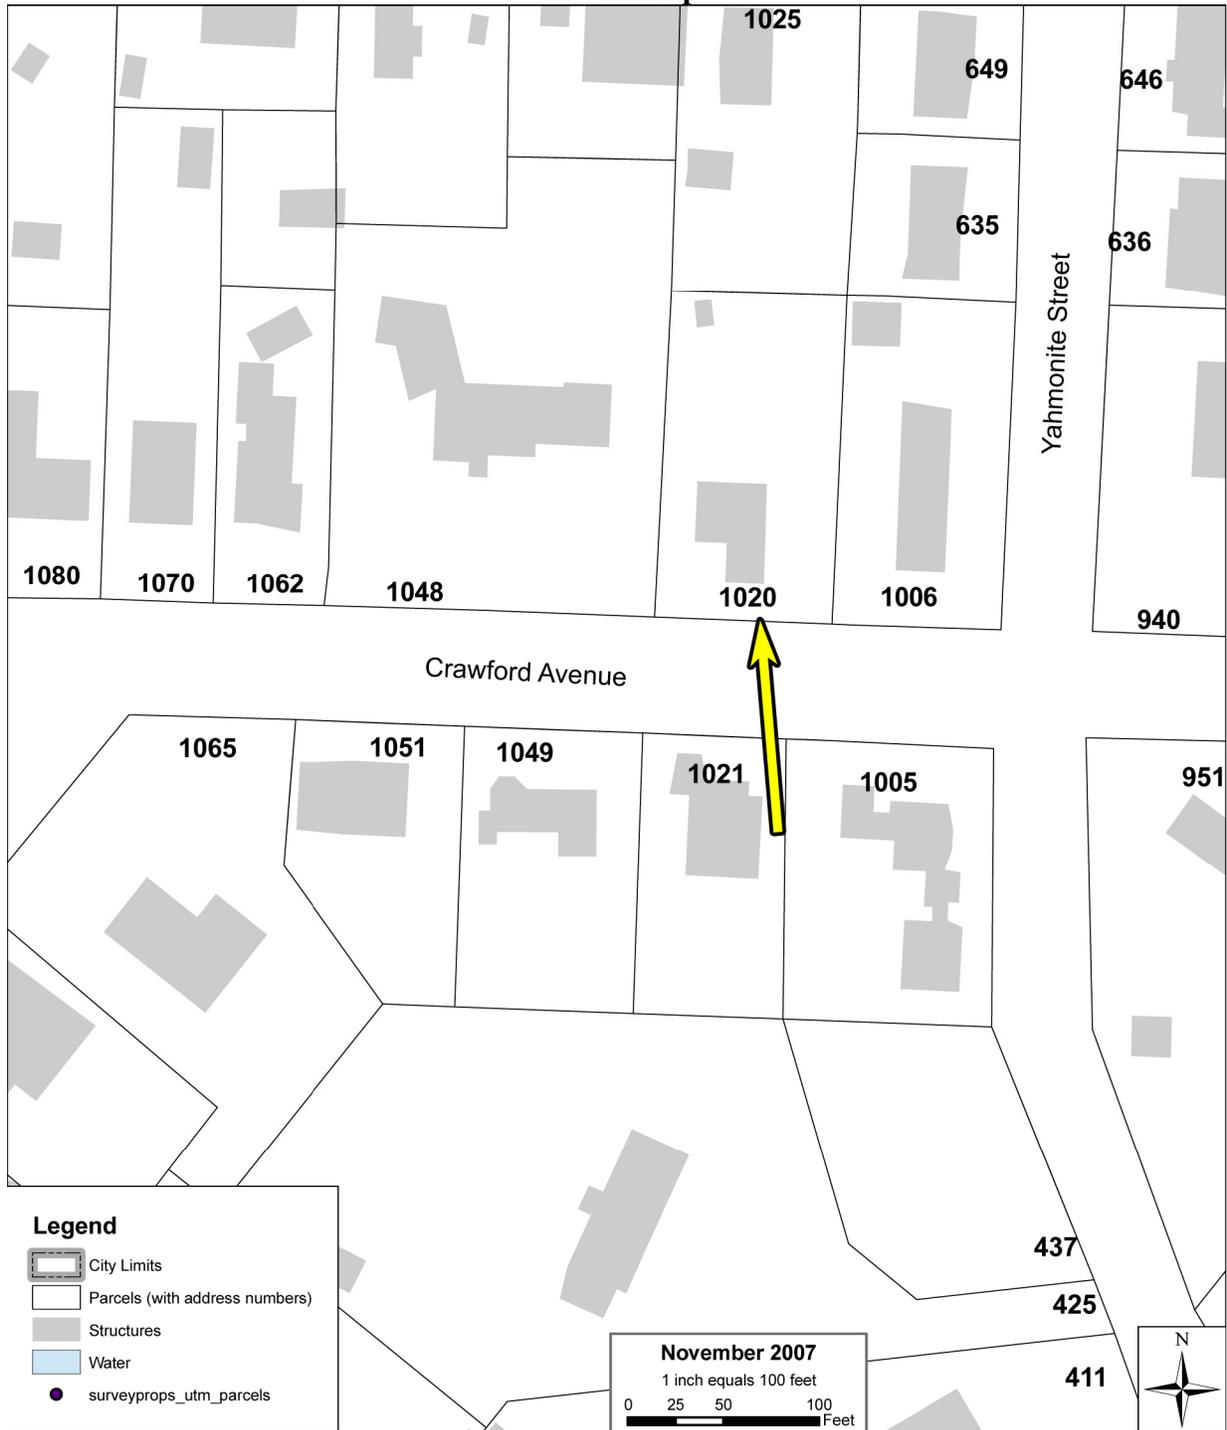
Sketch Map

22. Architectural style: **Late Victorian**
 Building type:
23. Landscape or special setting features: **This property is located on the north side of Crawford Avenue in the block west of Yahmonite Street. A planted grass lawn, with mature landscaping features, surrounds the house. Two large spruce trees and a large pine tree are located west of the house. A gravel driveway extends from the street to along the west side of the house.**
