COLORADO CULTURAL RESOURCE SURVEY

Architectural Inventory Form

- 1. Resource number: **5RT.471** Parcel number(s): **144001030**
- 2. Temporary resource number: **N/A**
- 3. County: **Routt**
- 4. City: **Steamboat Springs**
- 5. Historic Building Name: **Schnackenberg House**
- 6. Current Building Name: **Cooper House**
- 7. Building Address: **1062 Crawford Avenue**
- 8. Owner Name: **Nathaniel Cooper and Petra Chladek**
- Owner Organization:
- Owner Address: **P.O. Box 772142**
Steamboat Springs, CO 80477

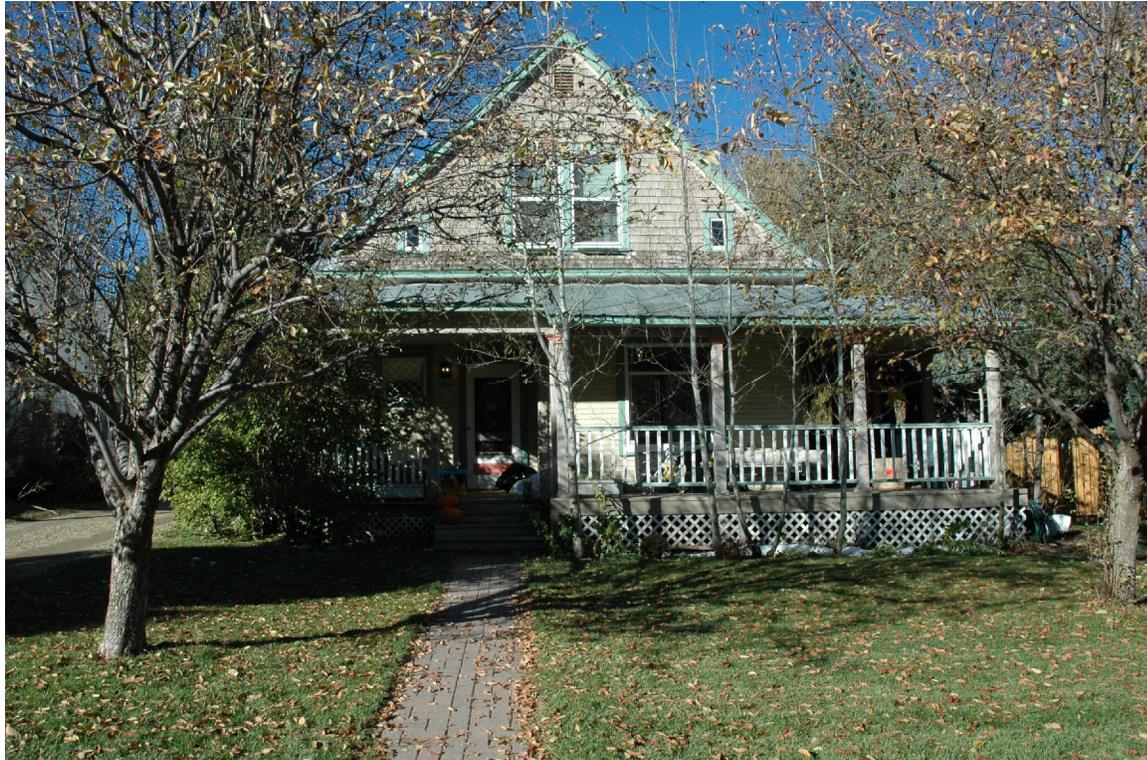
21. General architectural description:
This is a 1½-story, front gabled, wood frame dwelling, with multiple additions to its original north (rear) elevation. The original house measures approximately 40' N-S (deep) by 26' E-W (across), including a large, open, L-shaped front porch which extends across the entire facade (south elevation). The additions date from 1992 and 1998, and incorporate an attached garage. The original house is supported by a low sandstone foundation, and its exterior walls are clad with narrow, painted beige, horizontal wood siding, with painted chocolate brown 1" by 4" corner boards. Painted beige square-cut wood shingles appear in the upper gable ends. The original dwelling is covered by a steeply-pitched front gable roof, with lower intersecting gables on the east and west elevations. The roof is covered with metal roofing material and has painted green boxed eaves. A red brick chimney with a corbelled cap is located on the roof ridge. The L-shaped front porch is approached by three wood steps, and features a wood floor, a painted white open wood railing, painted beige square posts, and a low-pitched hipped roof. A large single-hung sash window, with leaded glass upper sash lights, overlooks the front porch to the east of the entry door. Another large single-hung sash window, with leaded glass lights, is located on the west elevation. Sets of paired 1/1 double-hung sash windows are located in the upper gable ends on the south end east elevations. Two 1/1 double-hung sash windows are located in the upper gable end on the west elevation.
