COLORADO CULTURAL RESOURCE SURVEY

Architectural Inventory Form

- 1. Resource number: **5RT.1062** Parcel number(s): **115212025**
- 2. Temporary resource number: **N/A**
- 3. County: **Routt**
- 4. City: **Steamboat Springs**
- 5. Historic Building Name: **Studer House; Lester House**
- 6. Current Building Name: **Shaffer House**
- 7. Building Address: **134 Hill Street**
- 8. Owner Name: **Robert Shaffer**
- Owner Organization:
- Owner Address: **P O Box 771399**
Steamboat Springs, Co 80477-1399

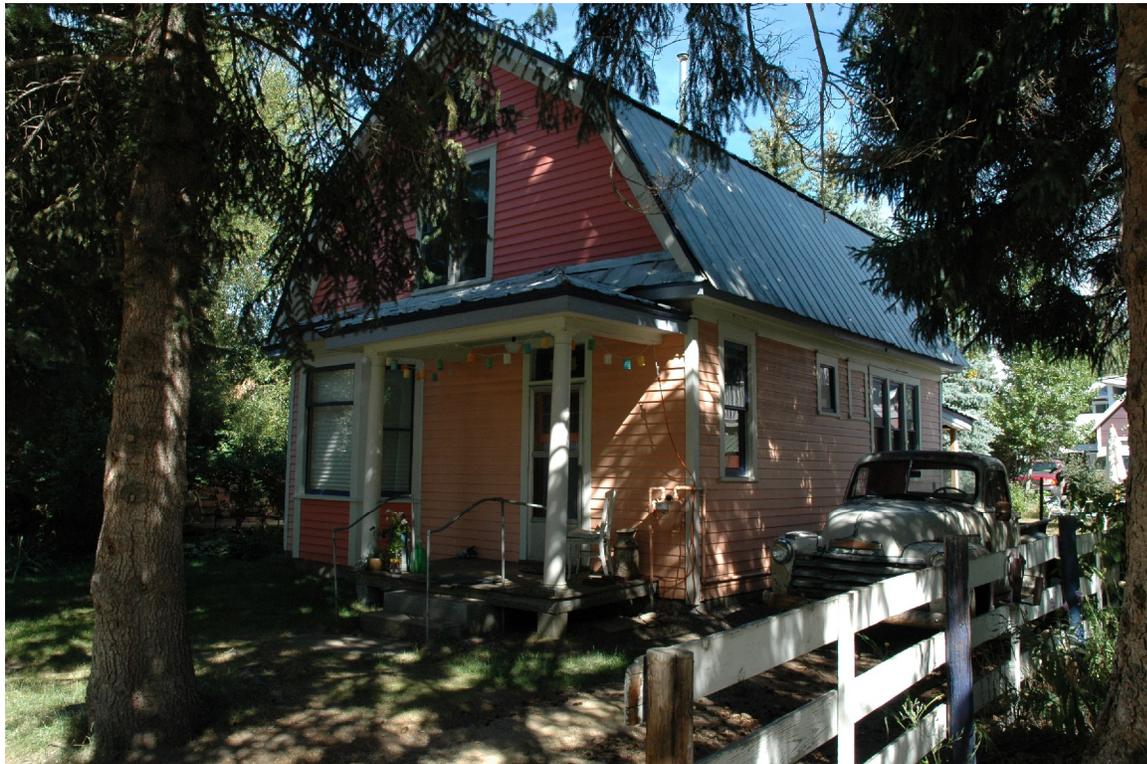
18. Roof configuration: **Gambrel Roof**
19. Primary external roof material: **Metal Roof**
20. Special features: **Porch**
Roof Treatment/Dormer
21. General architectural description:
This 1½-story Dutch Colonial Revival style house measures 26' N-S (deep) by 24' E-W (across). It is supported by a low unpainted concrete foundation, and its exterior walls are clad with painted pale pink horizontal wood siding with painted white 1" by 4" corner boards. The dwelling is covered by a steeply-pitched gambrel roof, with metal roofing material and with painted white boxed eaves. A shed-roofed dormer, with a 1/1 double-hung sash window, is located on the west facing roof slope. The house features an asymmetrical façade that fronts toward Hill Street on the south elevation. A painted pale pink and blue wood-paneled front door, with nine upper sash lights and a transom light, and covered by a silver aluminum storm door, enters the east end of the façade from a 5' by 10' open front porch. The porch is approached by two concrete steps, and features a tongue and groove wood floor, two painted white Tuscan columns, and a hipped roof. The property's address "134" is etched in the transom glass above the entry door. A canted bay, with a large single-hung sash window flanked on either side by a narrow 1/1 double-hung sash window, penetrates the façade wall to the west of the entry porch. Windows elsewhere are primarily 1/1 double-hung sash with painted blue wood frames and painted white wood surrounds. A painted white wood-paneled door with one upper sash light, and covered by an aluminum storm door, enters the east end of the north (rear) elevation from an open 8' by 12' hipped-roof front porch. This rear porch is approached by three wood steps, and has two painted white turned columns which support a hipped roof.
