COLORADO CULTURAL RESOURCE SURVEY

Architectural Inventory Form

- 1. Resource number: **5RT.2460** Parcel number(s): **144401014**
- 2. Temporary resource number:
- 3. County: **Routt**
- 4. City: **Steamboat Springs**
- 5. Historic Building Name: **Forgey House; Werner House**
- 6. Current Building Name: **Seabert House**
- 7. Building Address: **210 Hill Street**
- 8. Owner Name: **Elizabeth G. & C. Walter Seabert**
- Owner Organization:
- Owner Address: **35 Valverdant Circle
Steamboat Springs, CO 80487-3063**

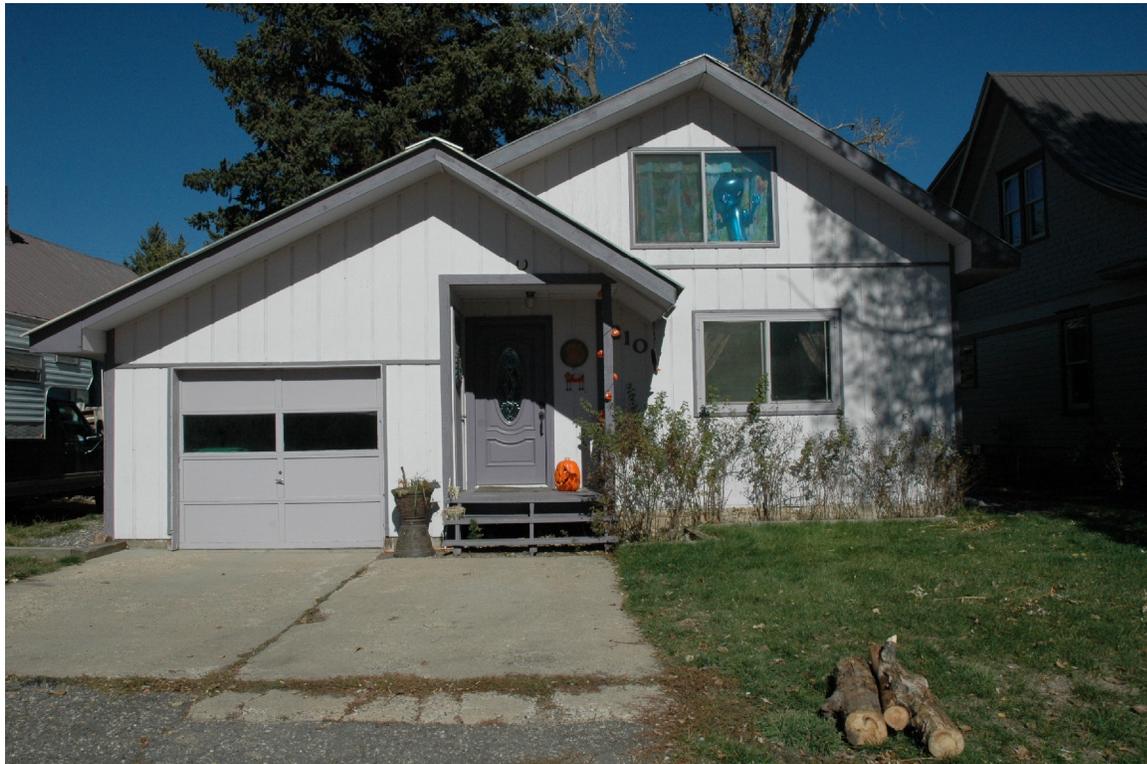
21. General architectural description:
This 1½-story wood frame dwelling is supported by an unpainted concrete foundation, and its exterior walls are clad with beige color horizontal wood siding. The house is covered by a moderately-pitched front gable roof, with an extension of the roof covering the attached garage which forms the south (front) end of the west (side) elevation. The roof is covered with metal roofing material, and the eaves are boxed with painted purple wood trim. The dwelling's asymmetrical façade faces toward Hill Street on the south elevation. A painted lavender wood-paneled front door, with a large oval-shaped light, enters the façade from a 3-step wood porch. The porch is recessed under the front eave of the garage roof, and has a painted lavender wood railing and one 4" by 4" wood post support. Two non-historic 1x1 horizontal sliding windows penetrate the façade wall - one to the east of the entry porch, and the other in the upper gable end. The east elevation is penetrated by a single-light fixed-pane window and by two 1x1 horizontal sliding windows. The north (rear) elevation is penetrated by a 1x1 horizontal sliding window and by a small single-light window in the upper gable end. An enclosed rear porch, covered by a low-pitched gable roof, forms the west end of the north elevation. A painted white wood door, covered by a painted lavender wood screen door, enters the enclosed porch from a concrete stoop. A single-light window penetrates the porch wall to the west of the door.

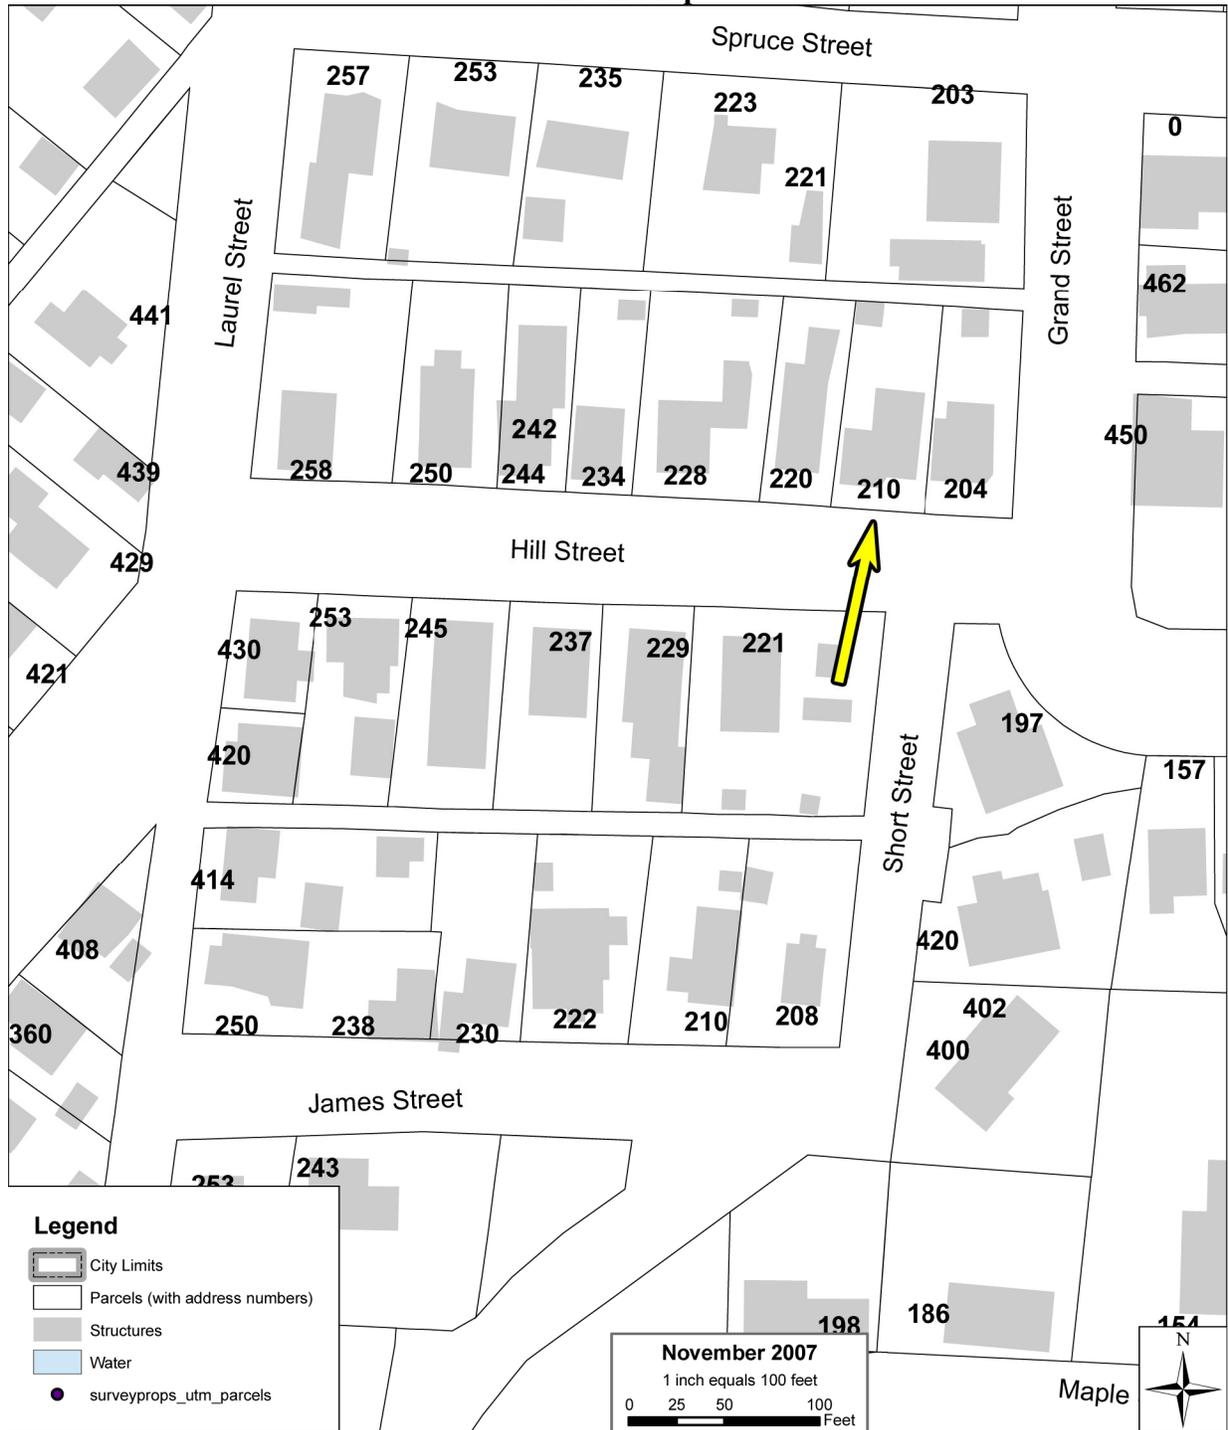
Sketch Map

23. Landscape or special setting features: **This property is located on the north side of Hill Street in the block between Laurel and Short Streets. A planted grass front yard, and narrow side yard flank the house's south and east elevations. A planted grass backyard is enclosed by an older wood privacy fence. A concrete driveway extends from the street to the garage door at the west end of the façade.**
