COLORADO CULTURAL RESOURCE SURVEY

Architectural Inventory Form

| 5. Historic building name: | Waggoner House | | |

48. Report title: **Old Town Steamboat Springs Residential Survey Phase X**

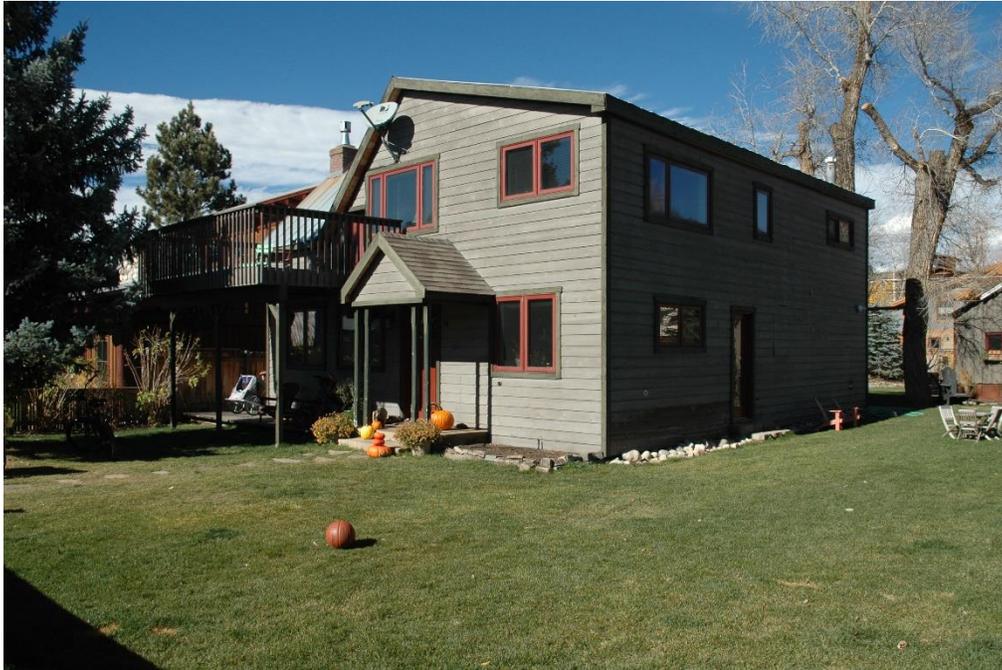
CD 1, Image 22, View to NW

This rectangular-shaped two-story dwelling measures 30' N-S (across) by 36' E-W (deep). It is supported by a low poured concrete foundation, and its exterior walls are clad with painted grey horizontal wood siding with 1" by 4" corner boards. The main part of the dwelling is covered by a distinctive saltbox roof form, with a steeply-pitched west slope and a low-pitched east slope. There is also an intersecting gable on the west elevation. The roof is covered with metal roofing material, and the eaves are boxed. A red brick chimney is in the west wall of the intersecting gable. A painted red wood-paneled front door, with six leaded glass upper sash lights, enters the south elevation (façade) from a 5' x 6' open front porch. This porch features a 2-step concrete floor, painted green chamfered wood post supports, and a gabled roof. To the west of this porch, there is a 10' x 14' uncovered second story porch supported by painted green 4" x 4" wood posts. The second story porch features a wood floor and an open wood railing. A painted red wood door opens onto this porch from the second story. A painted red glass-in-wood-frame door enters the east elevation. The home's windows are primarily 2-light casements with painted red wood frames and stained wood surrounds. The façade's second story wall contains a single-light fixed-pane window, flanked on either side by a single-light casement window.

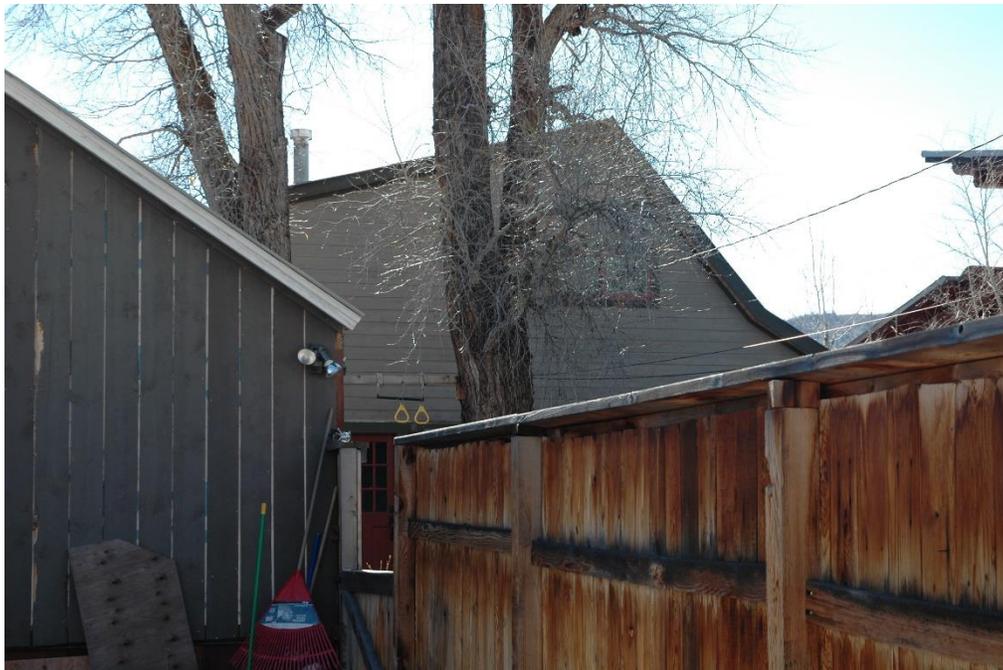
CD 1, Image 25, View to South

A wood-frame shed, which measures 18' by 16', is located southeast of the dwelling. This 1½-story building is supported by a poured concrete foundation, and its exterior walls are clad with painted pale brown vertical wood siding. The front-gabled roof is covered with metal roofing material, and the eaves are boxed. The south elevation contains a painted red wood-paneled door, with six upper sash lights. The south elevation also contains three single-light windows, including one in the upper gable end.
