COLORADO CULTURAL RESOURCE SURVEY

Architectural Inventory Form

| 5. Historic building name: | Elberson House, Nash House | |
| 7. Building address: | 44 Missouri Avenue | |

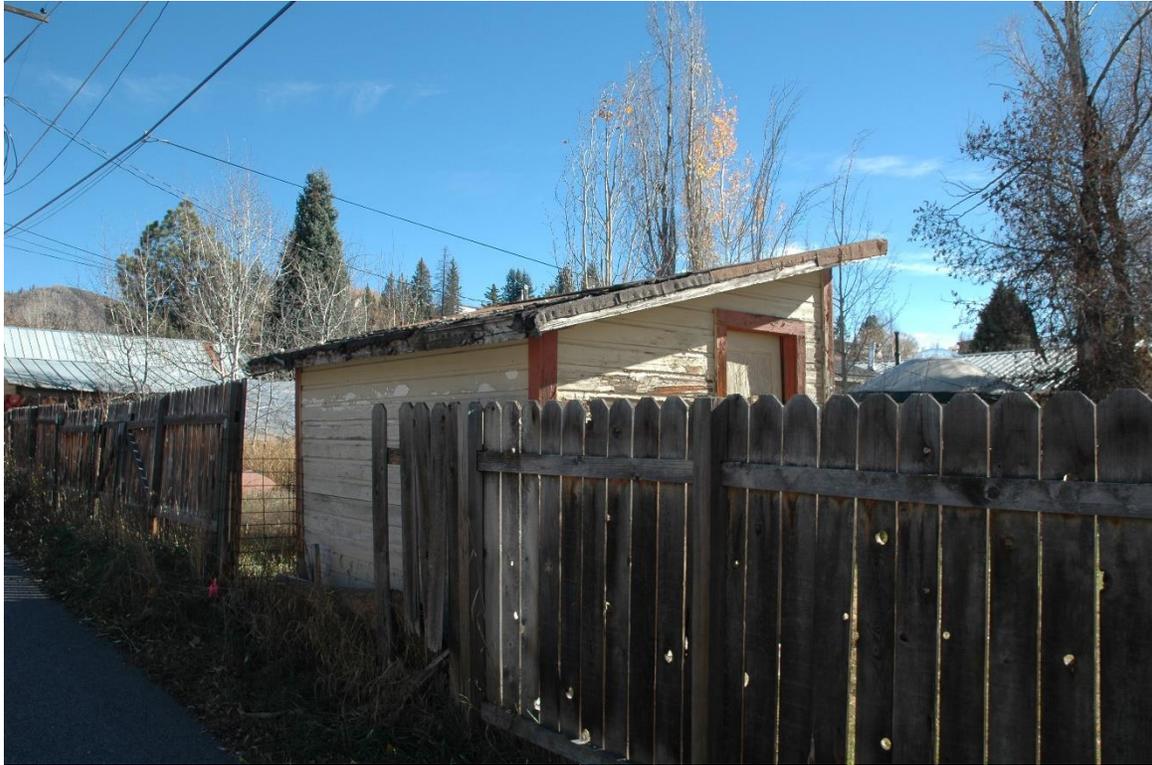
CD 1, Image 54, View to SE of Shed

A wood frame shed, which measures 10' N-S by 8' E-W, is located at the rear northeast corner of the property. This small utilitarian structure is supported by wood timbers on grade. Its exterior walls are clad with painted beige color horizontal weatherboard, with painted red 1" by 4" corner boards. The shed roof form is covered with deteriorated rolled asphalt roofing material, laid over 1x wood decking. A painted white wood-paneled door enters the shed's west elevation.

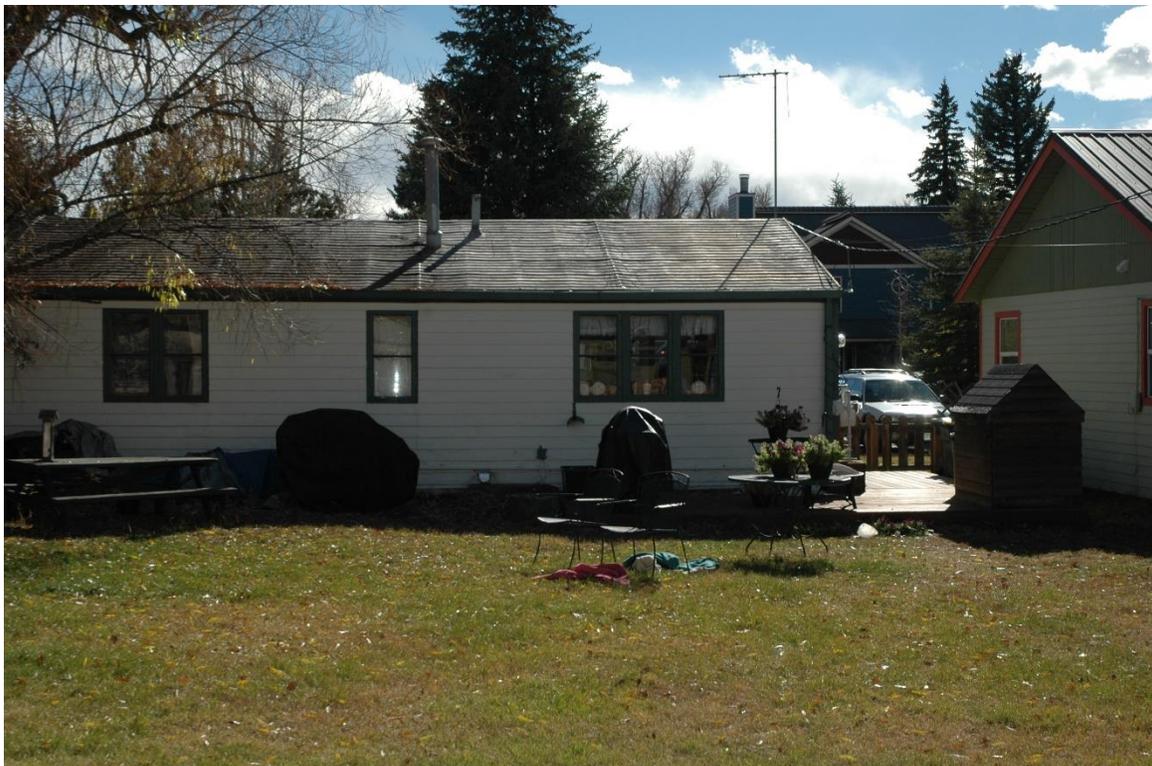
CD 1, Image 55, View to South

21. General architectural description:
This single-story dwelling measures 34' N-S (across) by 21' E-W (deep). It is supported by a low concrete foundation, and the exterior walls are clad with painted cream yellow horizontal wood siding with painted green 1" by 4" corner boards. The roof is a low-pitched side gable covered with grey asphalt composition shingles. The eaves are closed with painted green wood trim. A stained brown solid wood door, with a brown metal storm door, enters the façade (south elevation) from an 8' by 17' wood plank porch. The porch features an open wood railing, painted green 4" by 4" wood posts, with knee braces, and a shed roof. A narrow painted white wood-paneled door, with a painted green wood screen door, enters the west (side) elevation from an uncovered wood plank deck which wraps around the dwelling's rear northwest corner. A set of tripled 1/1 sash windows, with painted green wood frames and surrounds, overlook the front porch, west of the front door. Windows elsewhere are singled, paired, and tripled 1/1 sash, with painted green wood frames and surrounds.
