COLORADO CULTURAL RESOURCE SURVEY

Architectural Inventory Form

- 1. Resource number: **5RT.262** Parcel number(s): **133477001**
- 2. Temporary resource number: **N/A**
- 3. County: **Routt**
- 4. City: **Steamboat Springs**
- 5. Historic Building Name: **Milner Building**
- 6. Current Building Name: **Steamboat Art Company Building, et. al.**
- 7. Building Address: **903/907 Lincoln Avenue**
- 8. Owner Name: **JGS Homeowners' Association**
- Owner Organization:
- Owner Address: **903 Lincoln Avenue**
Steamboat Springs, CO 80477

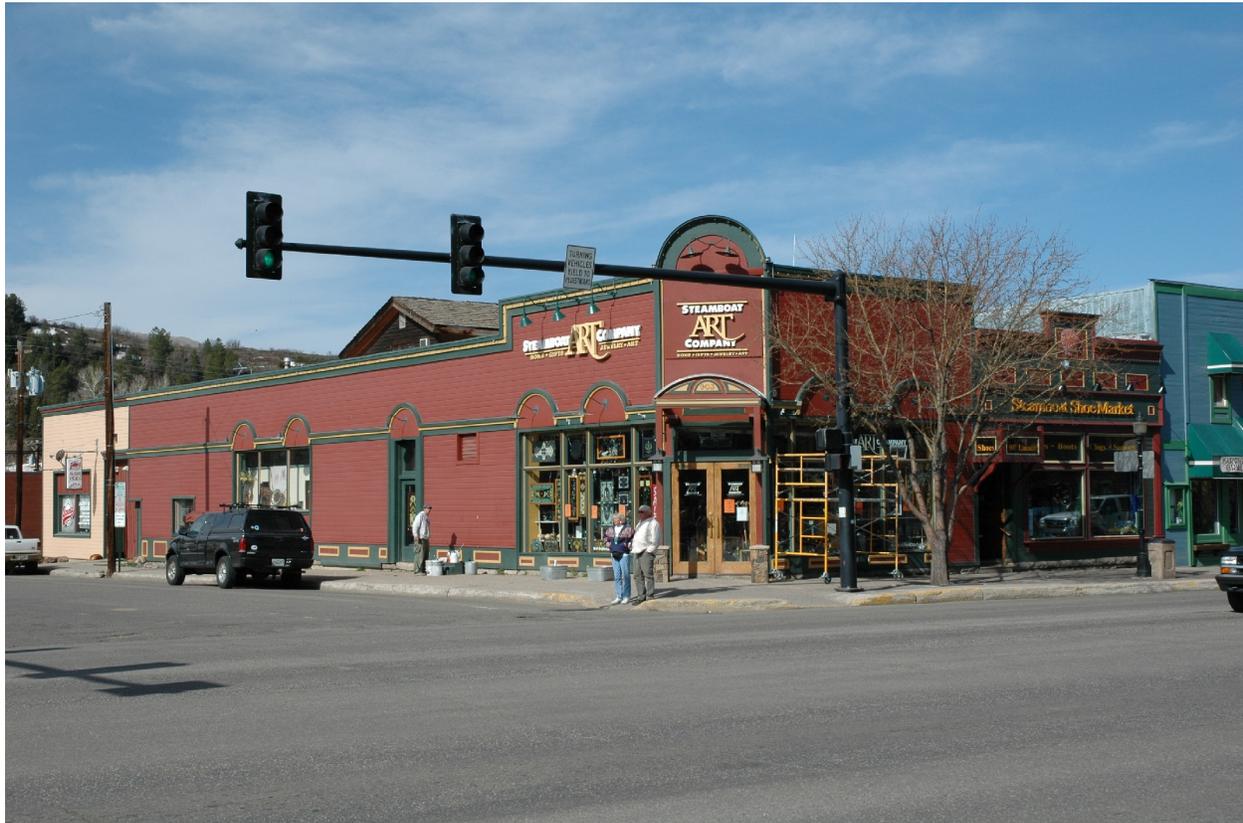
18. Roof configuration: **Flat Roof**
19. Primary external roof material: **Asphalt Roof/Composition Roof**
20. Special features: **N/A**
21. General architectural description:
This is a large, single-story, commercial building located at the western corner of Lincoln Avenue and 9th Street in downtown Steamboat Springs. Overall, the building measures 50' NW-SE (across) by 140' NE-SW (deep), and it is supported by a low coursed sandstone foundation. The building appears to consist of a ~50' by ~90' main section to the front, and a ~50' by ~50' concrete block extension to the southwest (rear) elevation. The main front section appears to be of brick construction, with stylized wooden facades applied to the northeast and southeast elevations.

A prominent corner entry faces the intersection on the east elevation. Here, a set of paired, stained natural brown, glass-in-wood-frame doors enter into the Steamboat Art Company. These doors are topped by a large transom light, beneath a segmental wooden arch. A wooden rounded arch parapet forms the top of the wall surface, extending above the roof line over the corner entry. This entry is further accented by an open segmental arch structure which projects out over the sidewalk. This arched structure is supported by two 6" by 6" wood posts set on high stone-faced pedestals. The corner entry is flanked on its northeast side (facing Lincoln Avenue) by a band of four single-light storefront display windows, with transom lights. These windows have painted green wood frames with painted yellow wood trim, and painted green, red and yellow wood-paneled kick plates. The corner entry is flanked on its southeast side (facing 9th Street) by another band of four single-light storefront display windows, also with transom lights, painted green wood frames with painted yellow wood trim, and painted green, red and yellow wood-paneled kick plates. Above the windows, the upper walls are clad with painted red horizontal weatherboard siding, with painted green wood trim, on both the northeast and southeast elevations. Wooden signbands advertising the "Steamboat Art Company," are affixed to the upper wall, over the
