COLORADO CULTURAL RESOURCE SURVEY

Architectural Inventory Form

I. IDENTIFICATION

- 1. Resource number: **5RT.2473** Parcel number(s): **115205019**
- 2. Temporary resource number: **N/A**
- 3. County: **Routt**
- 4. City: **Steamboat Springs**
- 5. Historic Building Name: **Luby House**
- 6. Current Building Name: **Hammond/Price House**
- 7. Building Address: **6 Missouri Avenue**
- 8. Owner Name: **Kristopher L. Hammond and Rebecca Price**
- Owner Organization:
- Owner Address: **P.O. Box 772566**
Steamboat Springs, CO 80477

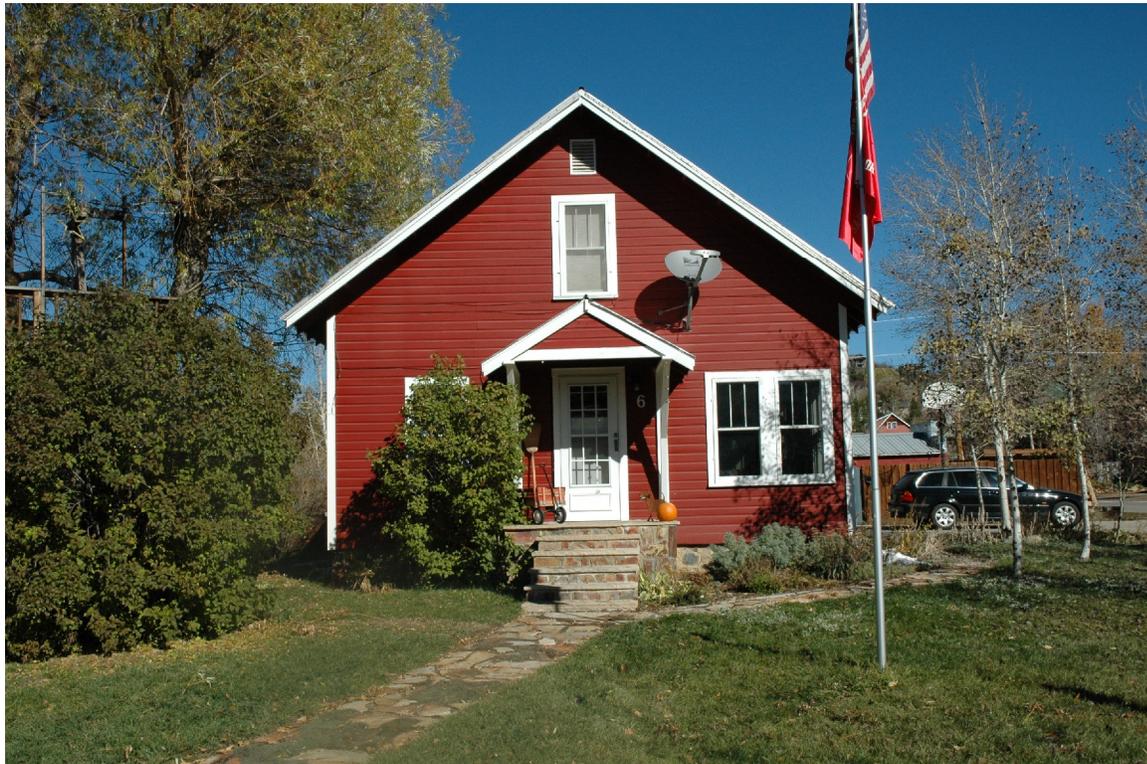
18. Roof configuration: **Gabled Roof/Front Gabled Roof**
19. Primary external roof material: **Metal Roof**
20. Special features: **Porch**
21. General architectural description:
This is a 1½-story wood frame dwelling. The extant house features a rectangular-shaped front gabled plan, which overall measures 29' by 44'. Included in these dimensions are the original 29' by 32' 1½ -story dwelling, and a 29' by 12' one-story gabled addition to the north (rear) elevation. The house is supported by a low stone foundation, and its exterior walls are clad with painted red horizontal weatherboard walls with painted white 1" by 4" corner boards. The front gabled roof is moderately-pitched, with metal roofing material, and with painted red rafter ends exposed beneath the eaves. A brick chimney is located just below the ridge on the east-facing roof slope. Windows are predominantly single and paired 3/1 (ribbon style) double hung sash, with painted white wood frames and surrounds. The house features a symmetrical façade which faces Missouri Avenue on the south elevation. Here, a painted white wood-paneled front door, with three upper sash lights, and covered by a white storm door, enters the center of the façade from a 4' by 7' front porch. This 7-step stone and concrete porch is covered by a gable hood with painted white wood knee brace supports. A horizontal sliding glass bypass door enters the gabled addition on the north elevation. A single-light fixed-pane window penetrates the addition's east elevation.
