COLORADO CULTURAL RESOURCE SURVEY

Architectural Inventory Form

- 1. Resource number: **5RT.2647** Parcel number(s): **116801016**
- 2. Temporary resource number: **N/A**
- 3. County: **Routt**
- 4. City: **Steamboat Springs**
- 5. Historic Building Name: **N/A**
- 6. Current Building Name: **McCarthy House**
- 7. Building Address: **12 Nob Street**
- 8. Owner Name: **Timothy B. McCarthy**
- Owner Organization:
- Owner Address: **P O Box 770526**
Steamboat Springs, Co 80477-0526

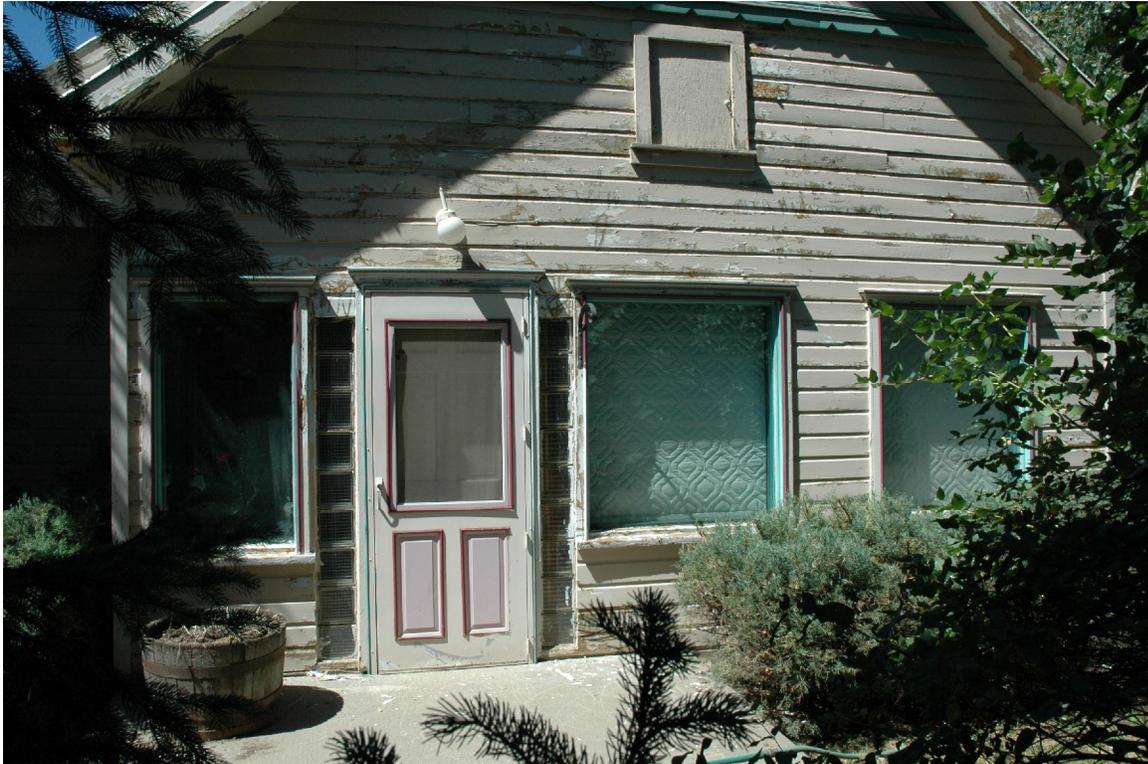
18. Roof configuration: **Gabled Roof/Front Gabled Roof**
19. Primary external roof material: **Metal Roof**
20. Special features: **Porch**
Chimney
21. General architectural description:
This single-story wood frame residence is supported by a low poured concrete foundation, and its exterior walls are clad with painted green horizontal weatherboard siding with painted white 1" by 4" corner boards. Painted beige or white horizontal weatherboard appears in the upper gable end on the east elevation, and painted white diagonal weatherboard appears in the upper gable end of the enclosed front porch, also located on the east elevation. Painted red diagonal siding appears in the upper gable end on the west (rear) elevation. The house is covered by a moderately-pitched front gable roof, with metal roofing material, and with painted white boxed eaves. Three skylights and solar panels are located on the south-facing roof slope. A short metal-capped red brick chimney is located just below the ridge on the north-facing roof slope. A painted white wood-paneled front door, covered by a painted red wood screen door, and with glass block sidelights, enters an enclosed gabled porch from an uncovered concrete stoop on the east elevation. The enclosed front porch measures approximately 18' N-S by 8' E-W, and it is penetrated by four single-light fixed-pane windows. A small painted red, side-hinged, wooden door is centered in the enclosed porch's upper gable end. A set of paired, painted red, vertical wood plank doors enter a walkout basement level at the west end of the south elevation. These doors open onto a short gravel driveway which extends to Nob Street to the south. The house's north elevation is penetrated by one 3-light window, a horizontally-oriented single-light fixed-pane window, and a vertically-oriented fixed-pane window. The south elevation wall is penetrated by one 1/1 single-hung sash window, one single-light fixed-pane window, and a band of three single-light fixed-pane windows. The home's windows primarily feature painted white wood frames and surrounds. A shed-roofed extension to the house's west elevation measures approximately 26' N-S by 8' E-W. A painted red glass-in-wood-frame door enters the north end of the west

elevation from an uncovered wood deck. Three single-light fixed-pane windows, and a set of paired 1/1 double-hung sash windows also penetrate the west elevation.
