COLORADO CULTURAL RESOURCE SURVEY

Architectural Inventory Form

- 1. Resource number: **5RT.1846** Parcel number(s): **145019004**
- 2. Temporary resource number: **N/A**
- 3. County: **Routt**
- 4. City: **Steamboat Springs**
- 5. Historic Building Name: **Unknown**
- 6. Current Building Name: **Routt County Environmental Health Department**
- 7. Building Address: **427 Oak Street**
- 8. Owner Name: **James and Janet Williams Living Trust**
- Owner Organization:
- Owner Address: **P.O. Box 770562**  
**Steamboat Springs, CO 80477**

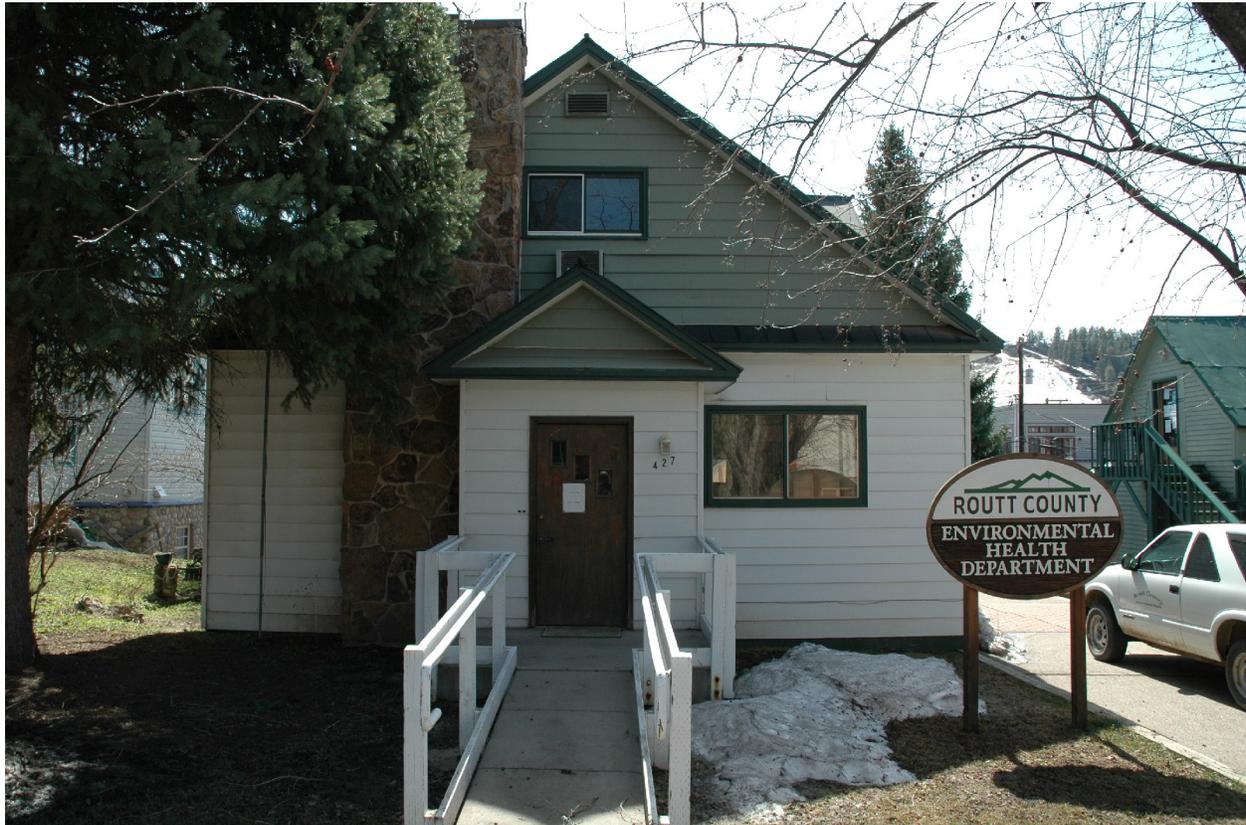
21. General architectural description:  
**Traditionally a single family dwelling, this wood frame building is now utilized as office space for the Routt County Environmental Health Department. The main 1.5-story portion of the building features a rectangular plan which measures 28' NW-SE (across) by 39' NE-SW (deep). There is also a 12' by 6' enclosed shed-roofed rear porch extension at the northwest end of the southwest (rear) elevation, and a small gable-roofed front porch on the northeast elevation (façade). The building is supported by a low painted green concrete foundation, and its exterior walls are clad with white and green horizontal aluminum siding. The roof is a moderately-pitched side-gable, covered with metal roofing material, and with painted white and green boxed eaves. A large, non-historic, stone fireplace chimney is located on the façade. Two non-historic 1x1 horizontal sliding windows penetrate the façade, including one in the upper gable end. Windows on the secondary elevations are also primarily non-historic 1x1 horizontal sliders with painted green wood surrounds. A solid wood door, with three stepped upper sash lights, enters the enclosed gable-roofed porch which is centered on the façade. A non-historic wooden handicapped ramp leads to this entry door. A stained natural brown glass-in-wood-frame door, with flanking sidelights, enters the northwest (side) elevation from a small 3-step metal porch. Another entry door, covered by a painted green wooden storm door, enters the enclosed shed-roofed porch on the rear (southwest) elevation.**

**This building displays a below-average standard of physical integrity, relative to the seven aspects of integrity as defined by the National Park Service and the Colorado Historical Society, Office of Archaeology and Historic Preservation - setting, location, design, materials, workmanship, feeling and association. The building's integrity has been diminished by the application of the following non-historic elements: horizontal metal siding, a large stone fireplace chimney on the façade, replacement of the original front porch with an enclosed gabled entryway, installation of several 1x1 horizontal sliding windows, including two on the façade, construction of a poorly-executed (from a historic preservation aesthetic viewpoint) handicapped accessible ramp.**
