COLORADO CULTURAL RESOURCE SURVEY

Architectural Inventory Form

- 1. Resource number: **5RT.3148** Parcel number(s):
- 2. Temporary resource no.: **N/A** **145028011**
- 3. County: **Routt**
- 4. City: **Steamboat Springs**
- 5. Historic building name: **Williams House**
- 6. Current building name: **608 Yampa LLC House**
- 7. Building address: **608 and 608½ Yampa Street**
- 8. Owner name and address: **608 Yampa LLC c/o Jon Wade**
P. O. Box 775430
Steamboat Springs, CO 80477-5430

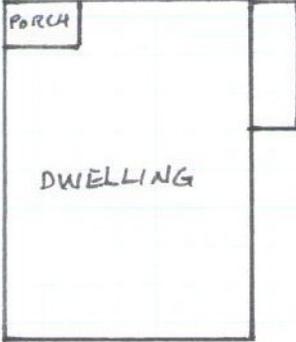
Sketch Map

This dwelling is located at the northern corner of Yampa and 6th Streets. A small gravel parking lot is located in front of the building along Yampa, while a poured concrete sidewalk parallels 6th Street where there is diagonal parking. A planted grass lawn, with a large willow tree and other deciduous trees, is located behind the dwelling to the northeast. Butcher Knife Creek flows generally northeast-southwest to the northwest of this property.
