This page intentionally left blank.

Steamboat Springs Historic Preservation Design Guidelines

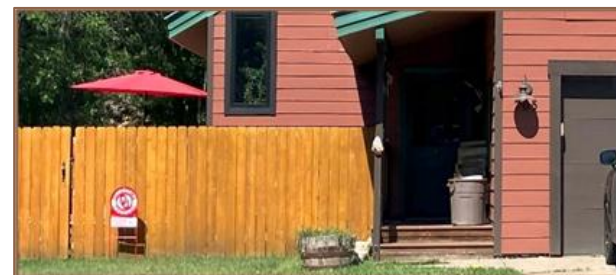
Photograph 5. Example of an appropriate simple wooden fence along the side of a residential street.

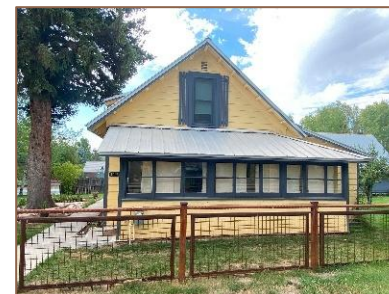
Photograph 6. Example of an appropriate transparent fence along the side of a residential street.

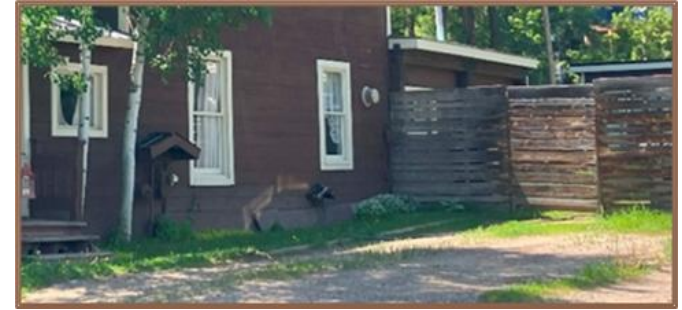
Photograph 7. Representative example of an appropriate side fence. Note that this horizontal wood picket is set back from the face of the building.

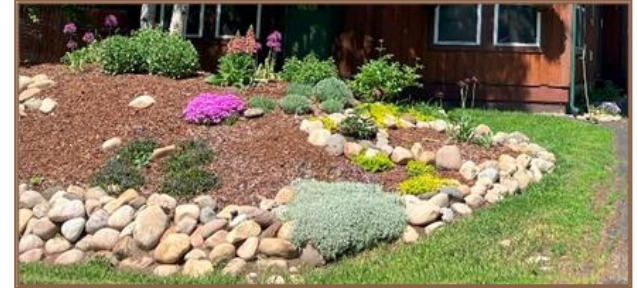
Photograph 9. Example of a landscape covered with rocks.

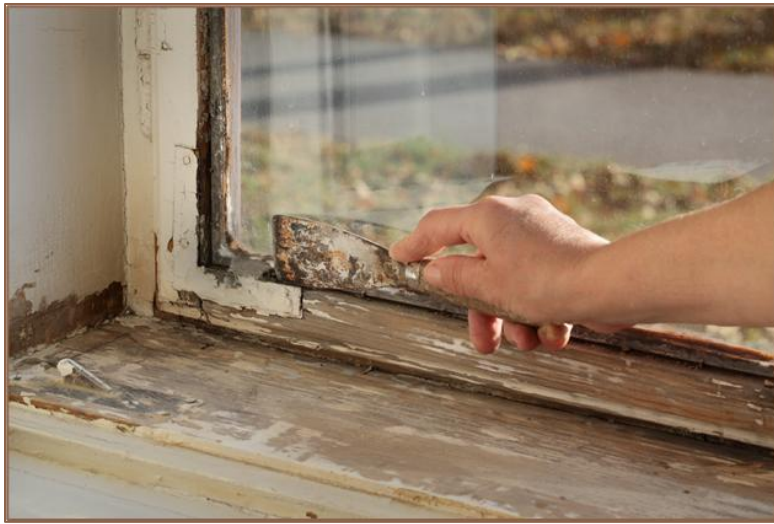
Figure 3. Window restoration. Deteriorated paint does not always indicate a window is beyond repair.⁶

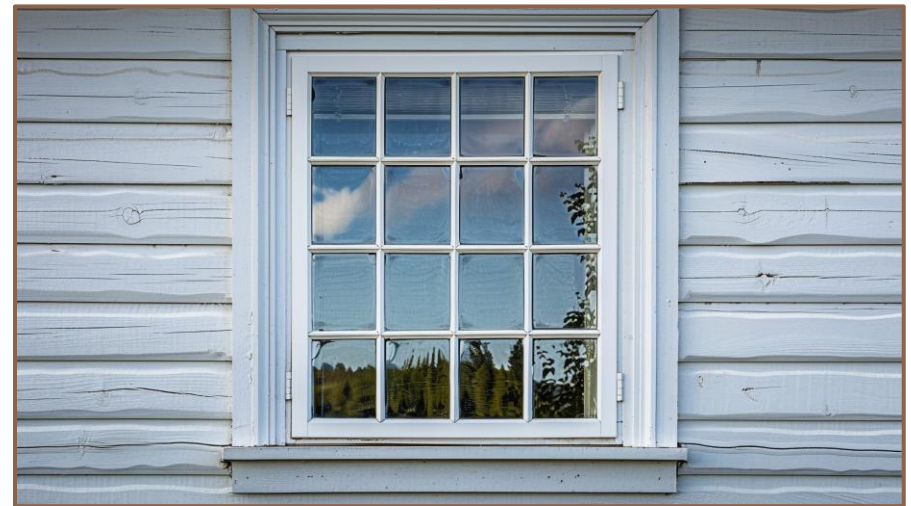
Figure 4. Example of a storm window.⁷

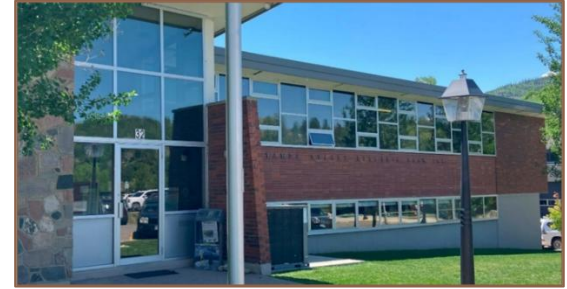
Photograph 12. Historic mid-century building with preserved historic windows.

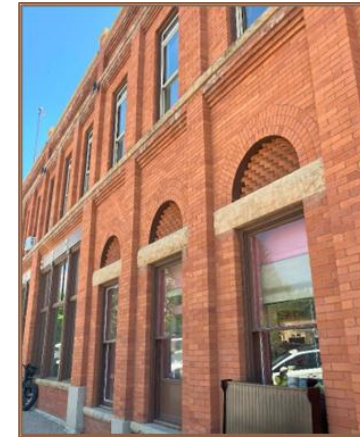
Photograph 13. Brick commercial building with maintained historic windows that have retained their positioning, number, and arrangement.

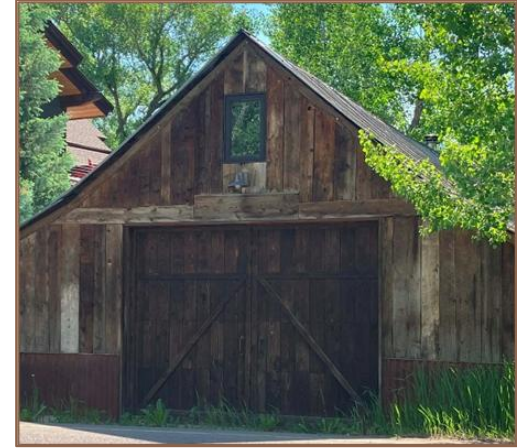
Photograph 14. Barn with non-historic picture window above doors.

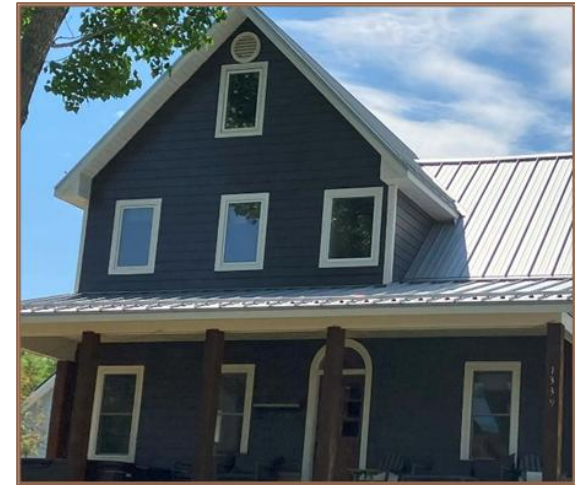
Photograph 15. House with updated vinyl windows.

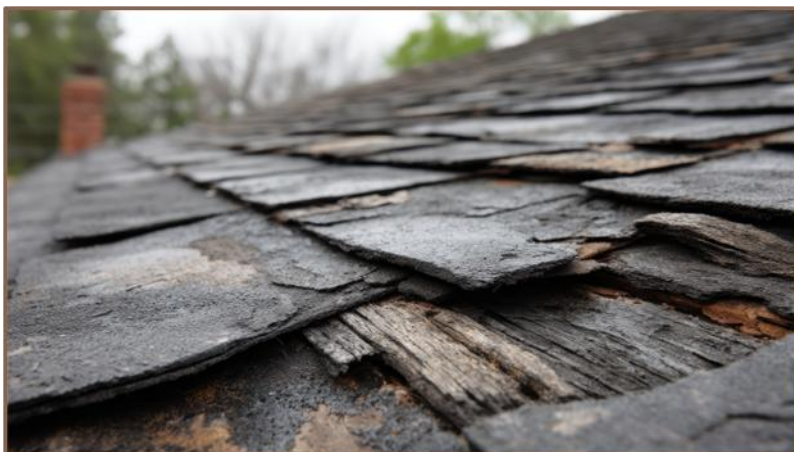
Figure 7. Example of a deteriorating roof.¹⁰

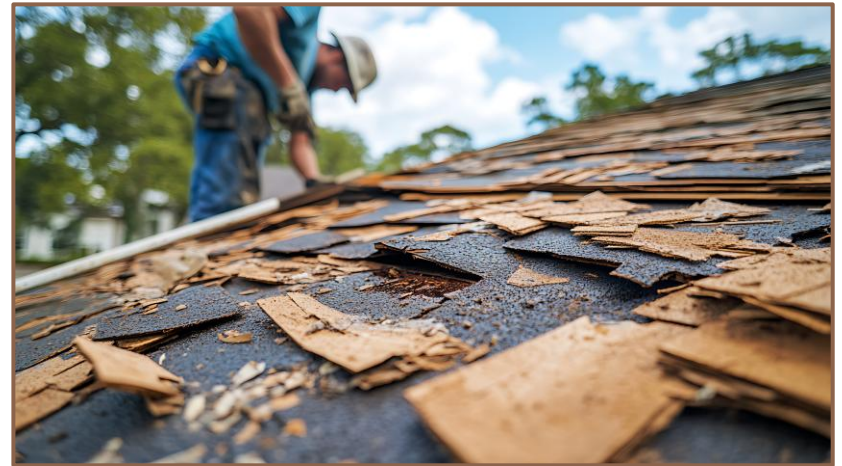
Figure 8. Example of wood shingles in the process of being replaced with similar, but new asphalt shingles.¹¹

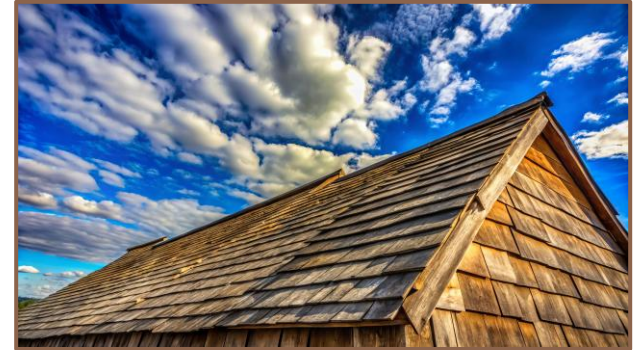
Photograph 17. Building with its original features and materials, including the wood shake roof.¹²

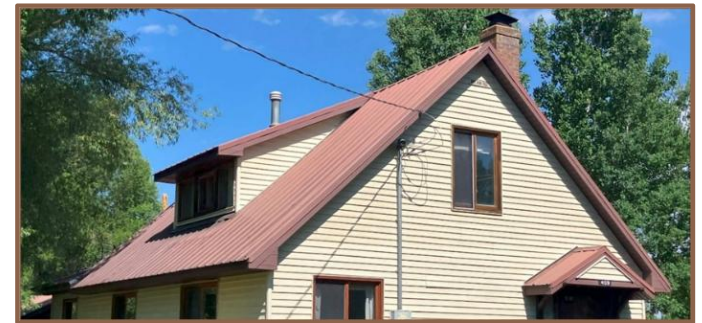
Photograph 19. Example of an upgraded standing seam metal roof with an unobtrusive dormer.

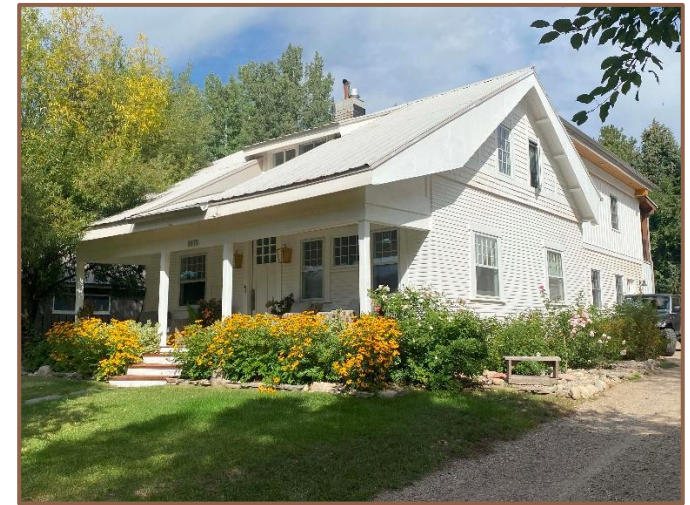
Photograph 20. Historic residence with upgraded standing seam metal roof.

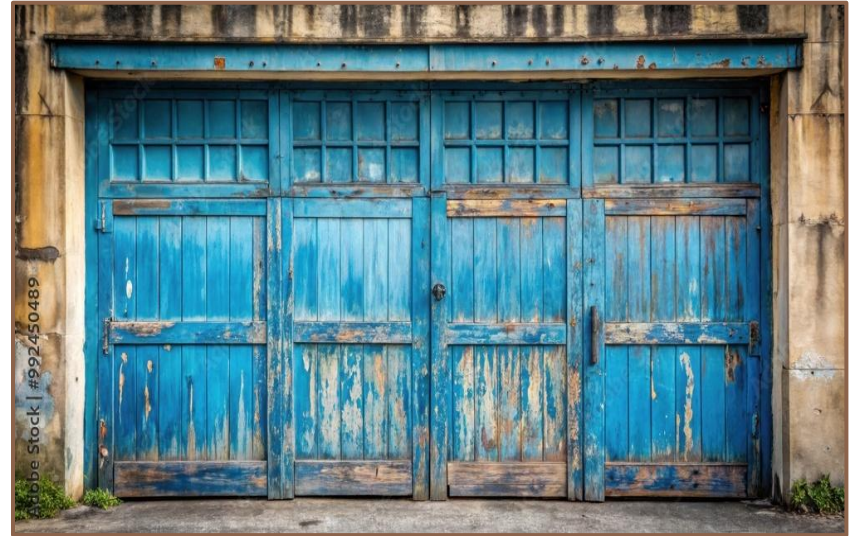
Figure 9. Example of slightly deteriorated woods door with peeling paint.¹³

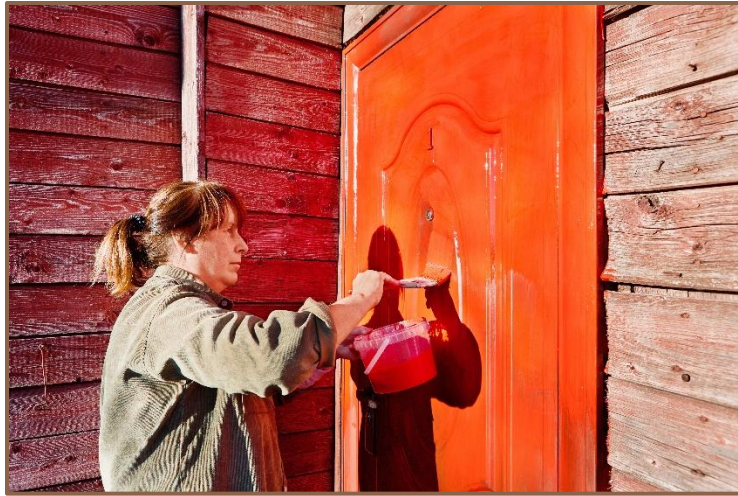
Figure 10. A historic wood door in the process of rehabilitation.¹⁴

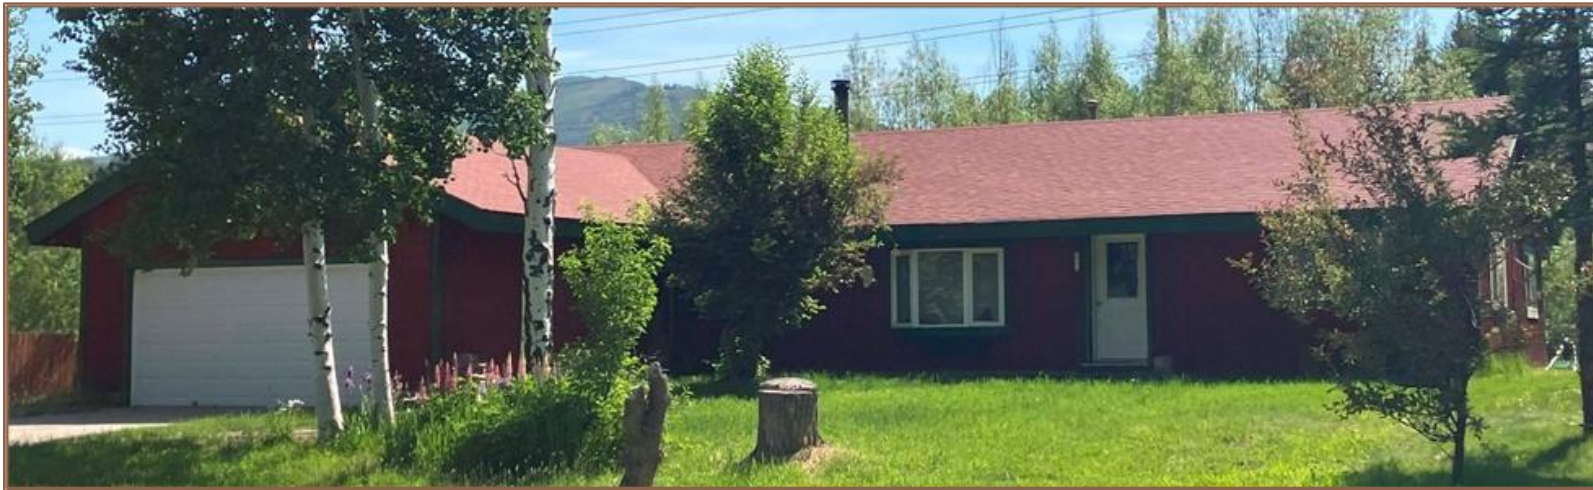
Photograph 21. Ranch style residence with original door placement and sizing.

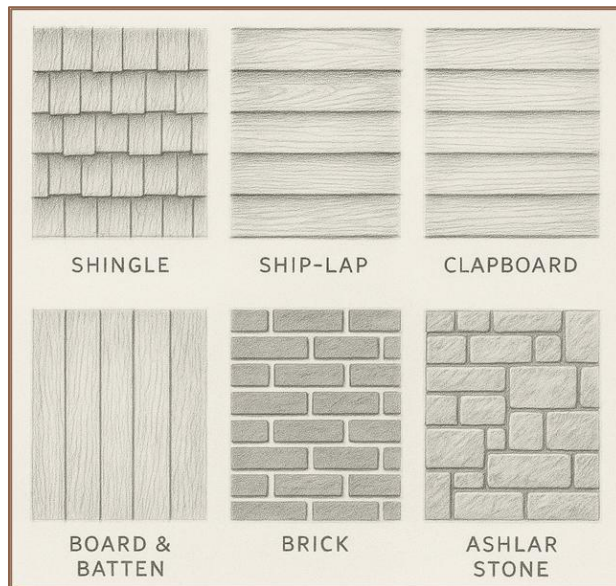
Figure 12. Different types of siding found in Steamboat Springs.¹⁷

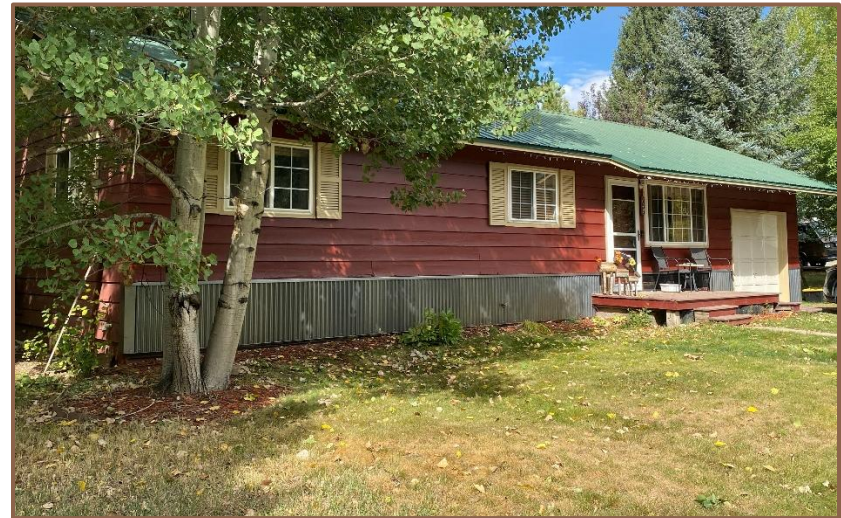
Figure 13. Example of corrugated steel siding over wood lap siding for the purposes of weatherproofing. The corrugated steel siding covering material is removable.¹⁸

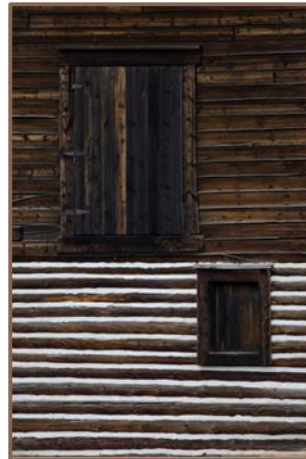
Photograph 23. Example of wood siding and daubing.

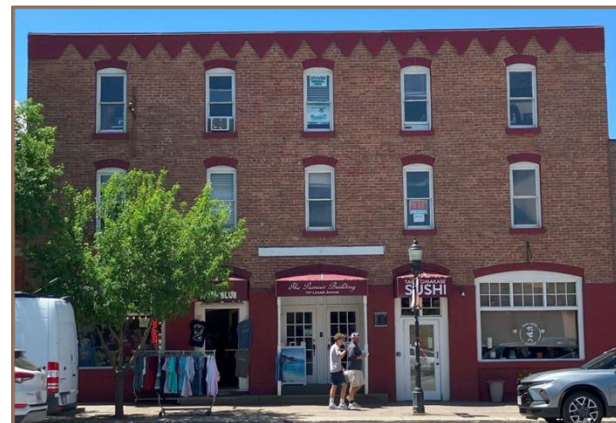
Photograph 25. Example of a commercial brick building with the original brick detailing painted over and wood siding added along the lower level of the façade that obscures the brick underneath.

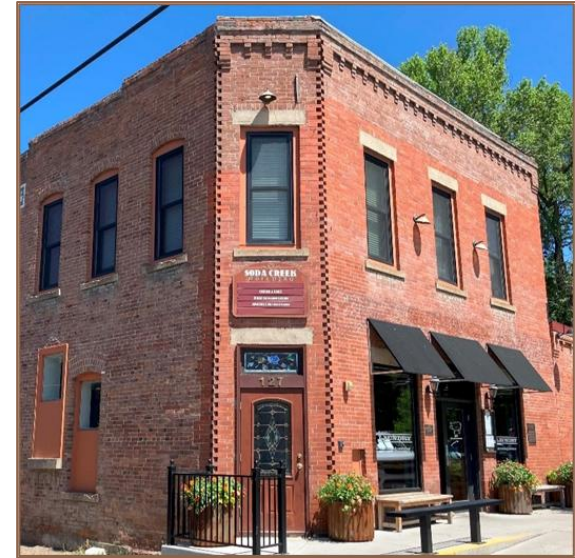
Photograph 26. An example of a building with brick sheathing that has been partially replaced. It maintains the historic running bond pattern and brick size and materials, while not obscuring that it is newer brick through its coloring.

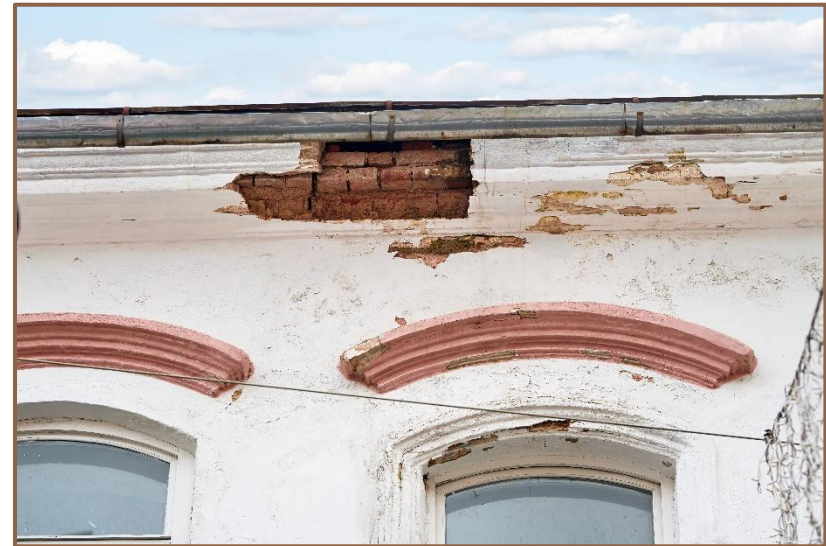
Figure 14. Example of a deteriorated stone cornice.¹⁹

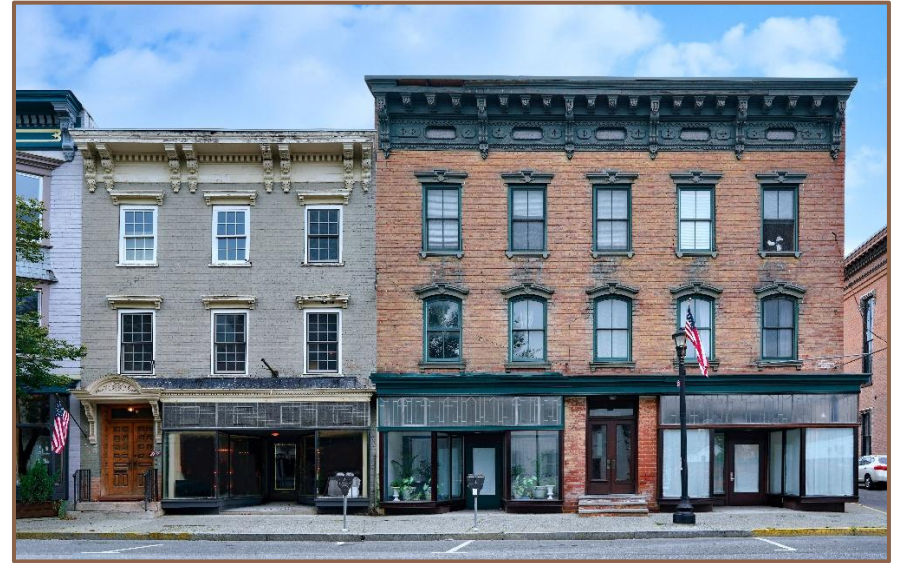
Photograph 28. Example of a row of commercial buildings that have maintained their significant architectural features.²⁰

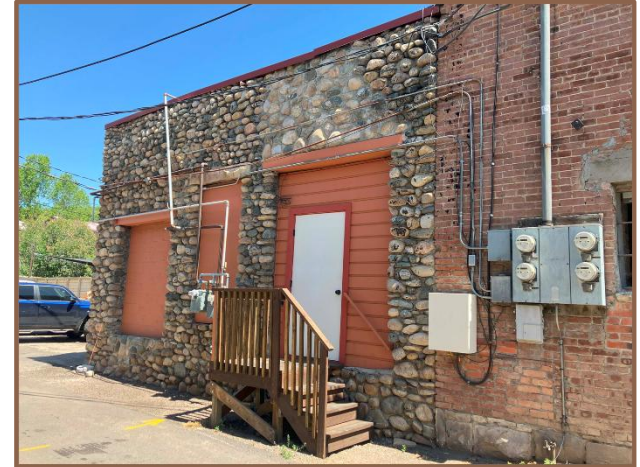
Photograph 29. Example of an addition with river rock façade facing attached to a historic brick building.

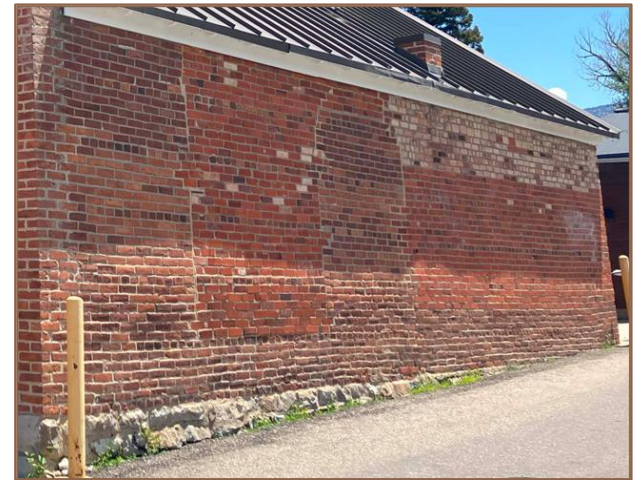
Photograph 30. Example of a historic building with replacement brick and roofing around historic elements.

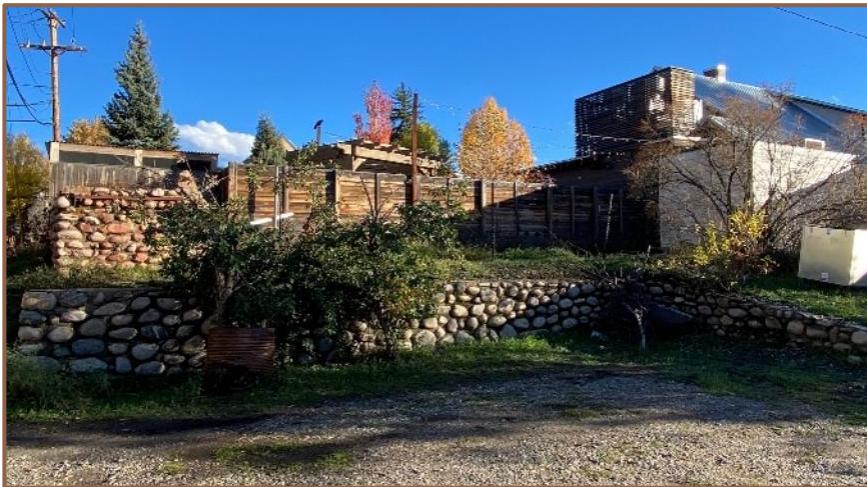
Photograph 31. View of river rock features in an alley.

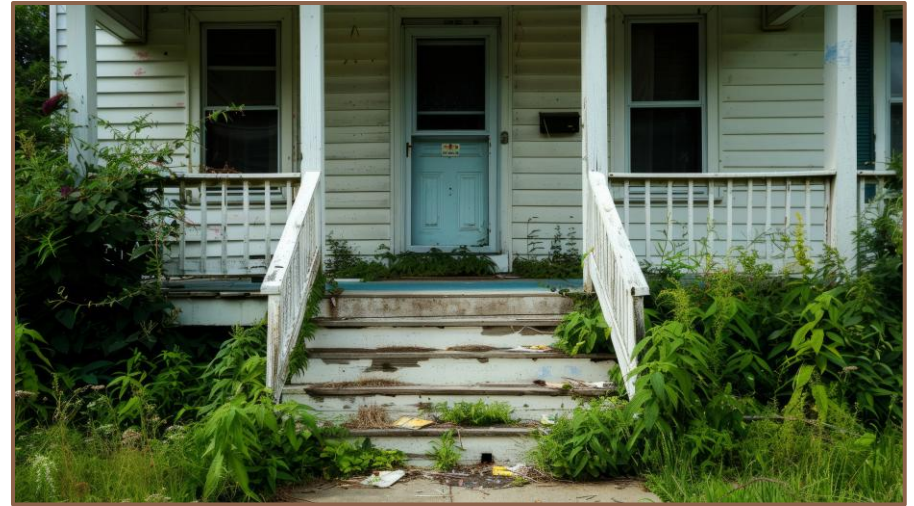
Figure 15. Example of a deteriorating front porch.²¹

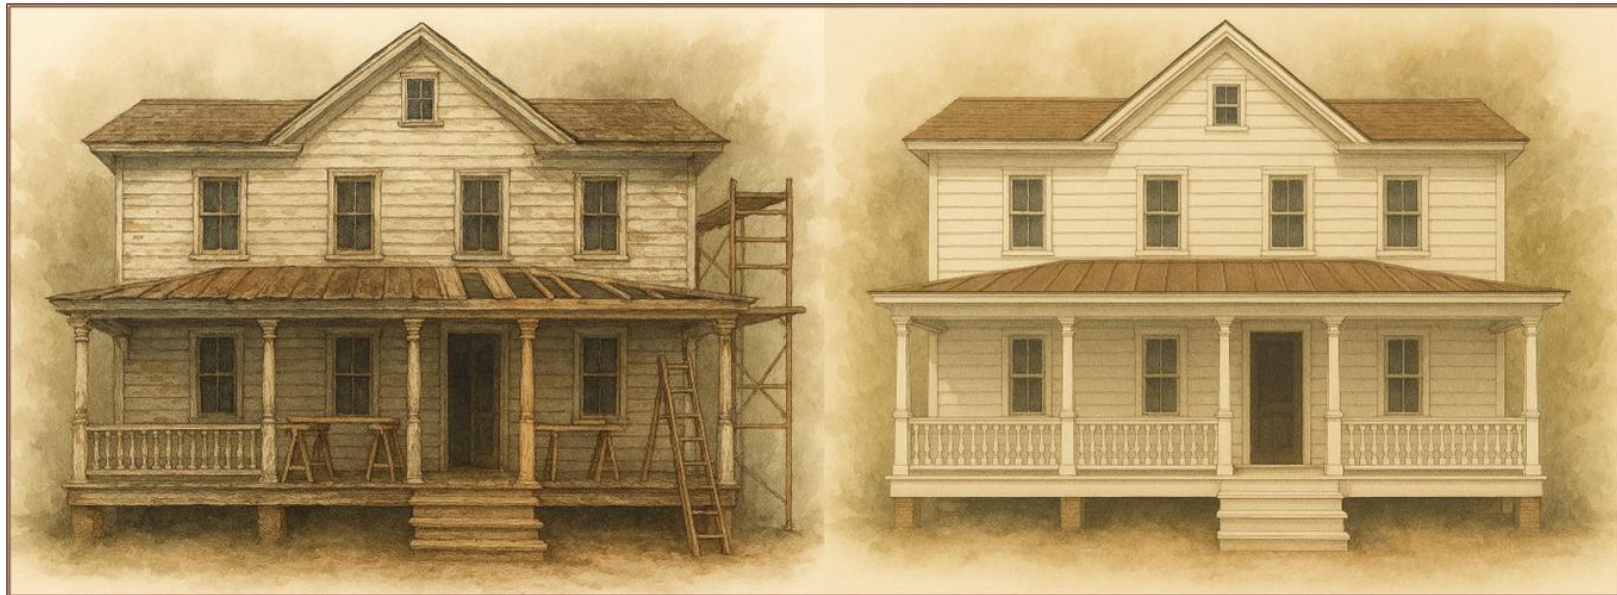
Figure 16. A deteriorating porch in the process of replacement and completion.²²

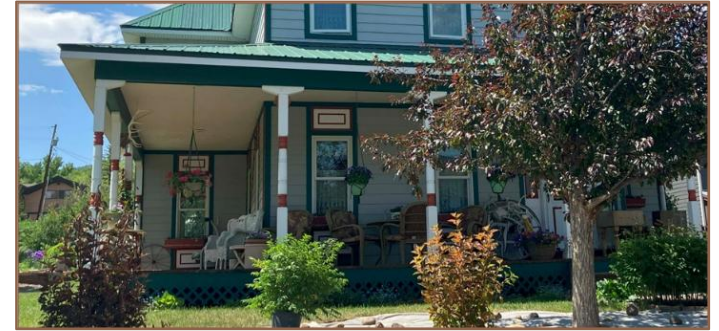
Photograph 33. Preserved wrap around porch with original turned decorative posts.

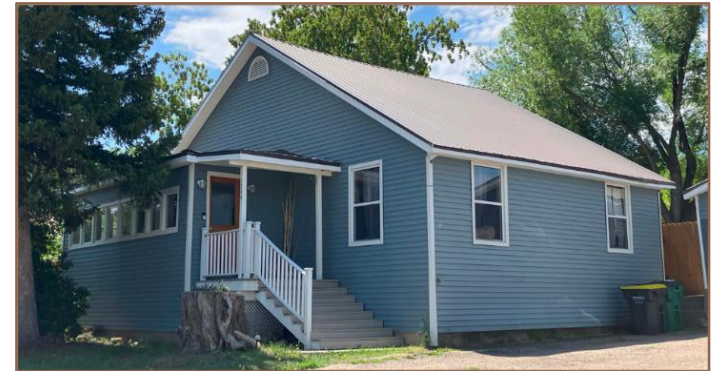
Photograph 34. Example of an enclosed front porch.

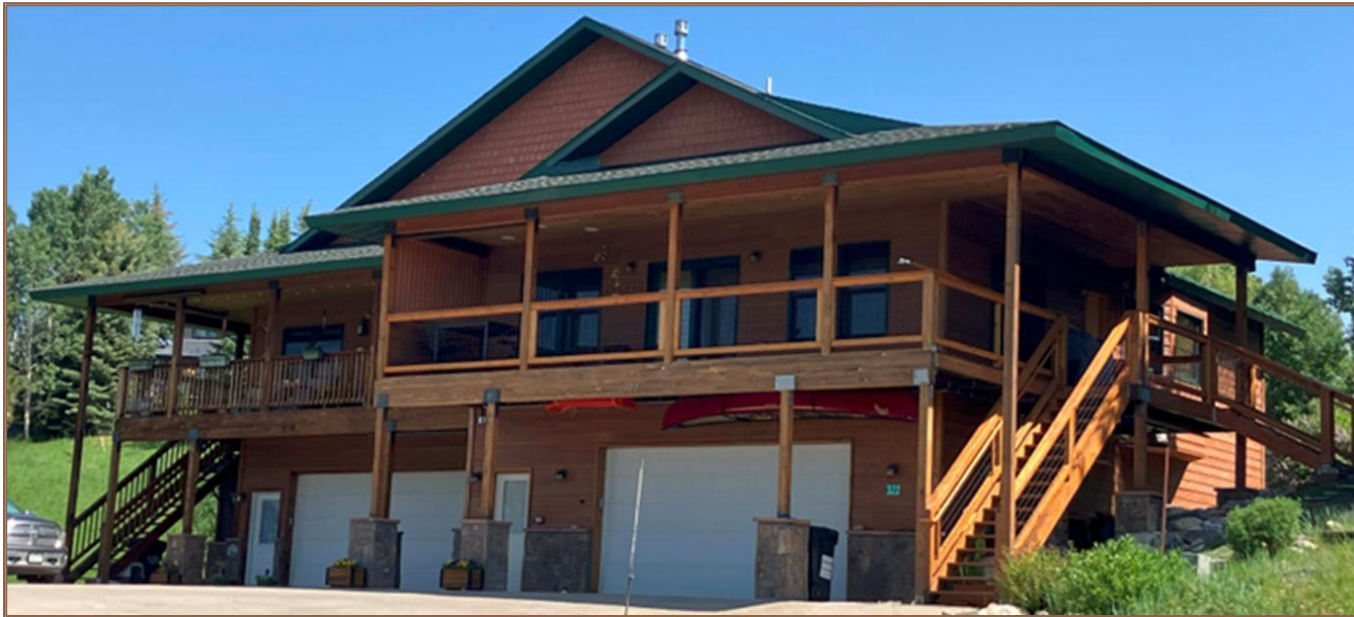
Photograph 35. Example of an updated balcony (right) next to an older balcony (left).

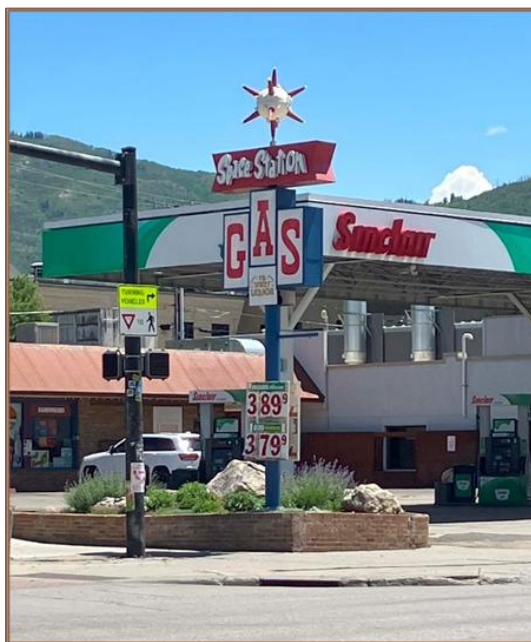
Photograph 50. A historic gas station sign located next to a more recent, updated gas station building.

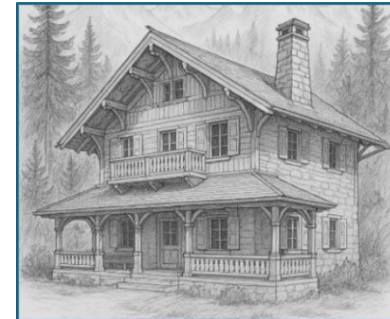
Figure 35. Sketch example of a Swiss Chalet style building.⁷²

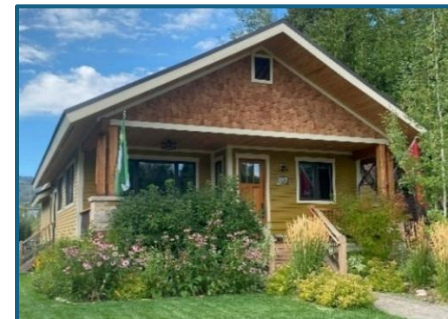
Photograph 65. Local example of a Craftsman style bungalow.

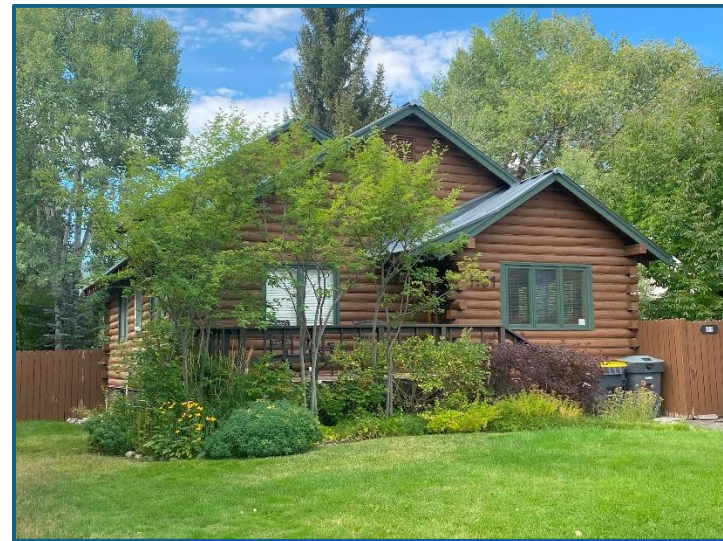
Photograph 66. Local example of a Rustic style cabin.

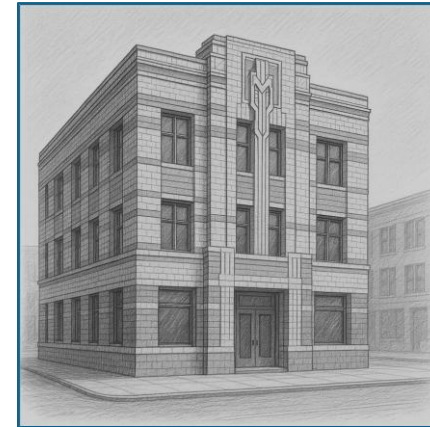
Figure 43. Sketch example of an Art Deco style commercial building.¹⁰⁷

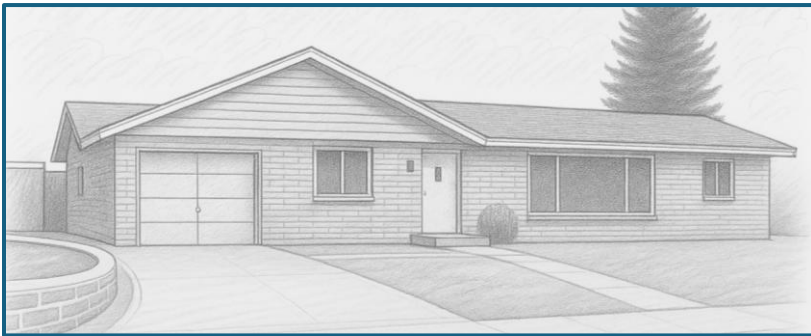
Figure 48. Sketch example of a Ranch style residence.¹²⁷

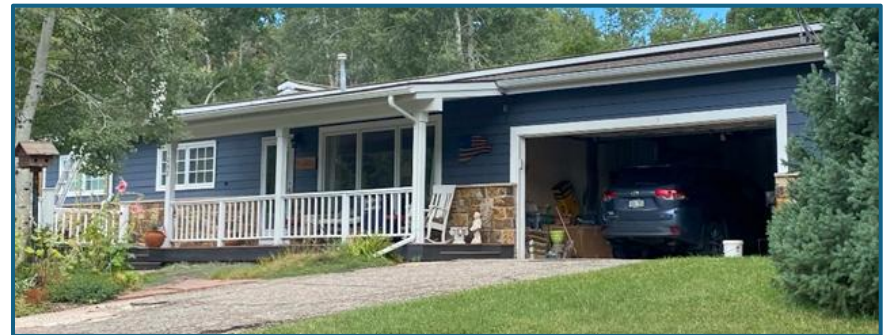
Photograph 74. Local example of a Ranch style residence.

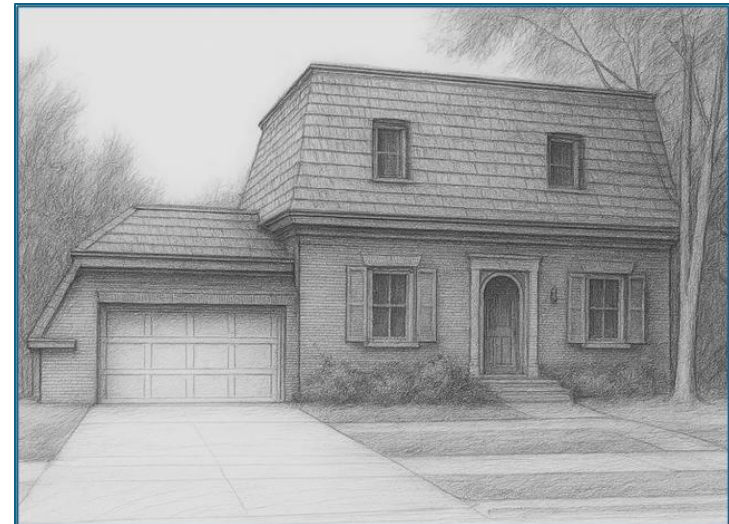
Figure 52. Sketch example of a Neo-Mansard style residence.¹⁴³

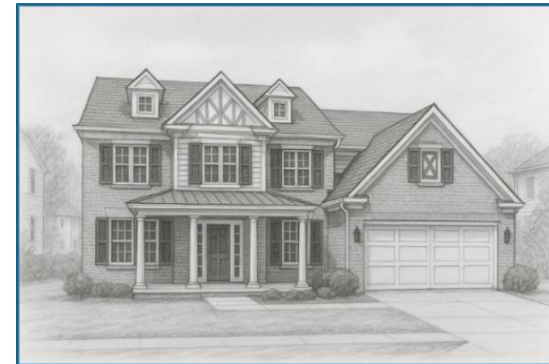
Figure 54. Sketch example of a New Traditional style residence.¹⁵²
