APPENDIX A – PROBLEMS AND NEEDS MAPS

Problems and Needs Map - Walton Creek

Citywide Stormwater Master Plan
City of Steamboat Springs, Colorado

Figure
A-1

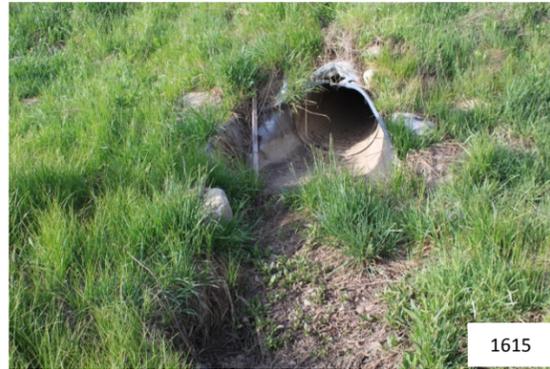
Location: East of Lincoln Avenue on Ingles Lane behind La Quinta Inn.
Problem/Solution: One-way or reed valve needed on outfall to Walton Creek to prevent high water levels in Walton Creek from backing up into Holiday Inn parking lot. Private detention pond outlet needs cleaning.

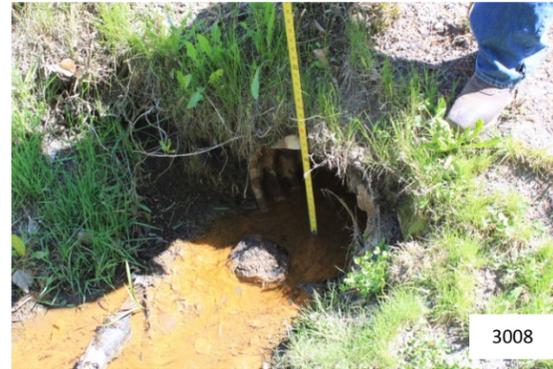
Location: South West corner of Walton Creek Road and Aspen Leaf Way.
Problem/Solution: Clean out 18-inch CMP invert.

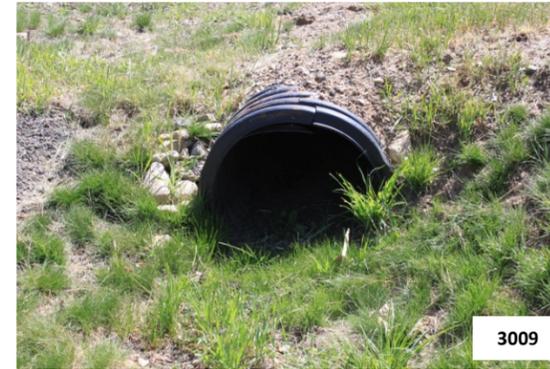
Location: Southern side of Walton Creek Road and Whistler Road.
Problem/Solution: Remove sediment in invert and restore grades to blend into roadside ditch.

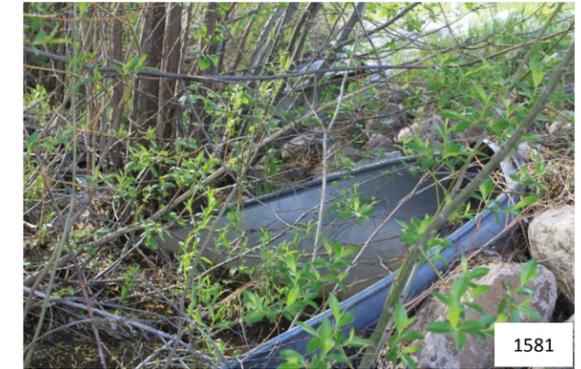
Location: East side of Lincoln near Walton Creek Road.
Problem/Solution: Remove trees, vegetation, and debris at u/s end of triple 48-inch CMPs beneath Walton Creek Trail.

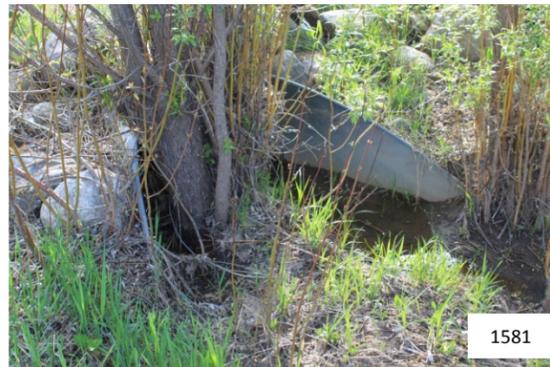
Location: East side of Lincoln near Walton Creek Road.
Problem/Solution: Remove trees, vegetation, and debris at downstream end of triple 48-inch CMPs beneath Walton Creek Trail.

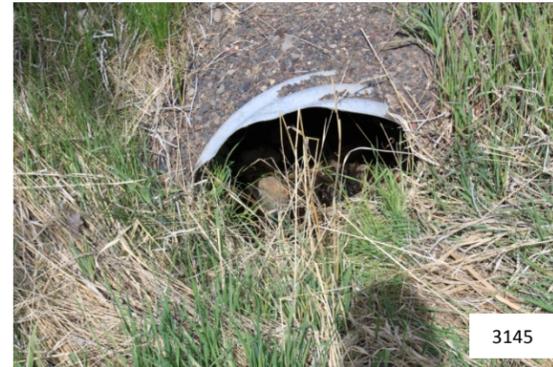
Location: Skyview Lane and Chinook Lane.
Problem/Solution: Remove sediment and vegetative growth from inlet and outlet of 24-inch CMP

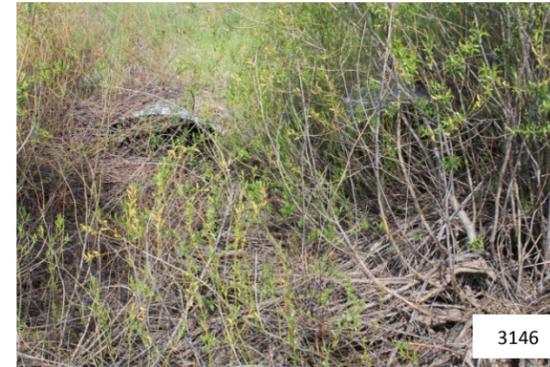
Location: Chinook Lane at Jackpine Court.
Problem/Solution: Remove vegetative growth and sediment at inlet to twin 66-inch CMP culverts; restore grades and provide outlet protection on outlet side.

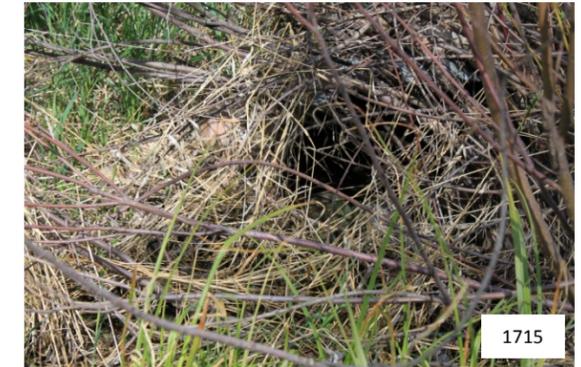
Location: At eastern end of Stone Circle, closest to Yampa River.
Problem/Solution: Vegetation removal required around 30-inch CMP.

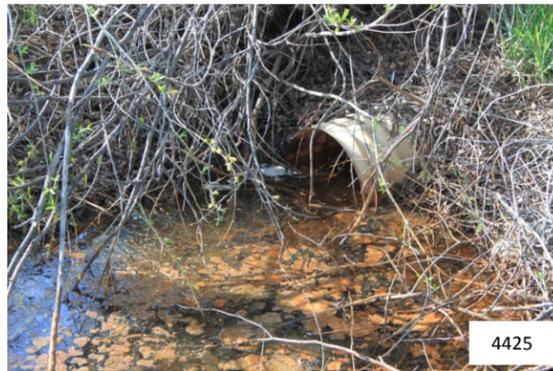
Location: East side of Lincoln Avenue, typical area drain discharge.
Problem/Solution: Remove silt, standing water, and vegetation from 18-inch CMP.

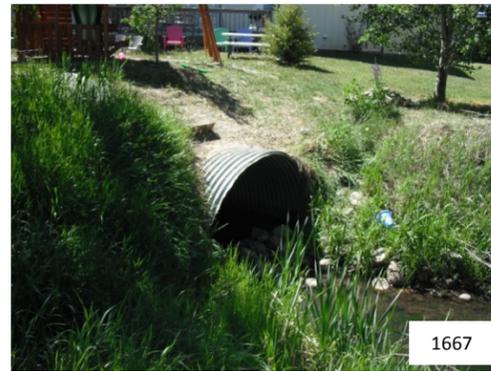
Location: Along tributary to Walton Creek (Bear Creek) west of Whistler Road.
Problem/Solution: Remove sediment from entrance to 72-inch pipe.

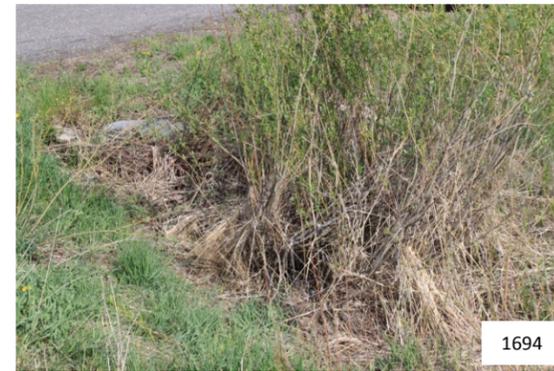
Location: Under Meadowood Court at intersection with Stone Circle.
Problem/Solution: Remove vegetation in and surrounding existing 24-inch CMP.

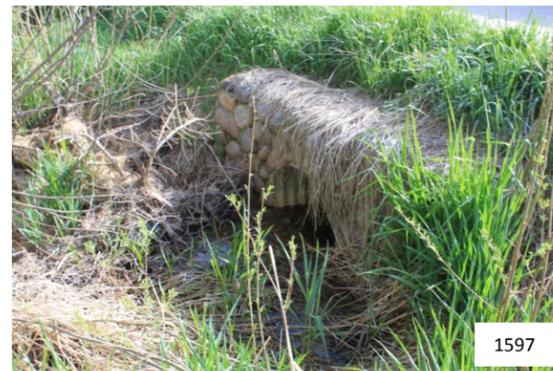
Location: On Yampa River Core Trail near connection to Willow Brook Court.
Problem/Solution: Remove vegetation and debris and add a flap gate to existing 18-inch CMP outfall.

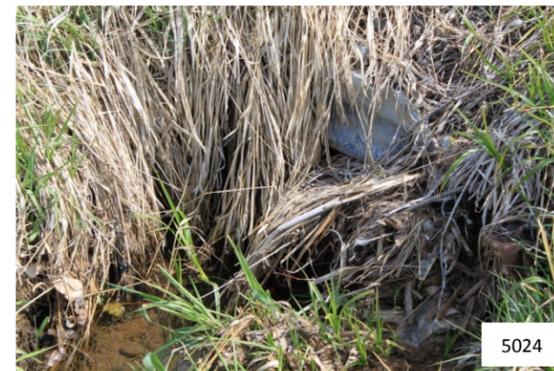
Location: Outfalls into Yampa River under Chinook Lane, South of Willow Brook Court.
Problem/Solution: Remove vegetation from blocked 24-inch CMP.

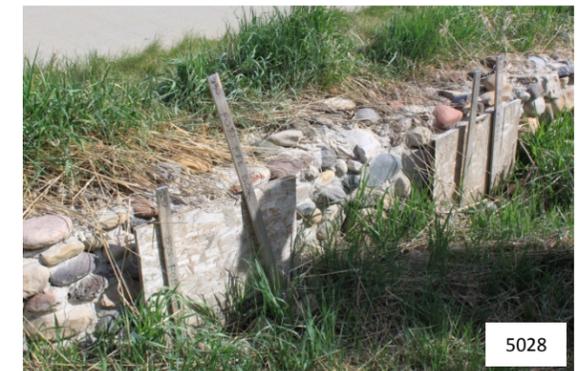
Location: Outfalls from pond in between Lincoln Avenue and Chinook Lane.
Problem/Solution: Remove vegetation and plywood from blocked Twin 18-inch CMP outfalls; install flap gate valves to prevent Walton Creek backflow.

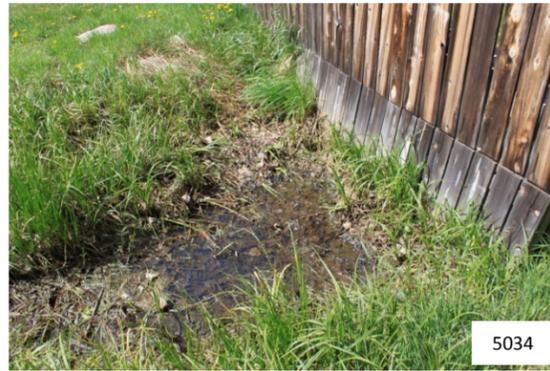
Location: Just South of end of Mariah Court in between residential homes.

Problem/Solution: Alter fence line that is blocking flow conveyance on private property.

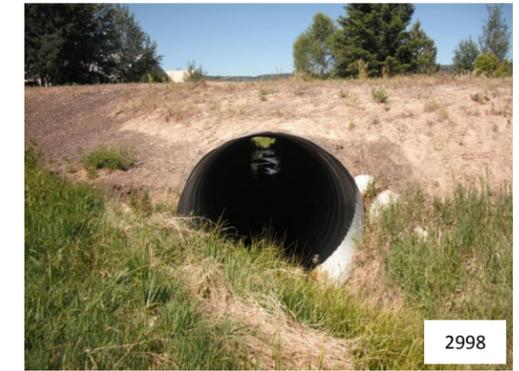
Location: Under Whistler Road just South of Redwood Court.

Problem/Solution: Remove silt and vegetation from existing CMP.

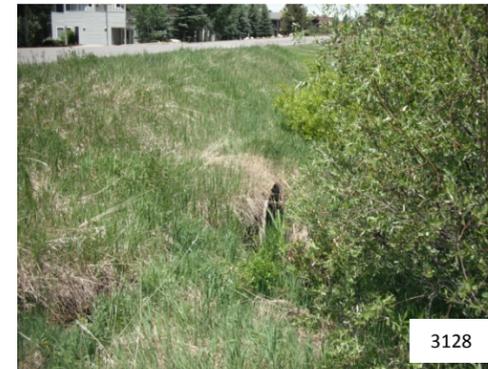
Location: Bear Creek Trail Crossing at Meadow Lane.

Problem/Solution: Remove sediment and vegetative growth from CMP inlet and outlet.

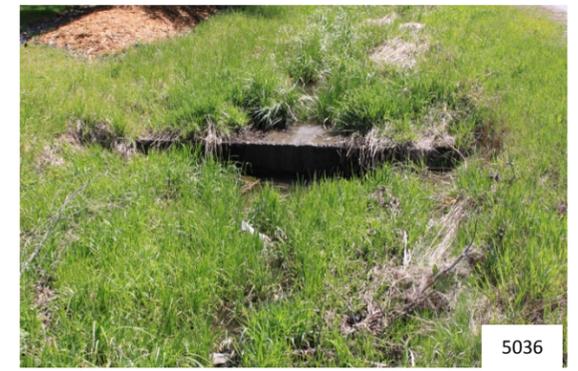
5036

Location: Northern side of Walton Creek Road
Problem/Solution: Remove vegetation and sediment to restore clear top of weir and downstream channel bottom elevation.

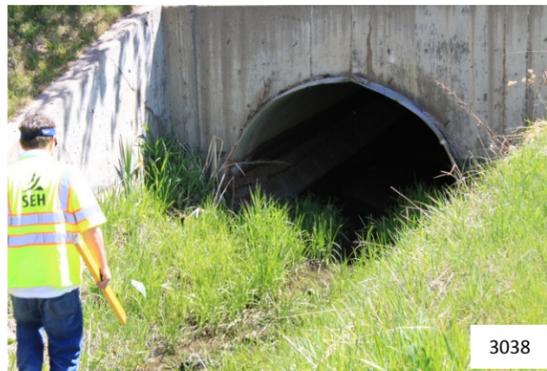
3038

Location: Northern side of Walton Creek Road at and Eagle Ridge Drive crossing.
Problem/Solution: Mow/Clear vegetation and restore grade.

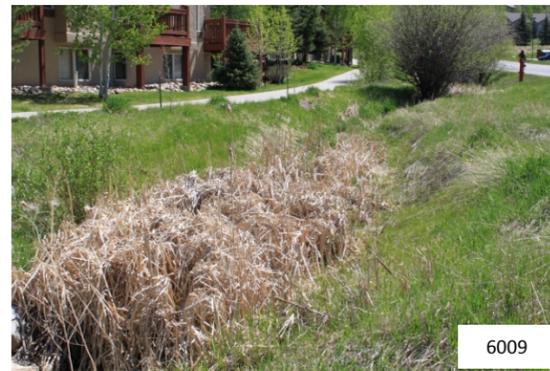
6009

Location: Northeast side of Walton Creek Road and Eagle Ridge Drive
Problem/Solution: Harvest/remove dead cattails/vegetation; restore grade and capacity of roadside ditch. Determine status of exposed PVC pipe.

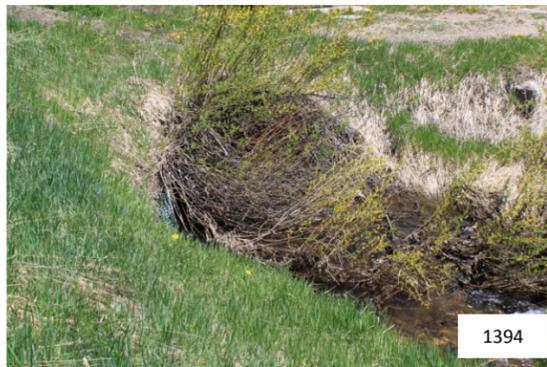
Location: East of Village Drive at Market on the Mountain.
Problem/Solution: Clear and remove vegetation blocking outfall from culvert beneath Market on the Mountain parking lot.

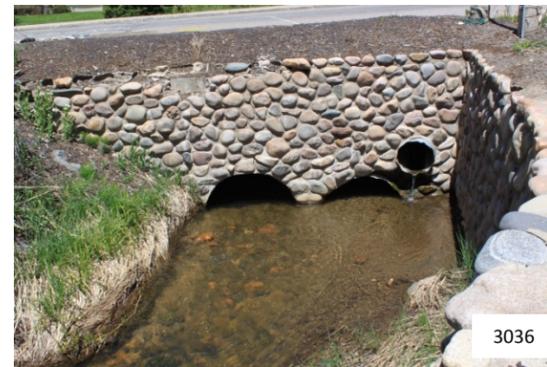
Location: Southeast corner of Village Drive and Apres Ski Way
Problem/Solution: Remove sediment and debris to restore capacity to twin 48-inch CMPs beneath Apres Ski Way.

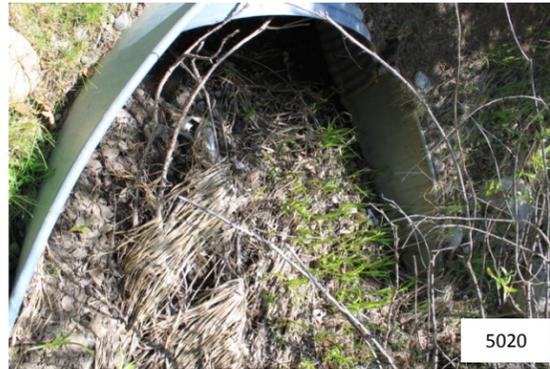
Location: North side of Apres Ski Way near Village Drive
Problem/Solution: Remove debris and sediment from outfall for 60-inch CMP on Apres Ski Way.

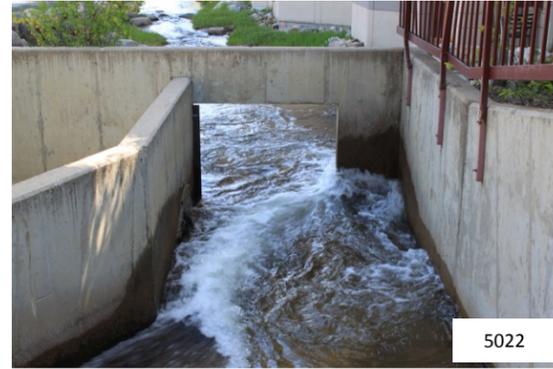
Location: South side of Ski Time Square Drive
Problem/Solution: Review 100-year floodplain elevations and snowmelt water surface elevations to ensure structure adjacent to Burgess Creek is protected during high water events.

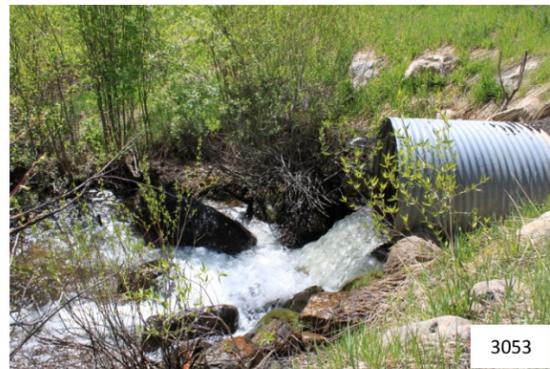
Location: At the intersection of Burgess Creek Road and Storm Meadows Drive
Problem/Solution: Install outfall protection and energy dissipation at 48-inch CMP outfall.

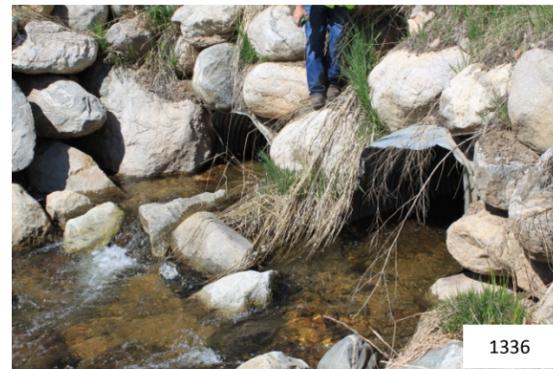
Location: On a private drive off Burgess Creek Drive Northeast of Storm Meadows Drive
Problem/Solution: Restore capacity of twin 42-inch CMPs beneath Stonecreek Court by removal of sediment/debris and installation of flared end sections.

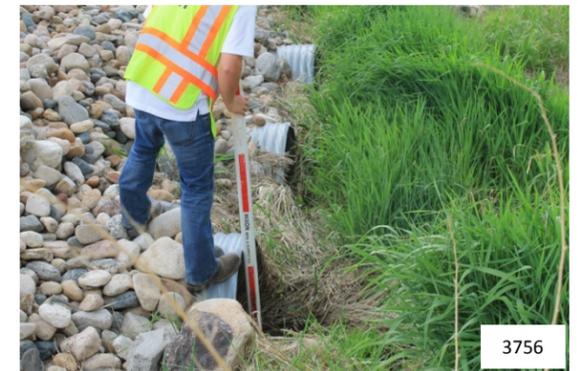
Location: Under Bangtail Way just East of Cattle Kate Circle.

Problem/Solution: Remove sediment and debris from Triple 48-inch CMPs.

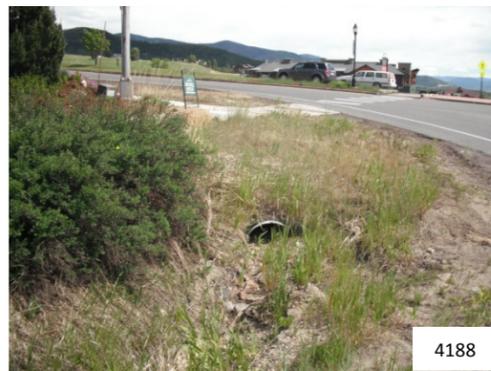
Location: At intersection of Steamboat Boulevard and Mount Werner Road.

Problem/Solution: Remove sediment and debris from 30-inch CMP.

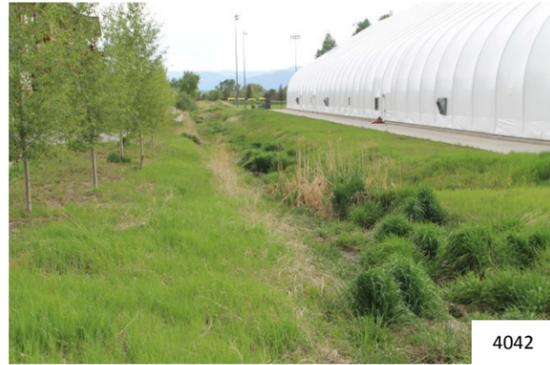
Location: Looking south along swale toward sports fields.

Problem/Solution: Unknown flowpath and outfall location across sports fields beneath Pine Grove Road and Lincoln Avenue, and the Yampa River Core Trail.

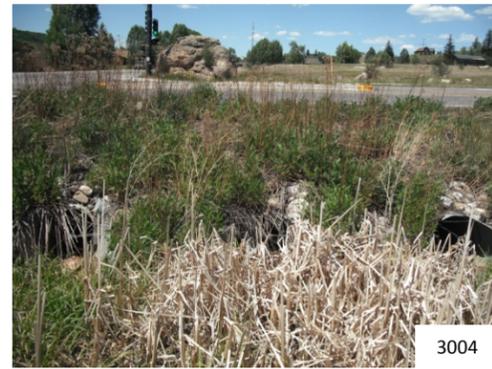
Location: Southeast corner of Central Park Drive and Pine Grove Road.

Problem/Solution: Unknown flowpath; cannot locate other end of triple CMPs.

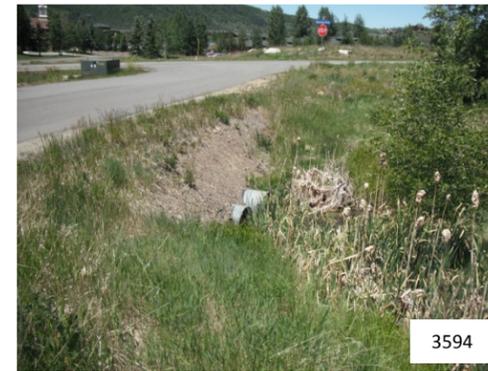
Location: Beneath Indian Summer Drive parallel to Steamboat Boulevard

Problem/Solution: Remove vegetation and debris from twin 35-inch RCPS.

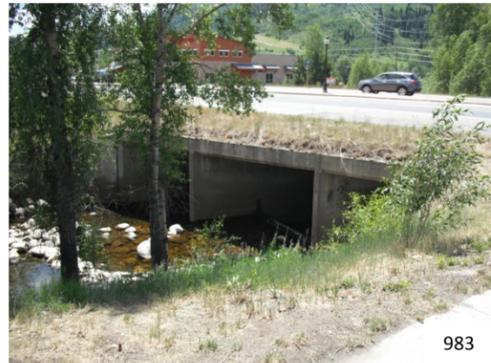
Location: Triple box culvert at Lincoln Avenue.
Problem/Solution: Needs handrail and/or guardrail to minimize the potential for pedestrian and vehicular accidents.

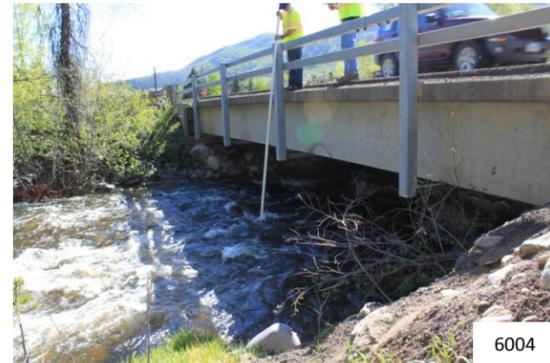
Location: Bridge over Fish Creek at Rollingstone Drive.
Problem/Solution: Check capacity to minimize the potential for backwater and flood risk.

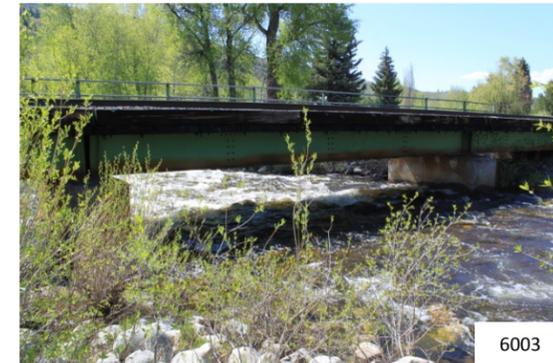
Location: Fish Creek crossing at railroad tracks.
Problem/Solution: Check capacity to minimize the potential for backwater and flood risk.

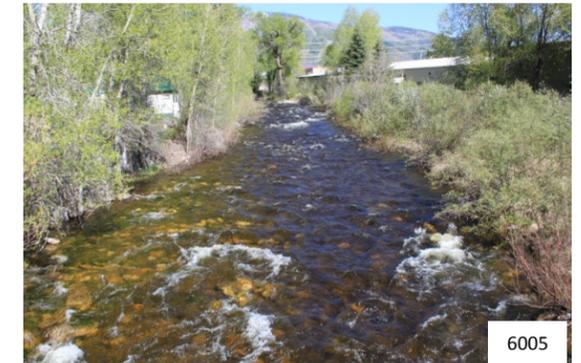
Location: Looking upstream from pedestrian bridge over Fish Creek on Yampa River Core Trail.
Problem/Solution: Potential for flooding properties in close proximity to Fish Creek.

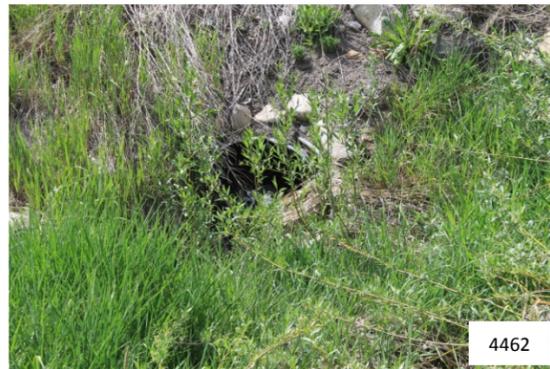
Location: Driveway culvert on Clearwater Trail just east of Steamboat Boulevard.
Problem/Solution: Remove sediment and debris to restore capacity.

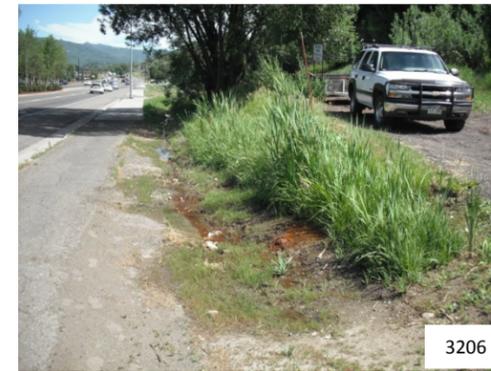
Location: East roadside swale for Lincoln Avenue by entrance to Hampton Inn

Problem/Solution: Regrade swale and clean out completely clogged 24-inch CMP at driveway.

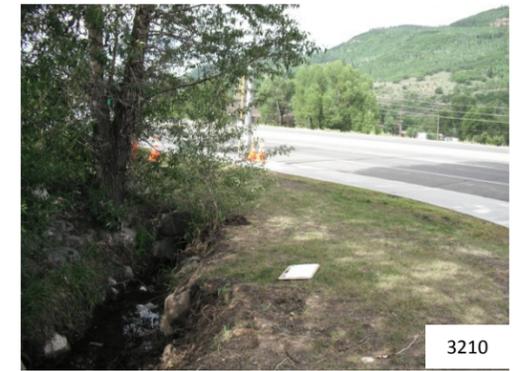
Location: Under Lincoln Ave by intersection with High Point Drive

Problem/Solution: Analyze seepage source and flowrates to size conveyance system to minimize nuisance flooding and icing issues. Continue aggressive maintenance schedule.

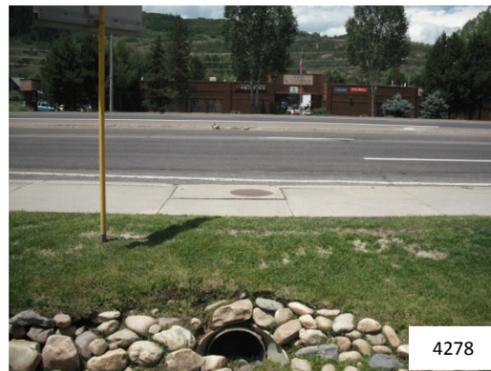
Location: Under Lincoln Avenue West of the Hampton Inn.

Problem/Solution: Restore grades and capacity of 24-inch CMP.

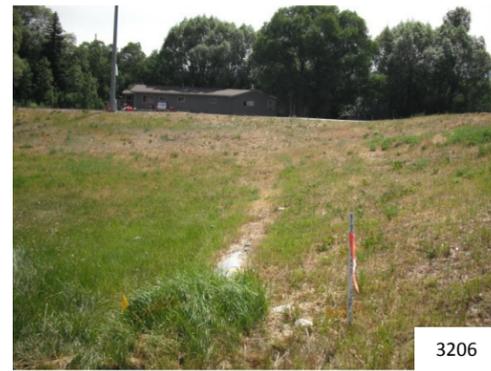
Location: West side of Lincoln Avenue at the southeast corner of Hampton Inn property.

Problem/Solution: Remove sediment and vegetative blockage from outfall pipe.

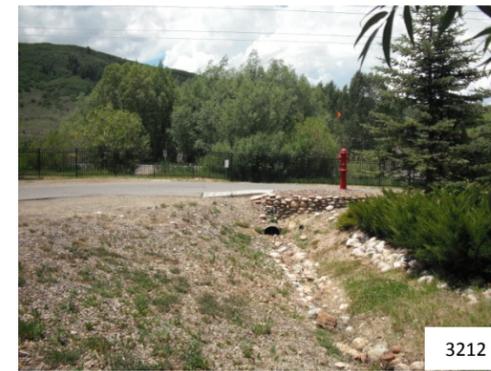
Location: CMP beneath service road west of Hampton Inn.

Problem/Solution: Restore capacity at inlet to CMP and remove sediment and vegetation at outfall.

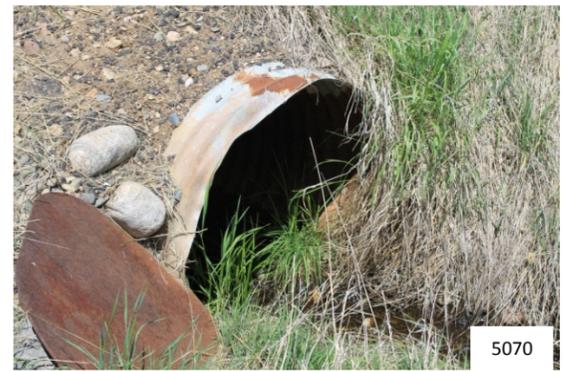
Location: Under Trafalgar Drive, just East of intersection with Pamela Lane.

Problem/Solution: Remove silt and debris from existing 36-inch CMP and restore grades in swale.

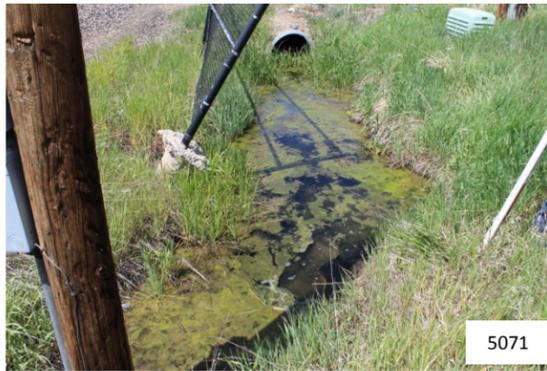
Location: Under Trafalgar Drive, just East of intersection with Pamela Lane.
Problem/Solution: Remove sediment and debris from 24-inch CMP and regrade swale to restore capacity.

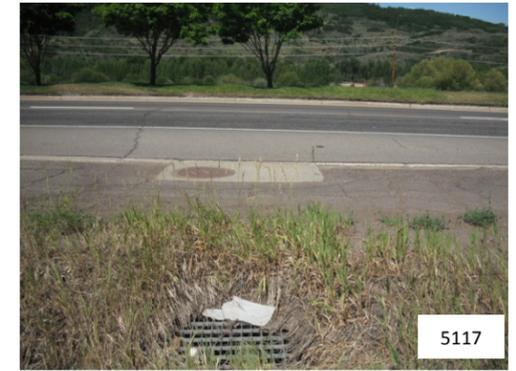
Location: At most Northern part of High Point Drive just East of Lincoln Avenue.
Problem/Solution: Maintain and clean out Type C inlet for roadside ditch and clean out Type R crossing at Lincoln Avenue.

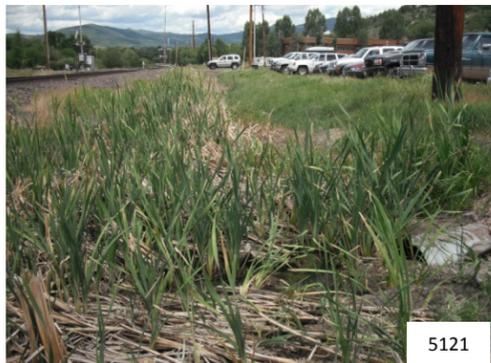
Location: Underneath back road East of Specialists Steamboat office and West of the Railroad tracks.
Problem/Solution: Remove vegetation, sediment, and standing water from existing 15-inch CMP.

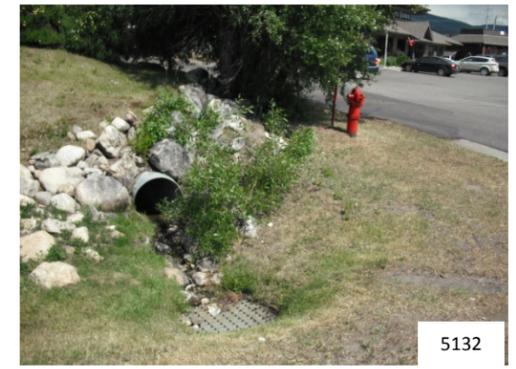
Location: East side of Lincoln Avenue, north of the Trafalgar Drive / Hilltop Parkway intersection.
Problem/Solution: Maintain swale and clean area inlet.

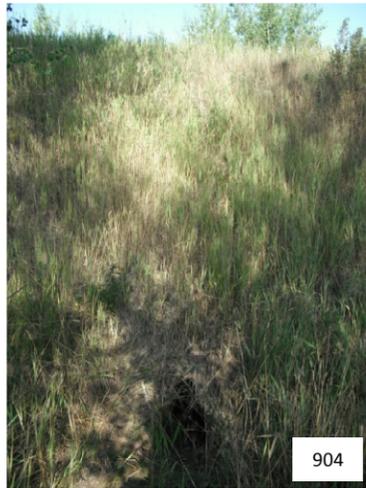
Location: Under East side of Anglers Drive loop.
Problem/Solution: Remove sediment from buried CMP and restore capacity.

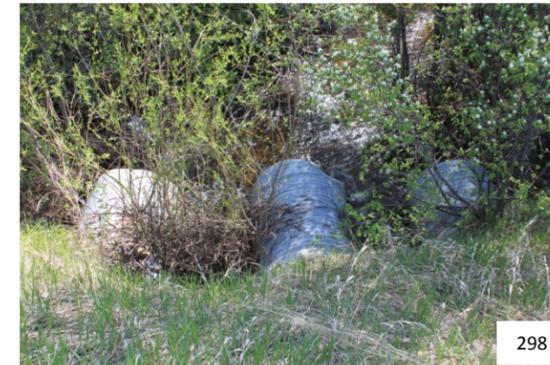
Location: Triple 54-inch CMPs conveying Spring Creek beneath Amethyst Drive.

Problem/Solution: Clear vegetative growth and debris to ensure maximum capacity of culverts.

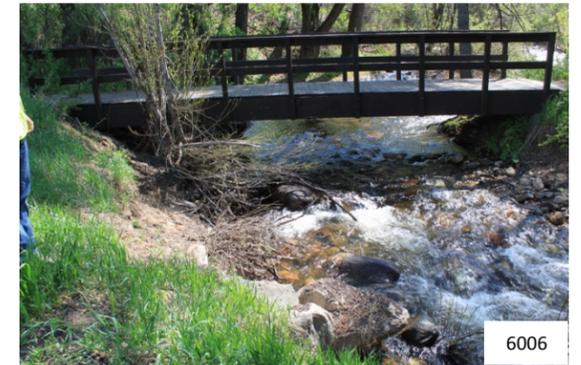
Location: Near pedestrian bridge at 2nd and Pine Streets.

Problem/Solution: Provide right bank protection just downstream of pedestrian bridge.

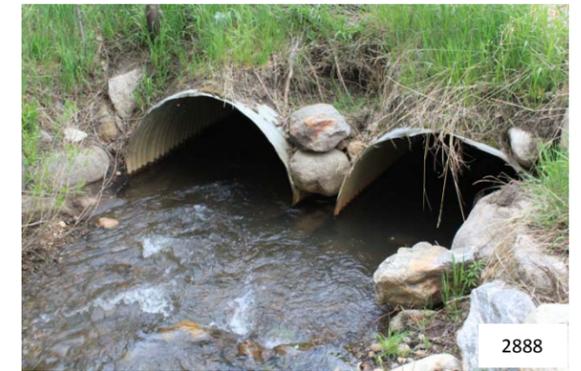
Location: Butcherknife Creek Twin 60-inch CMP outfall pipes just northwest of 6th Street.
Problem/Solution: Provide inlet protection and clean out sediment and debris to maximize capacity.

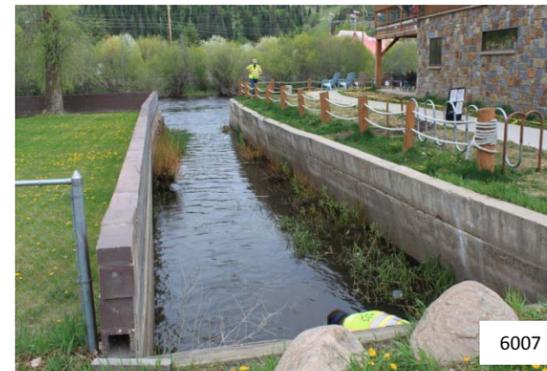
Location: Open channel from Yampa Street to the Yampa River.
Problem/Solution: Re-construct channel walls and clean out channel bottom.

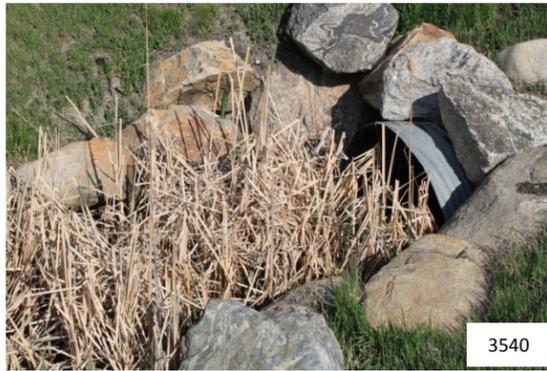
Location: Under Copper Ridge Circle at intersection with Elk River Road.
Problem/Solution: Remove sediment, debris, and vegetative growth from 60-inch CMP under north leg of Copper Ridge Drive.

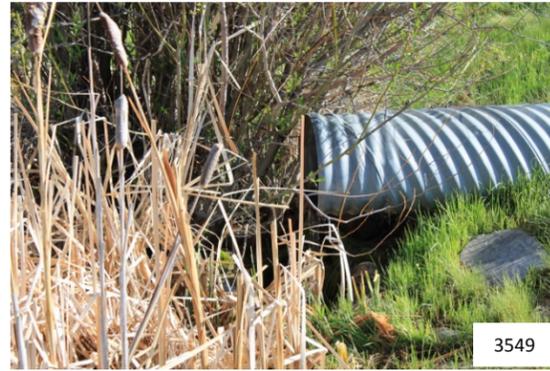
Location: Under Copper Ridge Frontage Road intersecting with Copper Ridge Drive.
Problem/Solution: Install erosion protection and remove vegetative growth to restore capacity.

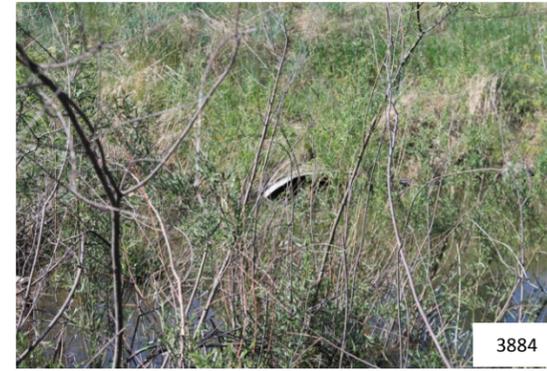
Location: Along Copper Ridge Creek just upstream of Outfall into Yampa River.
Problem/Solution: Remove sediment, vegetation growth from 48-inch CMP outfall.

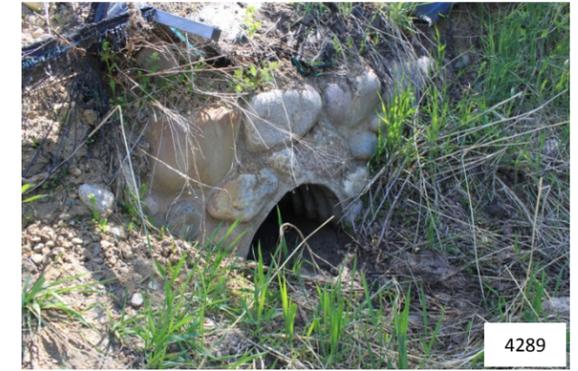
Location: Outfall into Yampa River from Copper Ridge Basin southwest of Lincoln Avenue behind Steamboat Rentals.
Problem/Solution: Remove sediment, debris, and vegetative growth from 18-inch CMP.

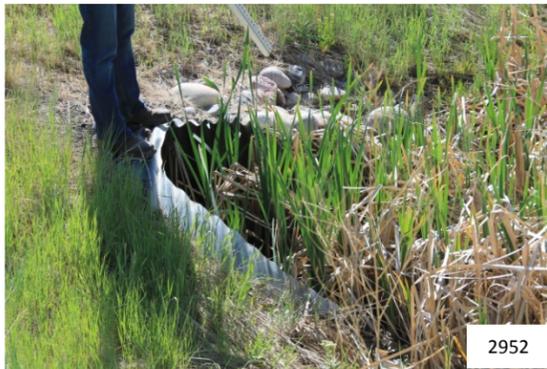
Location: Under Shield Drive at intersection with Elk River Road.
Problem/Solution: Remove sediment, debris, and vegetative growth at outfall for 48-inch CMP.

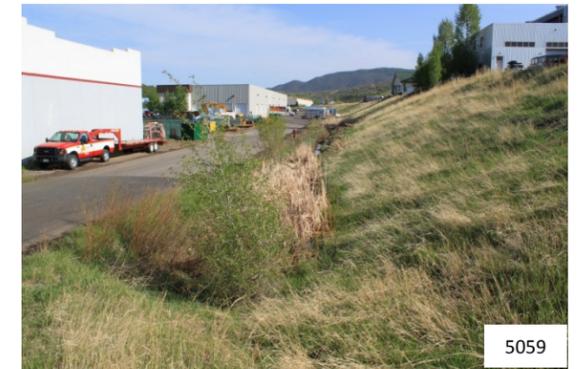
Location: Along South Copper Passage behind Wagner Rentals.
Problem/Solution: Remove vegetative growth and regrade swale to restore capacity.

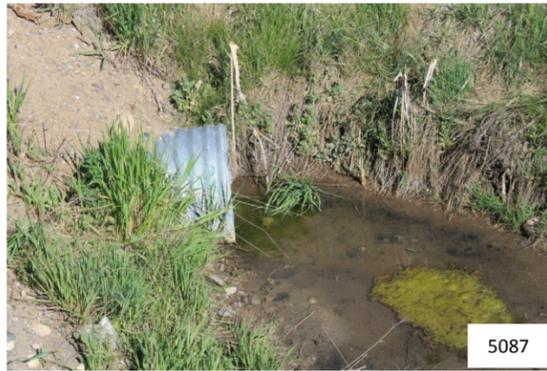
Location: West of the intersection of Downhill Drive and Radiator Road.
Problem/Solution: Remove sediment and debris from mouth of 24-inch CMP.

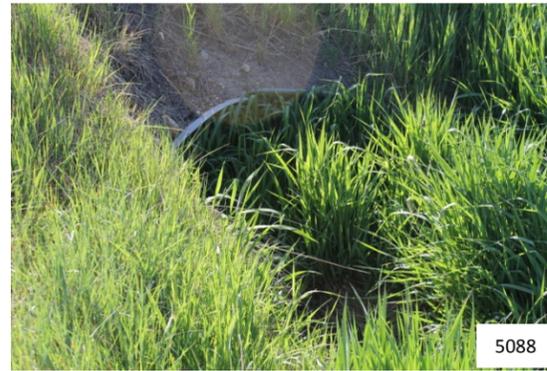
Location: Along Copper Ridge Creek where it crosses under Lincoln Avenue.
Problem/Solution: Remove silt and vegetation from existing 48-inch CMP to restore capacity.

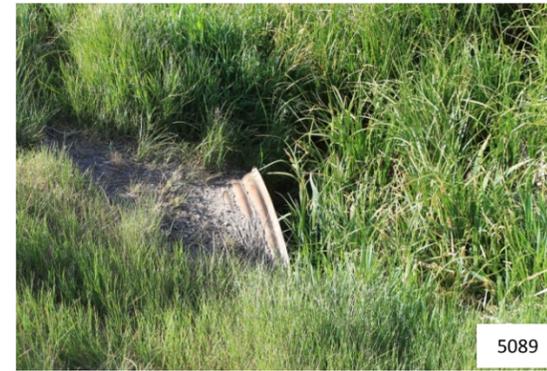
Location: Culvert beneath Lincoln Avenue west of Downhill Drive / Riverside Drive.
Problem/Solution: Remove silt, debris, and vegetative growth from existing 48-inch culvert under Lincoln Avenue to restore capacity.

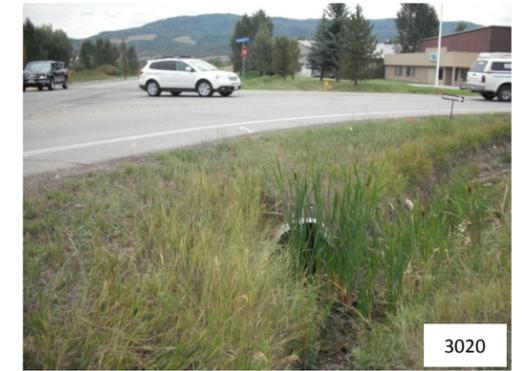
Location: At southwest corner of Downhill Drive and Elk River Road.
Problem/Solution: Restore original grade and remove sediment and vegetative growth.

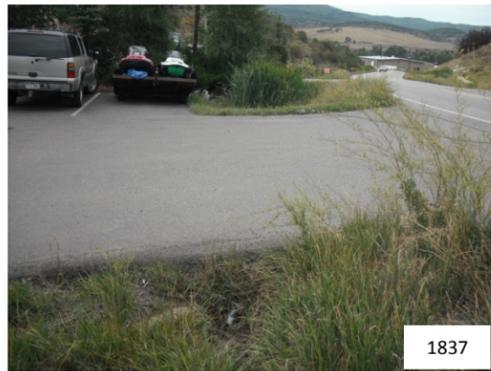
Location: At driveway opposite of Downhill Drive and West End Avenue
Problem/Solution: Remove sediment and debris from clogged area drain and roadside ditch.

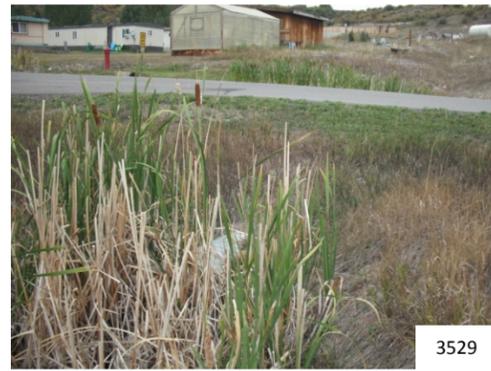
Location: At southwest corner of West End Avenue and Downhill Drive
Problem/Solution: Remove sediment and vegetation from clogged 24-inch CMP.

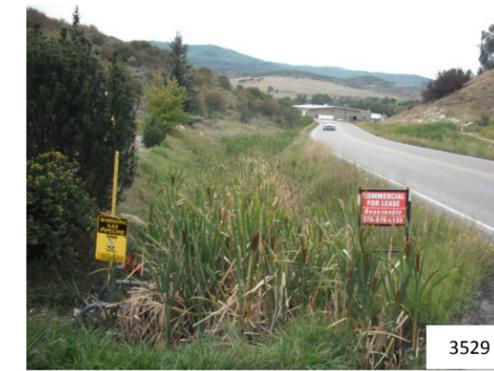
Location: Looking south along Downhill Drive at West End Avenue.
Problem/Solution: Clear sediment and vegetative growth from driveway culvert exit and restore capacity of roadside swale.

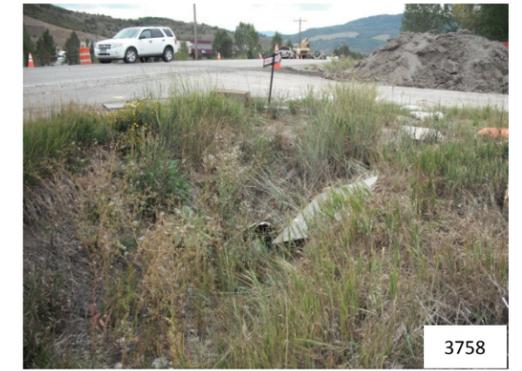
Location: Parallel to Elk River Road north of Downhill Drive.
Problem/Solution: Remove sediment, debris, and vegetative growth from small diameter CMP.

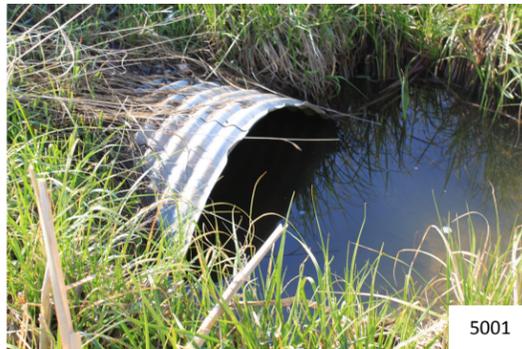
Location: Beneath Elk River Road at Copper Ridge Drive
Problem/Solution: Remove sediment and vegetation from CMP and re-grade to remove standing water.

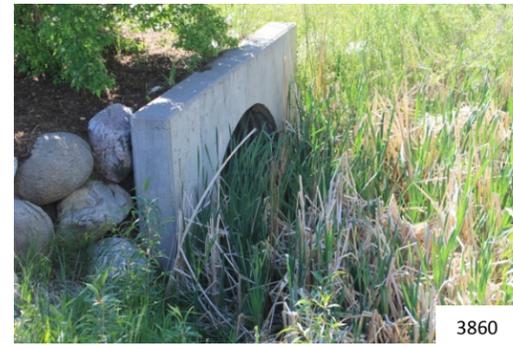
Location: Parallel to Elk River Road under Curve Plaza Driveway
Problem/Solution: Remove sediment and vegetation from outlet for CMP and re-grade to remove standing water.

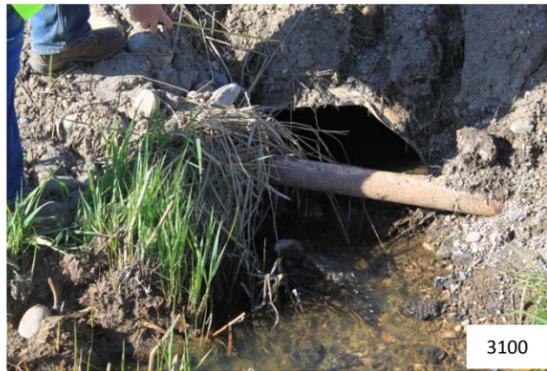
3100

Location: Culvert near northwest end of 13th Street conveying flows beneath 13th Street.
Problem/Solution: Remove sediment and vegetation from 24-inch CMP. Relocate utility line as necessary.

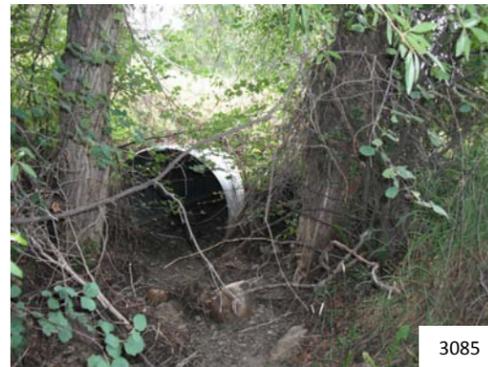
Location: Under Manitou Avenue between Pitkin Street and Gilpin Street.
Problem/Solution: Remove sediment and debris and replace Twin 36-inch CMPs.

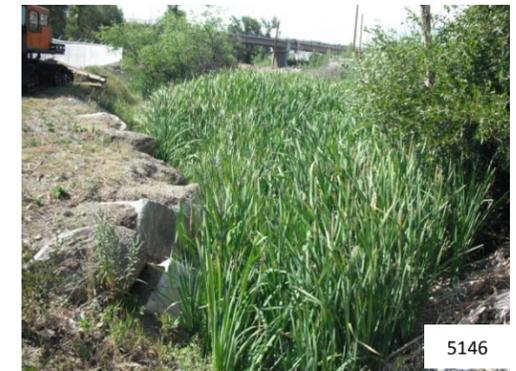
Location: Near Ferrell Gas off 13th Street
Problem/Solution: Remove vegetative growth to enhance conveyance to outfall.

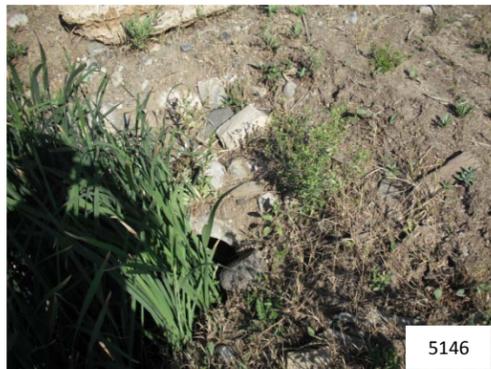
Location: At Ferrell Gas off 13th Street
Problem/Solution: Remove vegetation and blocked sediment from existing driveway CMP.
